# Supplementary Information

## **Introduction to Yunyan Temple Pagoda**

## **Background of the Yunyan Temple Pagoda Restoration**

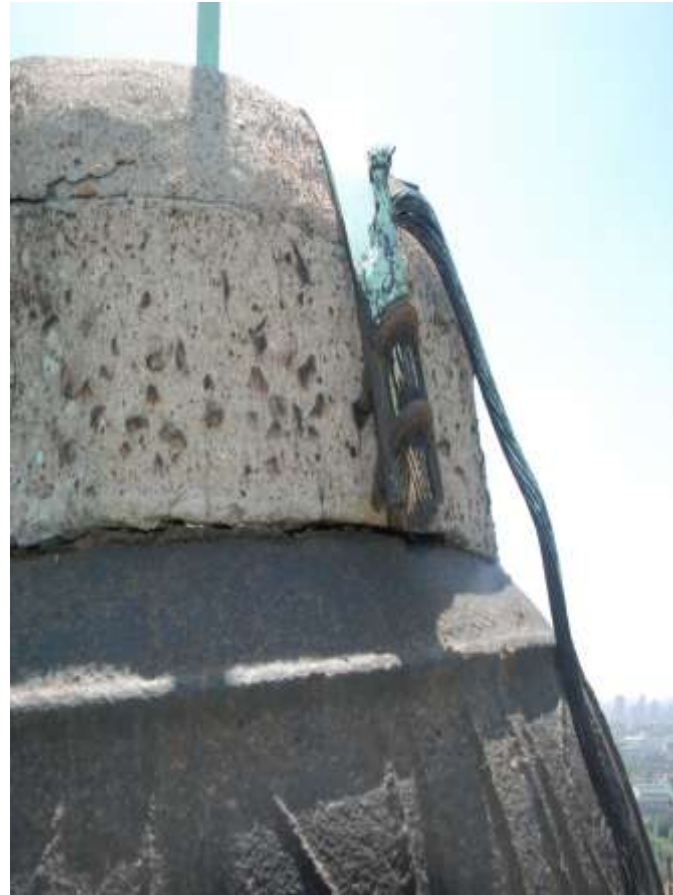
Before replacement

The original down conductor consisted of a single bare copper conductor with a relatively small cross-sectional area. During the maintenance project, it was replaced with two 100 mm<sup>2</sup> copper down conductors to improve electrical conductivity, reliability, and safety.

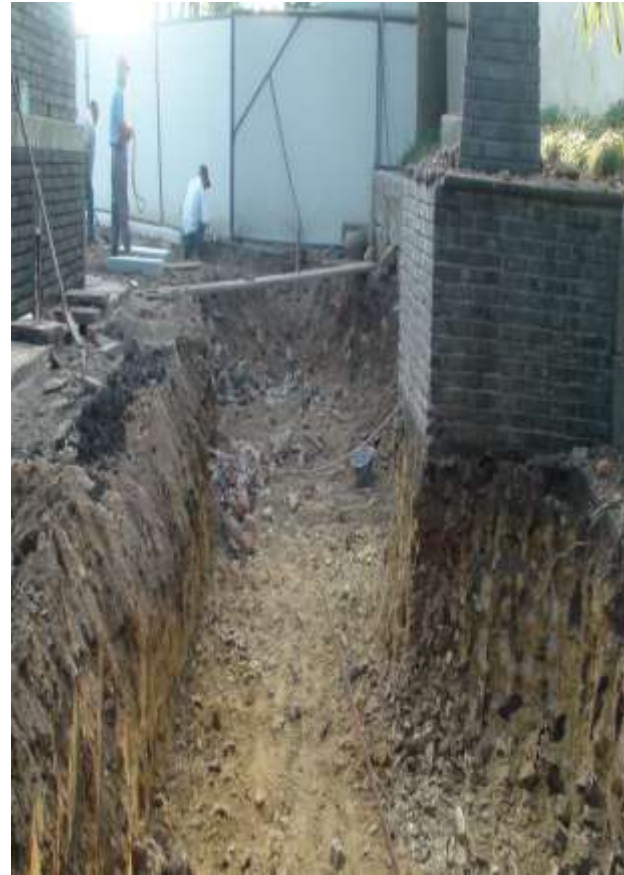
The original lightning-protection system did not include step-voltage protection. The 2015 intervention therefore introduced a step-voltage protection system around the grounding area of the pagoda.

step-voltage protection

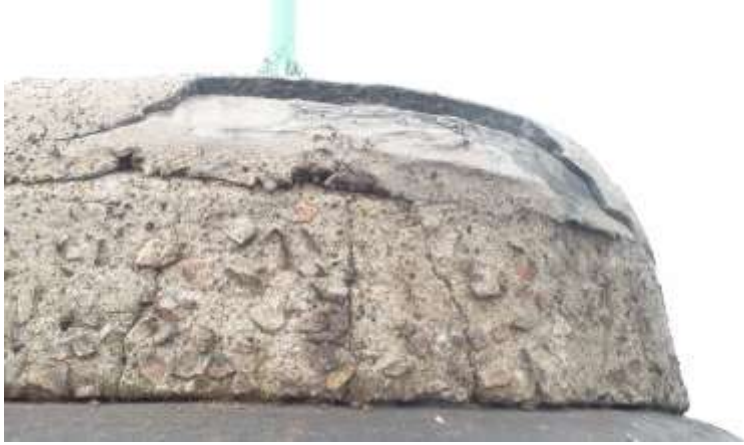
Cracking and detachment of the protective coating around the lightning-rod installation point

Detached and cracked areas were repaired using crack-resistant and water-resistant repair mortar.

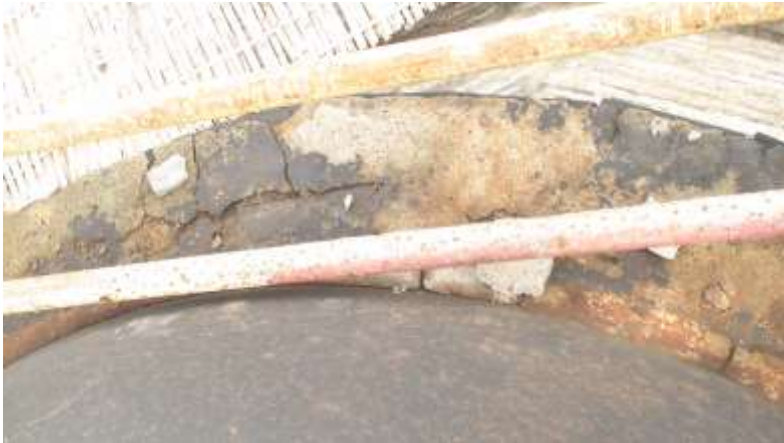
Detachment of the protective surface layer from the inverted-bowl element of the finial

Reinstatement of the protective surface layer on the inverted-bowl element

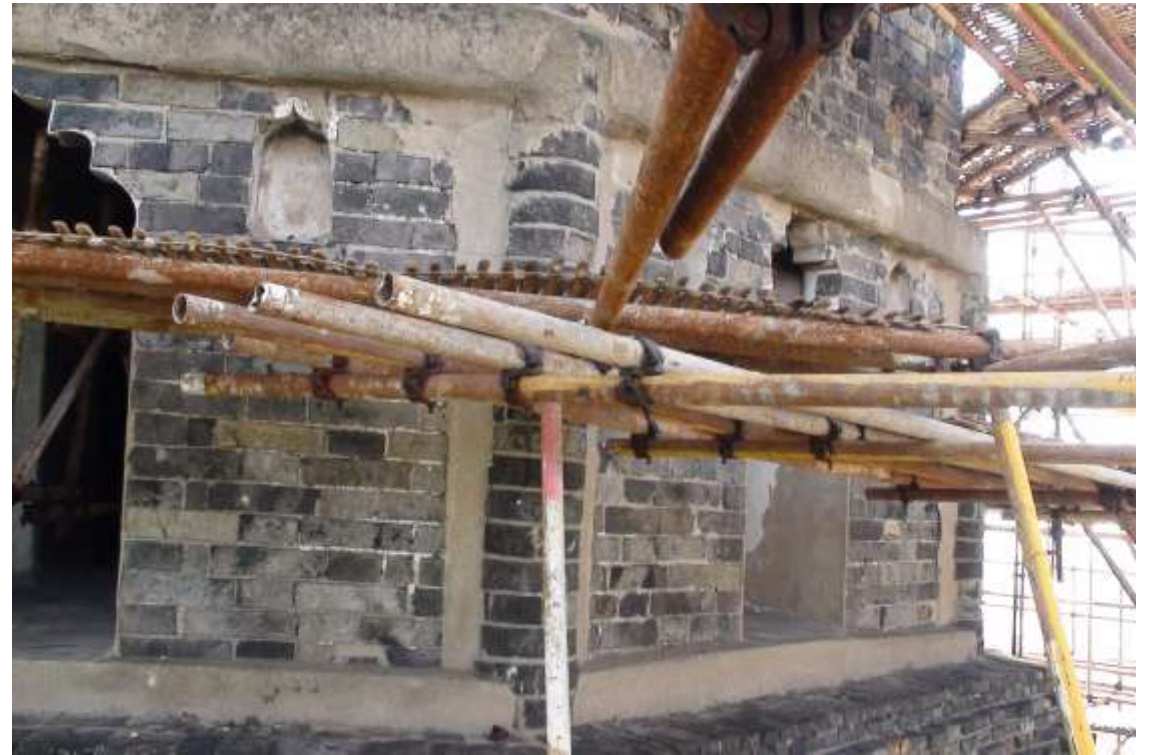
Circumferential steel hoops and corner steel plates were introduced during the 1957 stabilisation campaign. After long-term exposure to moisture, some of these steel components had corroded and expanded, causing cracking and separation of the surrounding masonry. Before intervention, each corner masonry column was measured and photographically documented.

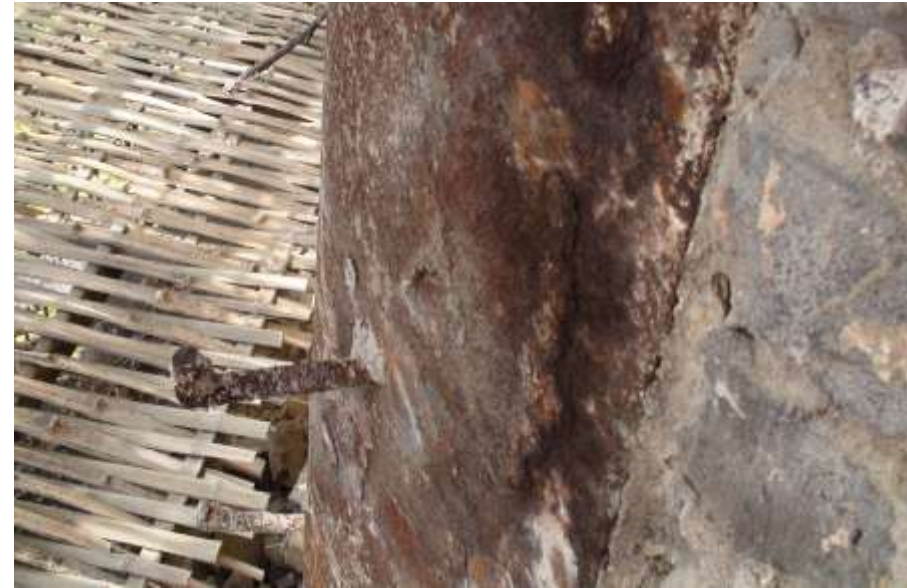
Mild surface corrosion before treatment

Where the locally exposed corner steel plates showed only mild corrosion, loose corrosion products and dust were removed. Two coats of anti-corrosion coating were then applied, after which the corner masonry columns were rebuilt using custom-made bricks.

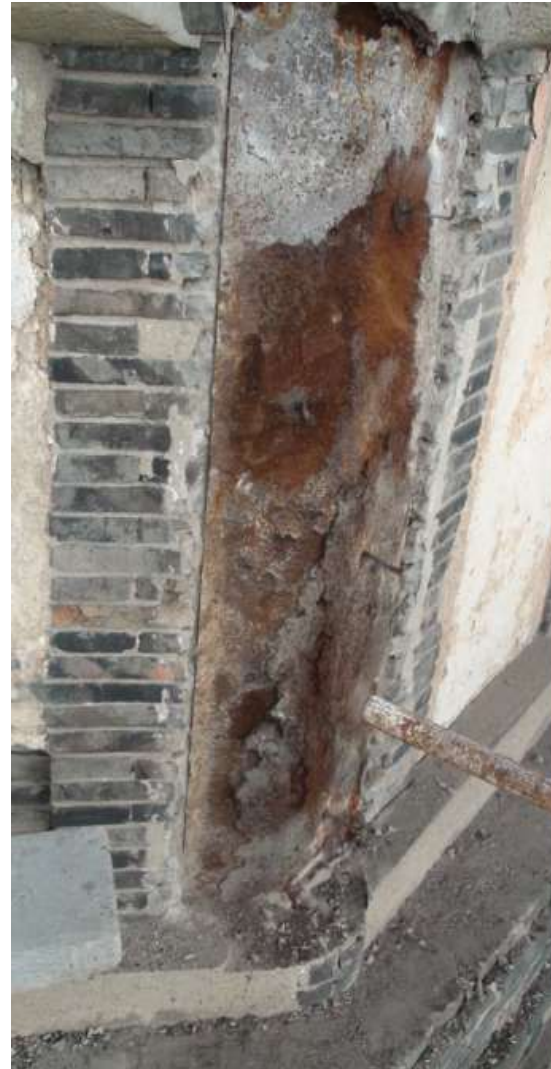
Severe corrosion of the steel plate within corner masonry column No. 5 at the fourth level

Severely corroded corner steel plates were exposed and cleaned, and their original dimensions were recorded. A new steel plate of matching dimensions was welded to the retained plate, followed by the application of an anti-corrosion coating.

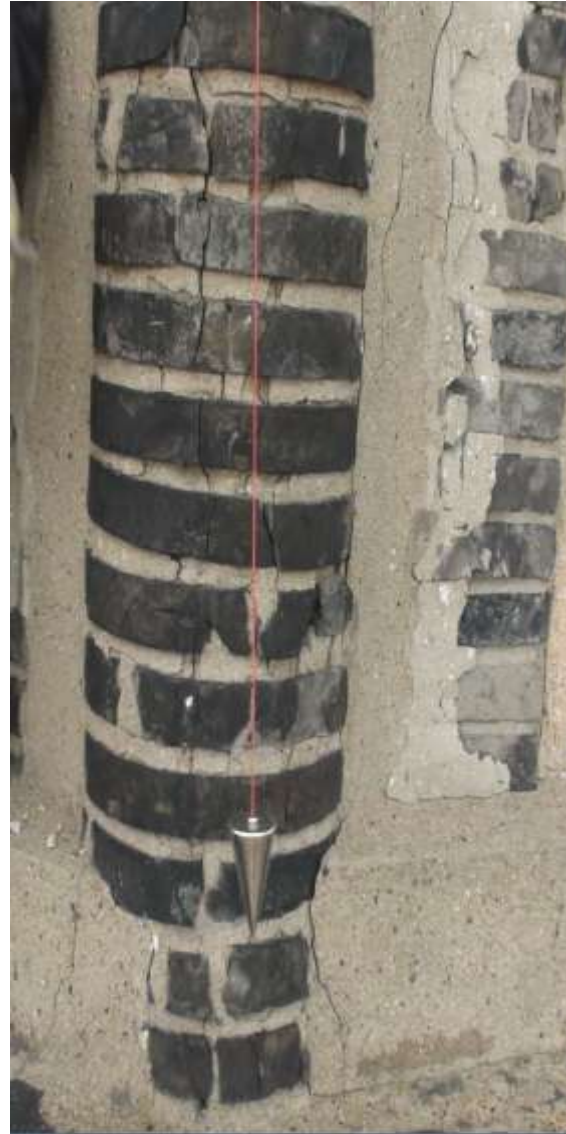
Original condition of corner masonry column No. 5 at the fourth level

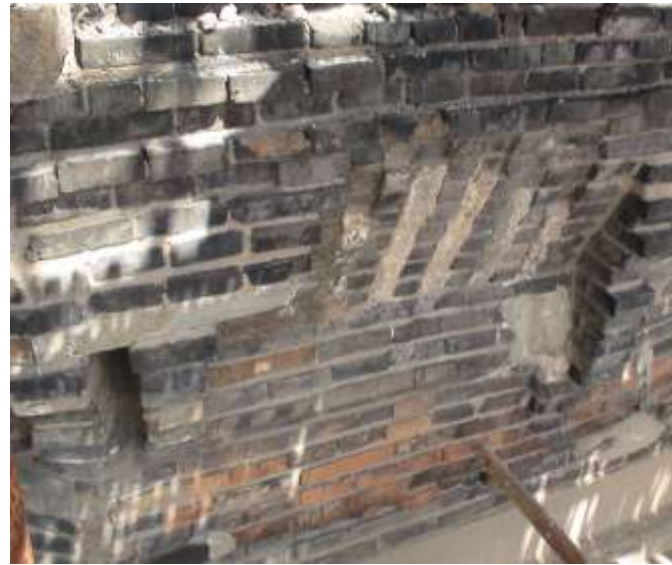
Before repointing

Open and deteriorated masonry joints allowed rainwater to penetrate the pagoda body and wash out portions of the internal earthen infill, potentially accelerating material deterioration. Following the on-site technical assessment, comprehensive masonry repointing was undertaken across the affected external surfaces.

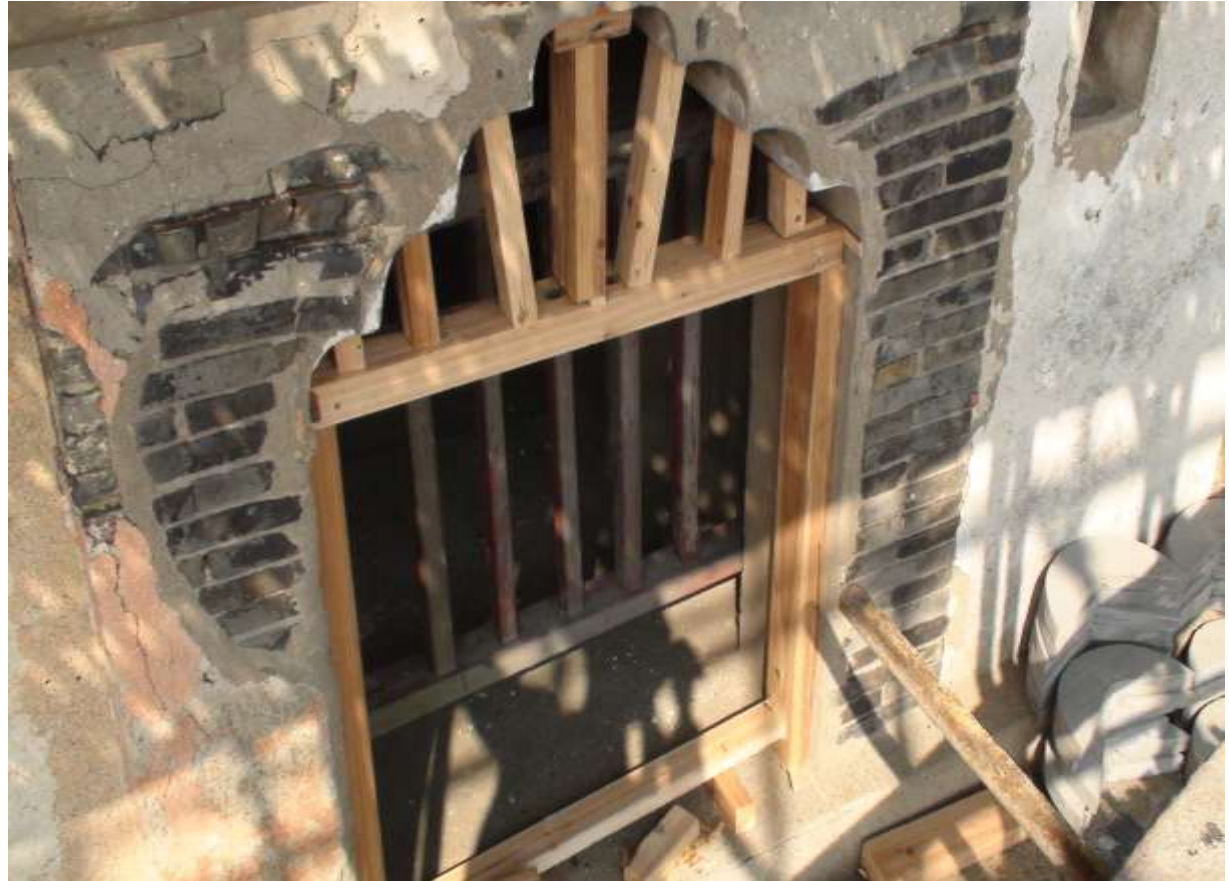
Existing reinforcing bars exposed as a result of corrosion  
and mortar loss

Temporary timber supports were installed beneath the deformed arched opening. Seven grooves were cut along the masonry joints, and two reinforcing bars were inserted into each groove before being concealed with compatible repair mortar.

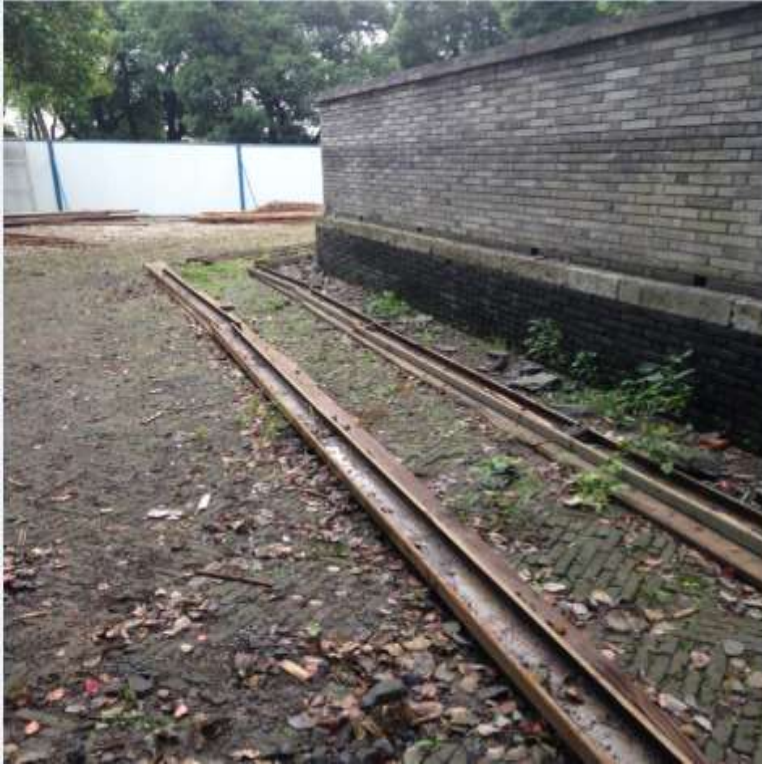
The original blue-brick paving provided inadequate surface drainage and allowed water to accumulate around the pagoda.
