# Long-term evolution and reactivation mechanisms of a typical loess–mudstone landslide in eastern Qinghai: Insights from remote sensing and in situ monitoring

## Case Report

**Keywords:** Loess–Mudstone Landslide, Toe Excavation, Landslide Reactivation, Evolutionary History, GNSS Monitoring

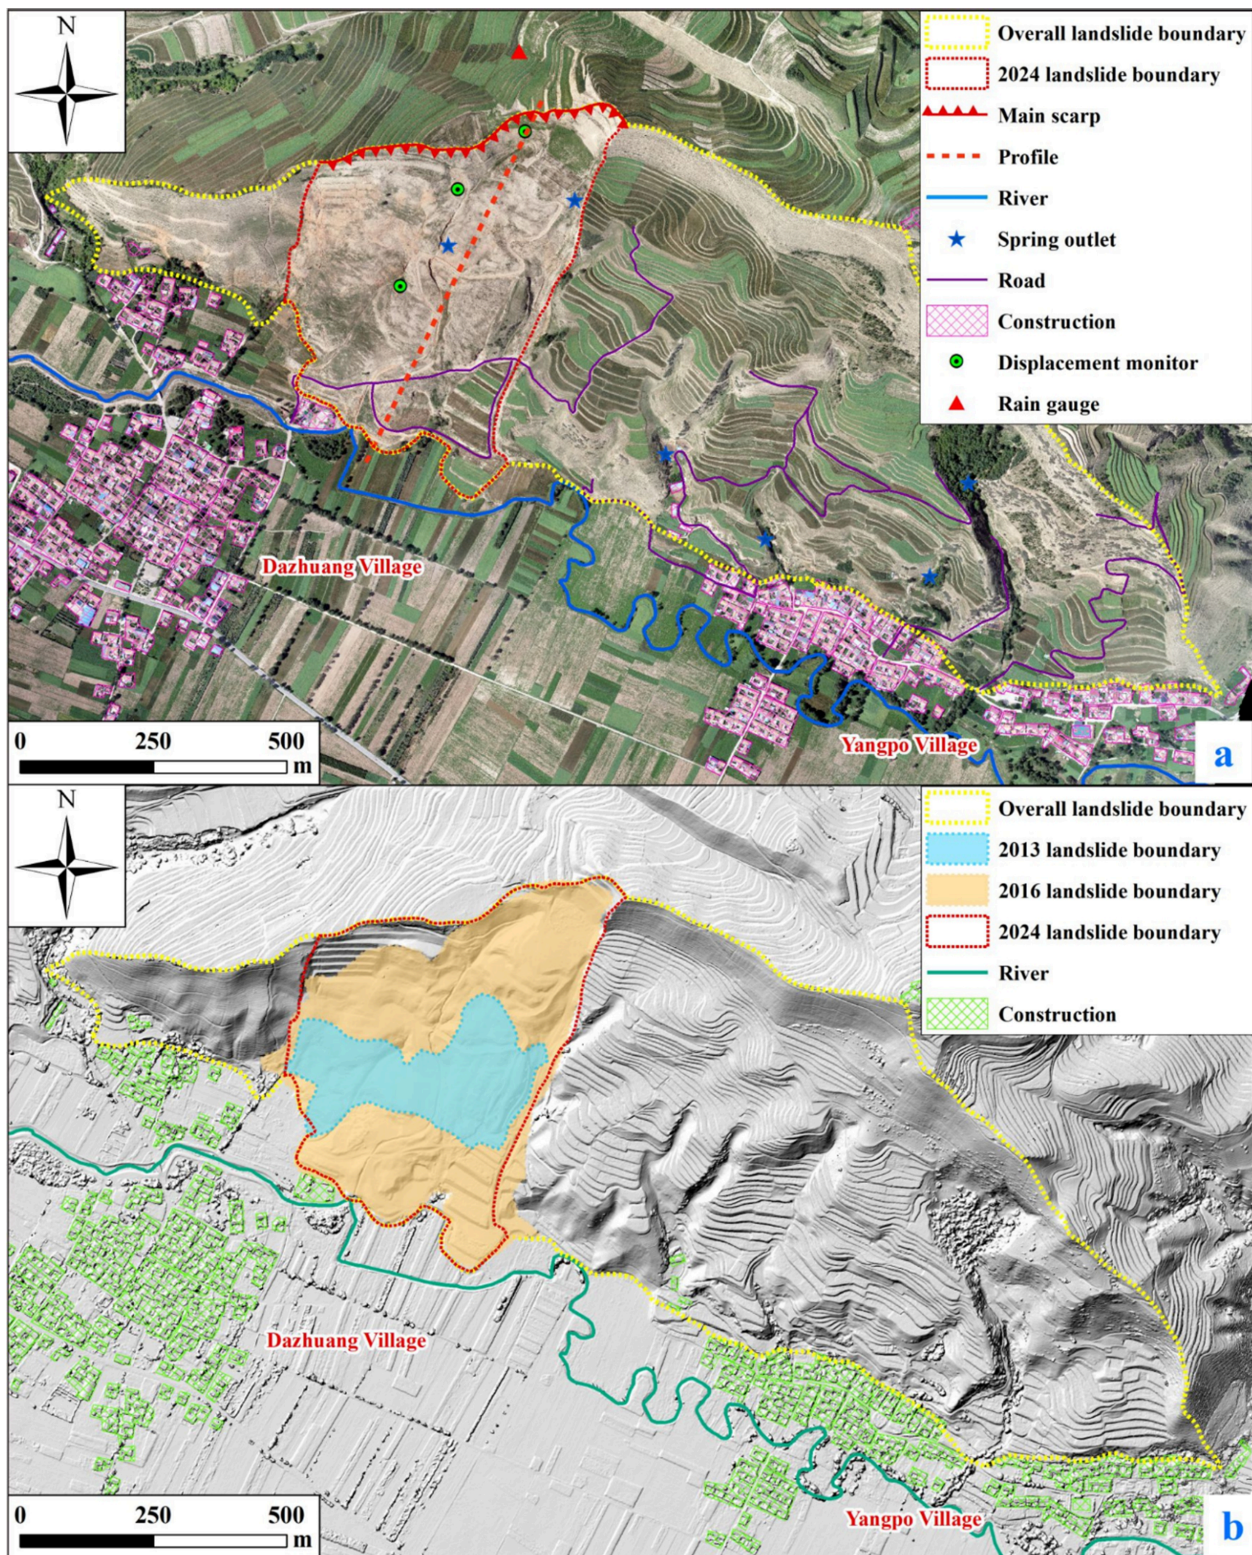
**Figure 2**

The river flows along the southern toe of the landslide, and several spring outlets occur in the middle and eastern parts of the slope, indicating groundwater discharge within the slope. Cracks in the upper slope, local ponded depressions, and the strip-shaped subsidence zone near the water-diversion project may all affect surface-water concentration and infiltration (Fig. 2a).

Comparison of the historical landslide boundaries (Fig. 2b) shows that the landslide area identified in 2013 was mainly concentrated in the middle–front part of the slope. Following the large-scale reactivation in 2016, the landslide expanded markedly toward the rear margin and both lateral sides. In 2024, the landslide generally retained the main outline formed in 2016, although local adjustments remained at the rear margin and along parts of the boundary. Historical investigation records indicate that the Dazhuang landslide experienced sliding events of different magnitudes in 2007, 2010, and 2016, demonstrating repeated activity within and around the pre-existing landslide. Its detailed evolutionary process is further analyzed in Section 5 using multi-temporal orthophotos.

Geomorphology, historical landslide boundaries, and monitoring layout of the Dazhuang landslide. (a) Landslide morphology and monitoring locations; (b) comparison of the landslide boundaries mapped in 2013, 2016, and 2024.

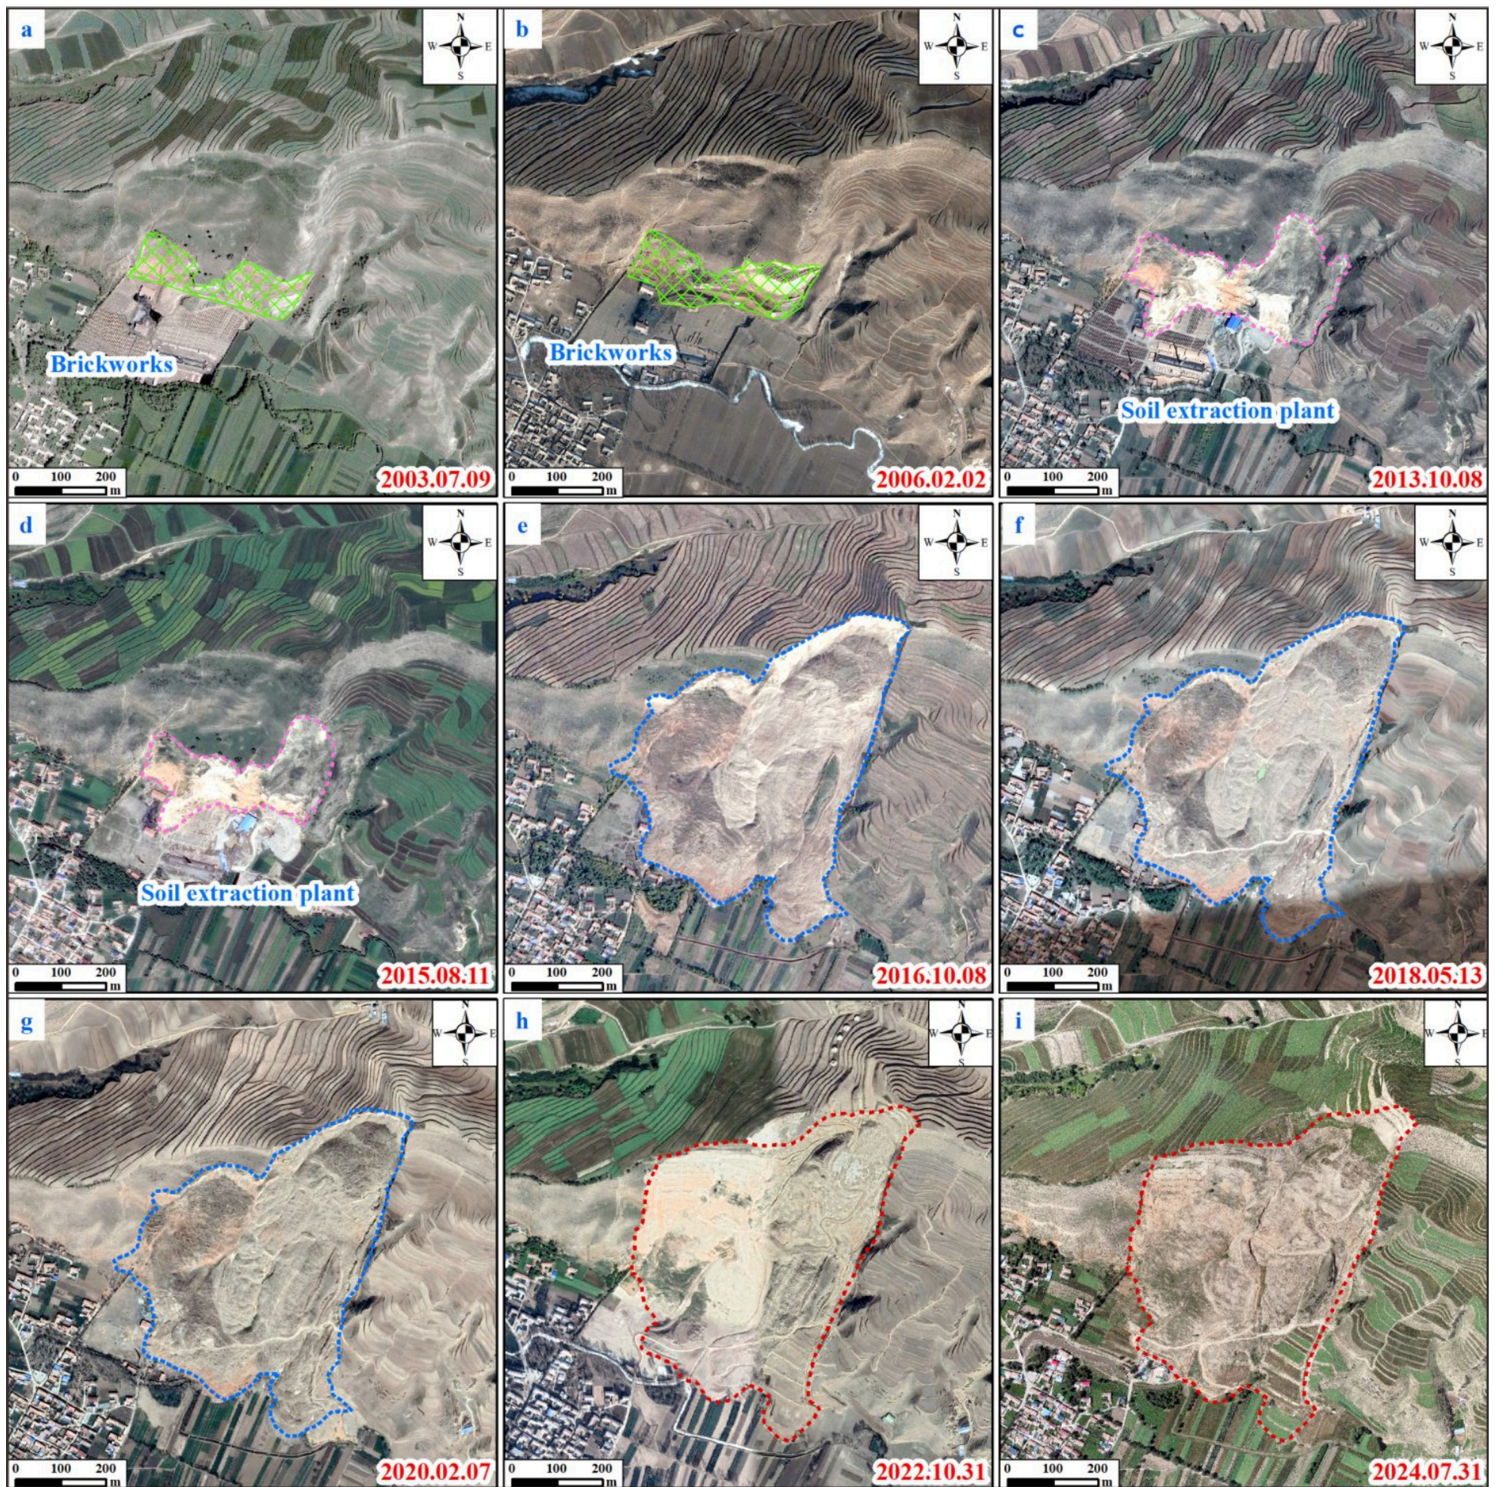
**Figure 3**

From the mid-1970s onward, long-term slope cutting and soil excavation for brick production at the slope toe gradually created a steep excavation face approximately 15–20 m high. Orthophotos from 2003 and 2006 (Fig. 3a, b) show that the excavation extent above the brickworks continued to expand, progressively disturbing the original toe morphology and support conditions. Historical records indicate that cracks began to appear in the upper slope in 2005, after which the slope entered a stage of pronounced deformation. Long-term toe excavation altered the slope geometry and boundary conditions, creating an adverse engineering geological setting for subsequent sliding.

On 25 September 2016, the Dazhuang landslide underwent another large-scale reactivation, involving a sliding volume of approximately  $5.4 \times 10^6 \text{ m}^3$ . Imagery acquired in October 2016 (Fig. 3e) shows pronounced upslope expansion of the rear margin, widespread destruction of the original terraces, strong internal topographic disruption, and a distinct tongue-shaped accumulation at the front. This event produced the largest mapped spatial expansion in the 2003–2024 imagery and largely established its present overall morphology.

From 2018 to 2020, changes in the overall landslide boundary were limited, and the rear scarp and frontal morphology formed in 2016 were largely preserved. By 2022, the overall outline largely retained the earlier morphology, but the upper rear margin locally expanded further upslope, indicating episodic reactivation of the pre-existing landslide. The 2024 imagery shows only limited changes in the overall outline relative to 2022, while the newly expanded rear-margin area remained preserved.

Multi-temporal orthophotos showing the evolution of the Dazhuang landslide from 2003 to 2024: (a) 9 July 2003; (b) 2 February 2006; (c) 8 October 2013; (d) 11 August 2015; (e) 8 October 2016; (f) 13 May 2018; (g) 7 February 2020; (h) 31 October 2022; and (i) 31 July 2024. The green shaded areas in panels (a) and (b) indicate the excavation extent of the brickworks. The pink dashed lines in panels (c) and (d) delineate the mapped landslide or deformation area affected by soil extraction activities. The blue

dashed lines in panels (e)–(g) and the red dashed lines in panels (h)–(i) indicate the interpreted landslide boundaries at the corresponding stages.

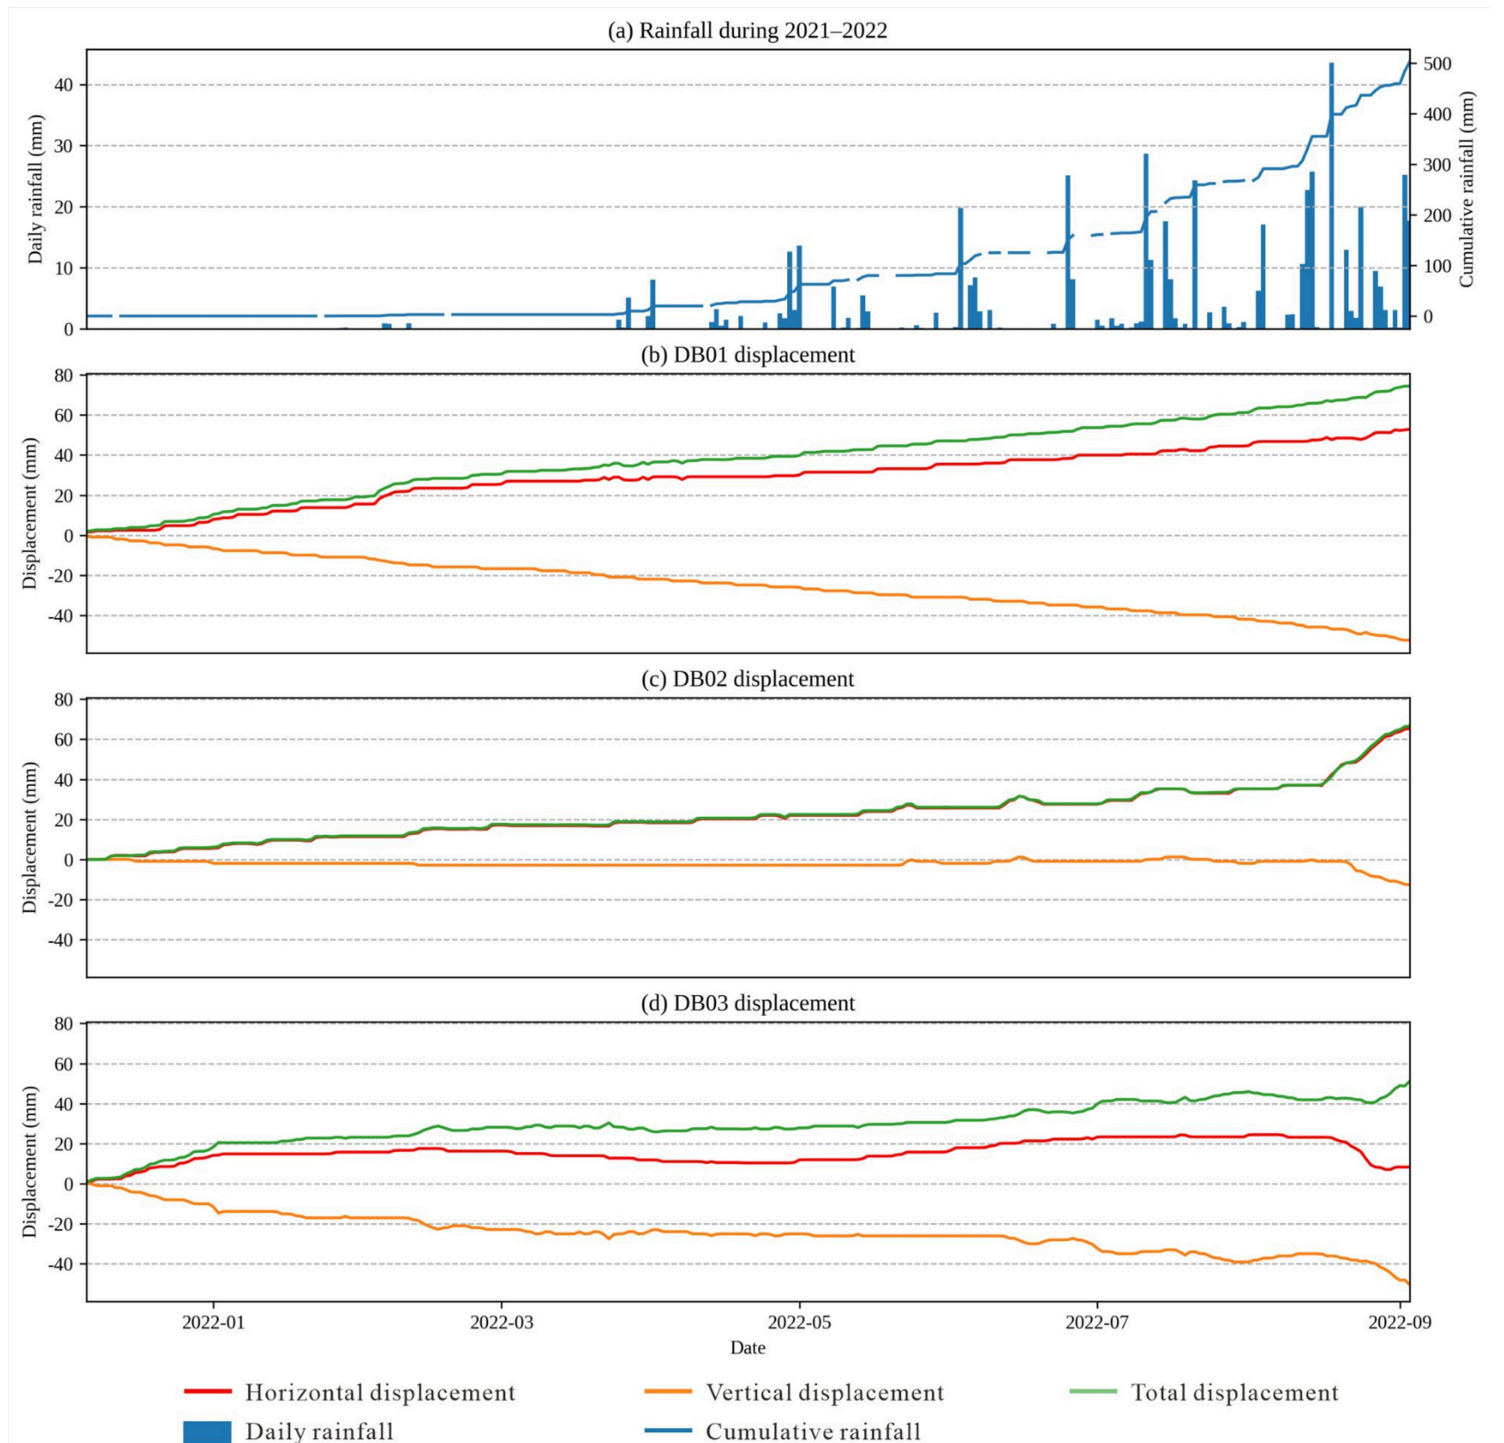
**Figure 4**

Concurrent GNSS monitoring recorded sustained deformation (Fig. 4). Over the 2021–2022 monitoring period, total cumulative displacements at DB01, DB02, and DB03, located in the upper, middle, and lower parts of the landslide north of the Dazhuang brickworks, reached 72.6, 66.5, and 51.6 mm, respectively. Following the heavy rainfall on 17 August 2022, deformation accelerated, most clearly at DB02. An additional displacement of approximately 29.5 mm was recorded between 17 August and 3 September. The monitoring records show that the magnitude and timing of deformation varied across the slope.

Pronounced reactivation occurred in 2022. The increase in GNSS displacement during the August rainfall supports rainfall as a trigger for the renewed movement. Rainfall infiltration can increase the water content and unit weight of slope materials and soften weak zones and mudstone, promoting renewed movement.

Rainfall and GNSS displacement monitoring results of the Dazhuang landslide from 2021 to 2022. (a) Daily and cumulative rainfall; (b–d) horizontal, vertical, and total displacement at DB01 (upper slope), DB02 (middle slope), and DB03 (lower slope), respectively.

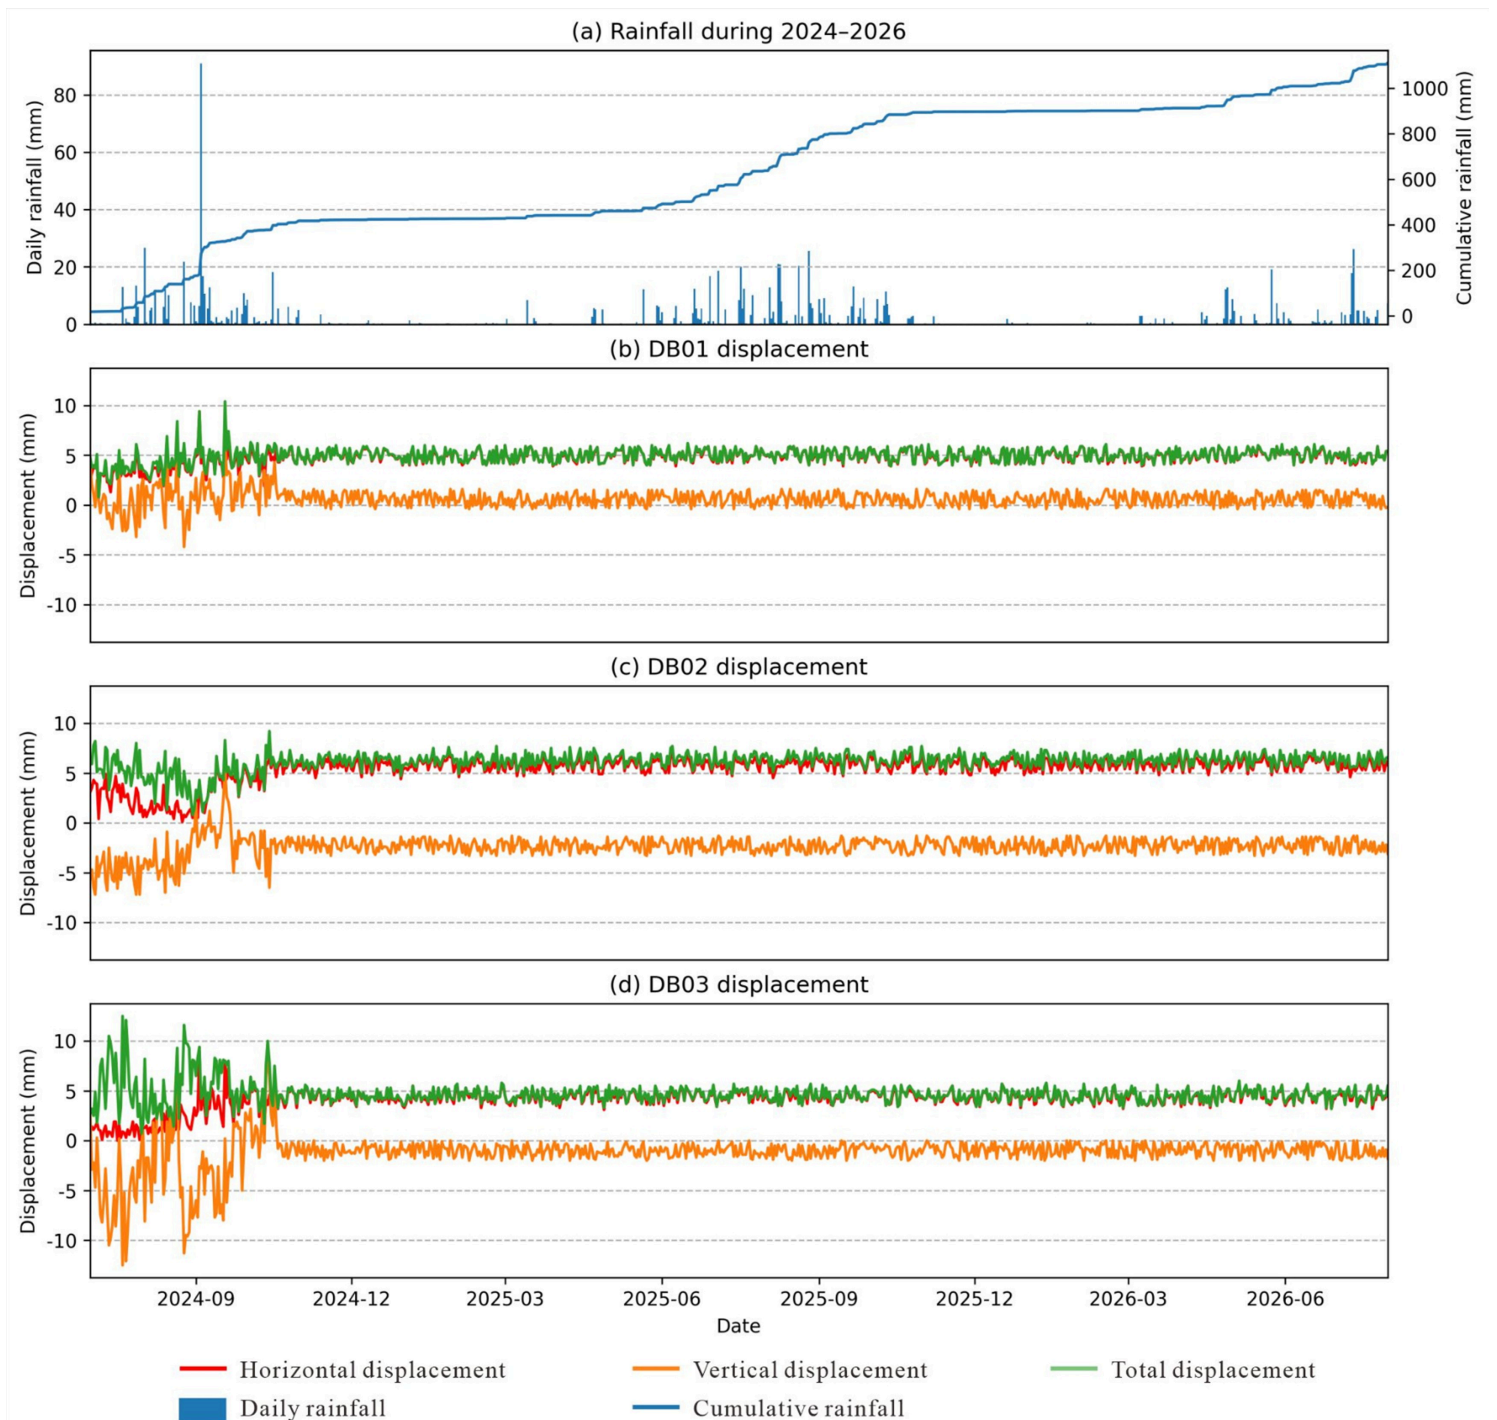
**Figure 5**

GNSS records from 2024 to 2026 were used to assess activity after the 2022 reactivation (Fig. 5). The three monitoring points initially showed fluctuations of varying amplitudes in horizontal, vertical, and total displacement. From autumn 2024 to July 2026, the recorded displacements generally fluctuated within a millimeter-scale range without sustained acceleration. This pattern indicates lower activity at the monitored locations than in 2022.

Several substantial rainfall events occurred during 2024–2026, but the three monitoring points showed no sustained acceleration associated with these events. Together, the two monitoring periods document pronounced deformation in 2022 followed by low-amplitude displacement fluctuations in 2024–2026. Pre-existing cracks, weak zones, and local runoff concentration remain relevant to future activity and warrant continued monitoring.

Rainfall and GNSS displacement monitoring results of the Dazhuang landslide from 2024 to 2026. (a) Daily and cumulative rainfall; (b–d) horizontal, vertical, and total displacement at DB01 (upper slope), DB02 (middle slope), and DB03 (lower slope), respectively.

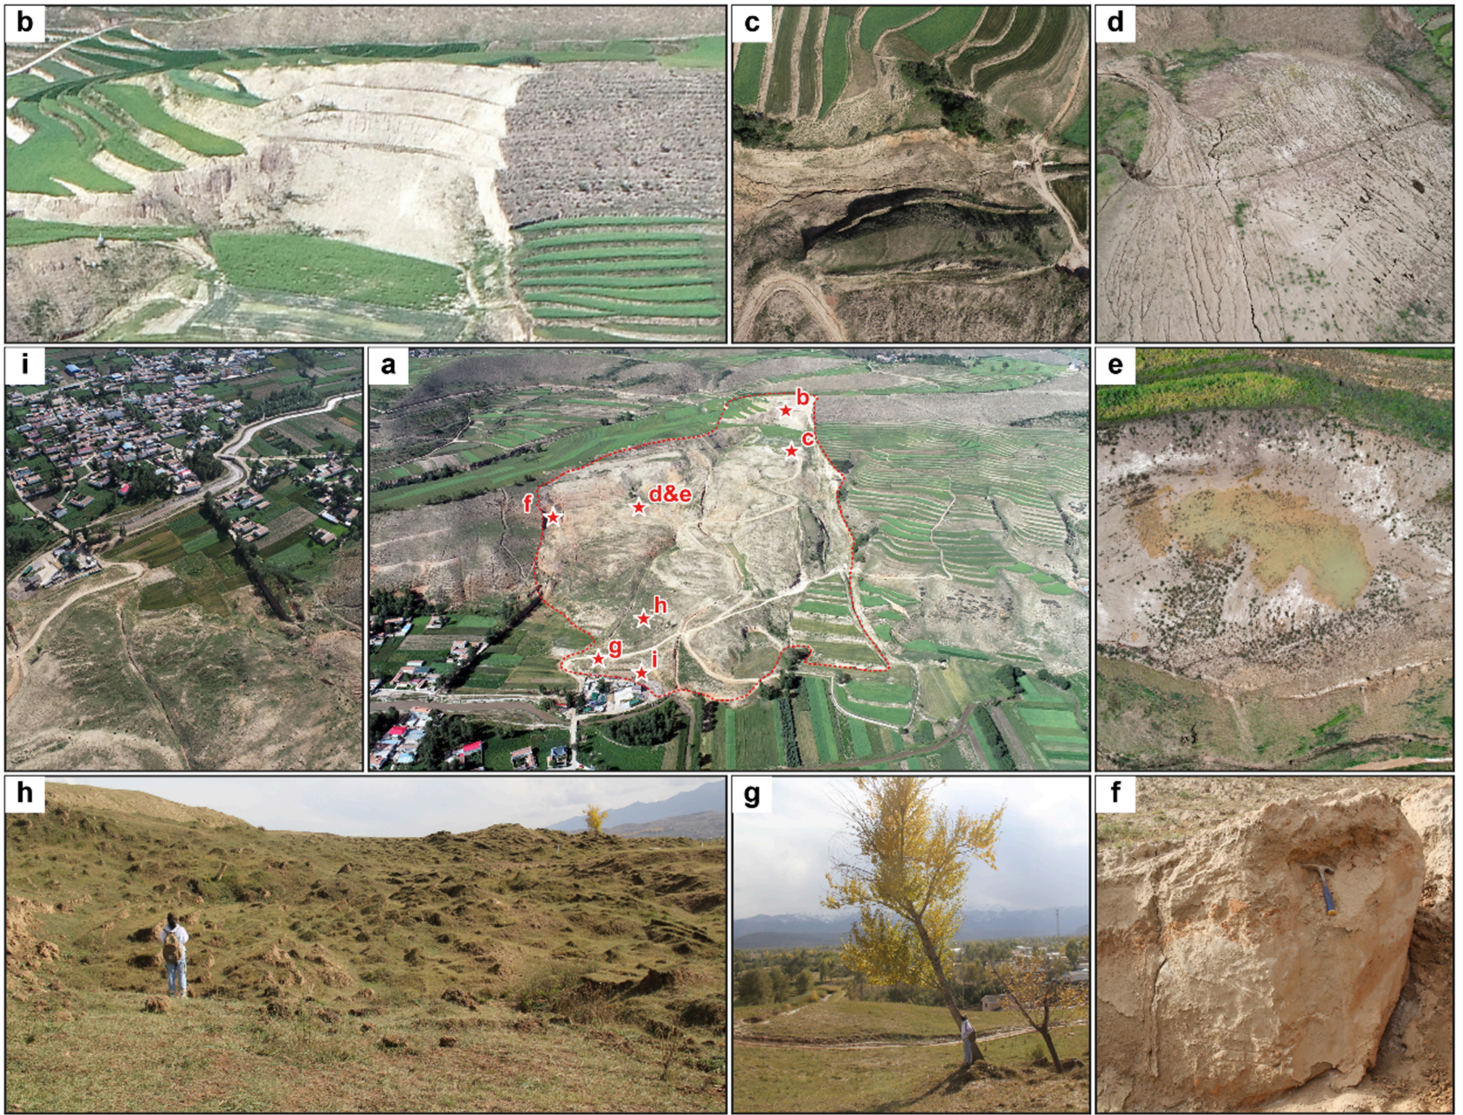
**Figure 6**

To further characterize the surface deformation, sliding-mass composition, and hydrogeological features of the Dazhuang landslide, a field investigation was conducted in 2024. The investigation focused on the landslide boundary, main scarp, rear-margin cracks, local ponding and seepage, sliding-mass materials, and depositional characteristics at the landslide front. Figure 6a shows the overall landslide morphology and the locations of representative investigation sites. The red dashed line indicates the landslide boundary, whereas the red stars and corresponding letters mark the locations of the geological features shown in Fig. 6b–i.

A prominent main scarp occurs along the rear margin of the landslide (Fig. 6b), where a relatively continuous tensile zone and tensile cracks are visible (Fig. 6c), indicating pronounced tensile deformation in the rear part of the slope. Strip-shaped subsidence and a seepage zone occur locally in the middle–upper part of the landslide (Fig. 6d), while a distinct ponded depression and adjacent tensile cracks are present in the upper part of the landslide (Fig. 6e). A strip-shaped subsidence zone approximately 0.2 m wide near the pipeline of the Yinda–Jihuang Water Diversion Project may concentrate surface runoff and promote infiltration. Owing to repeated sliding and long-term deformation, the landslide mass is strongly fragmented and contains mixed materials. Locally, loess is mixed with highly weathered mudstone debris (Fig. 6f), and loose, irregular deposits occur in the middle–lower accumulation zone (Fig. 6h). Trees are locally tilted and bent (Fig. 6g), indicating that the slope has undergone sustained or repeated slow deformation. The landslide front is close to the residential area (Fig. 6i), indicating that renewed landslide activity could directly affect residents and infrastructure near the slope toe.

Typical surface deformation and depositional features of the Dazhuang landslide. (a) Panoramic view; (b) main scarp; (c) through-going tensile cracks at the rear margin; (d) seepage zone near the Yinda–Jihuang Water Diversion Project; (e) ponded depression and tensile cracks in the upper part of the landslide; (f) mixed deposits of loess and highly weathered mudstone debris; (g) tilted trees associated with slope deformation; (h) blocky deposits in the accumulation zone; and (i) landslide toe and adjacent residential area. The red dashed line denotes the landslide boundary, and the red stars and corresponding letters indicate the locations of the features shown in each panel.

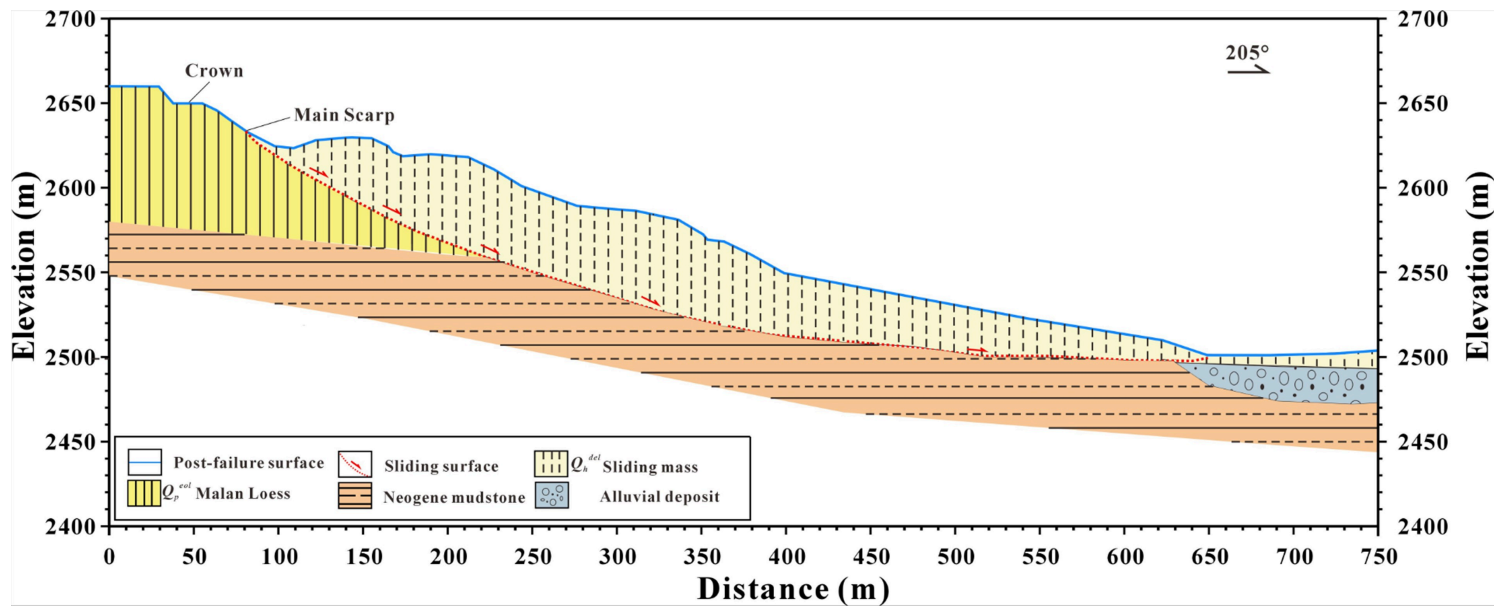
**Figure 7**

Based on topographic data and field investigation results, a longitudinal geological profile of the Dazhuang landslide was constructed along the main sliding direction of approximately 205° (Fig. 7). The profile is approximately 750 m long, and the ground-surface elevation decreases from about 2,660 m at the rear margin to approximately 2,500 m at the front, giving a relative relief of about 160 m. The slope shows an overall stepped morphology descending from rear to front, consistent with the multiple landslide benches identified during the field investigation. A prominent main scarp occurs at the rear margin. The interpreted sliding surface extends from the rear margin into the slope, dips gently toward the front, and gradually approaches the ground surface near the landslide toe. The frontal terrain is relatively gentle, with local alluvial deposits.

The longitudinal profile shows Quaternary Malan loess overlying Neogene mudstone. The interpreted sliding surface lies within the loess in the rear segment and approaches the loess–mudstone contact zone farther downslope. This geometry links deformation in the rear loess to the stratigraphic and hydrological conditions in the middle and lower parts of the slope.

Interpreted longitudinal geological profile of the Dazhuang landslide. The location of the profile is shown in Fig. 2.
