# Effectiveness of grey and green engineered solutions for protecting the low-lying muddy coast of the Chao Phraya Delta, Thailand

## Supplemental Information

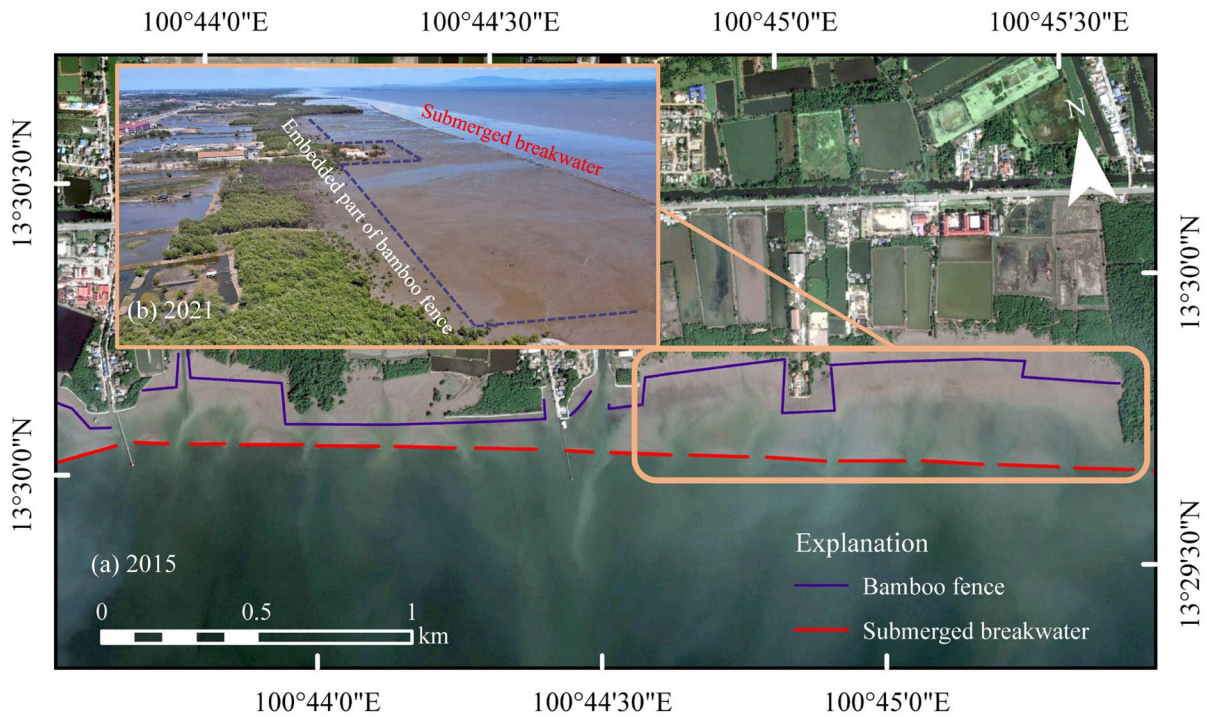
**Figure S2.** (a) Submerged breakwaters between Sta.15+000 to Sta.18+400 effectively traps sediment behind the structure. (b) Sediment trapped by submerged breakwaters. The purple dashed line shows the embedded part of bamboo fence, which completely deteriorated since 2015.

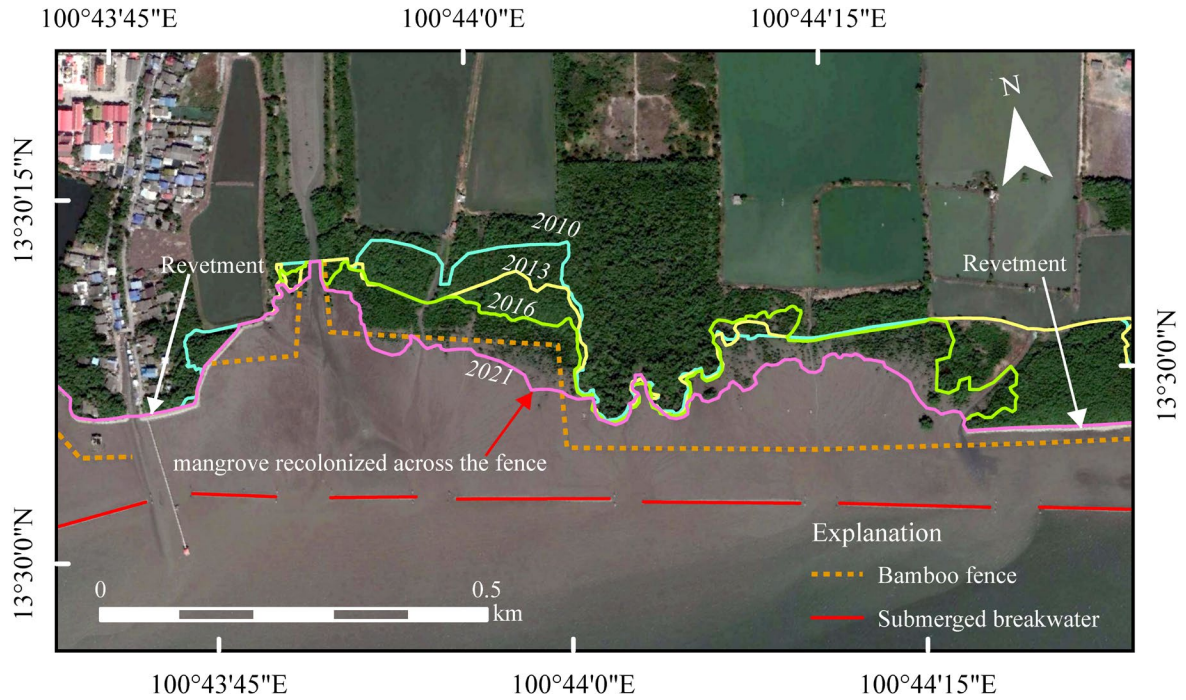
**Figure S3.** Mangroves recolonized seaward across the deteriorated bamboo fence between Sta.15+040–Sta.16+500.

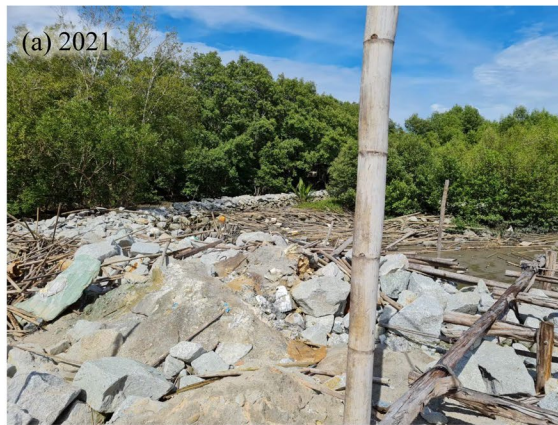
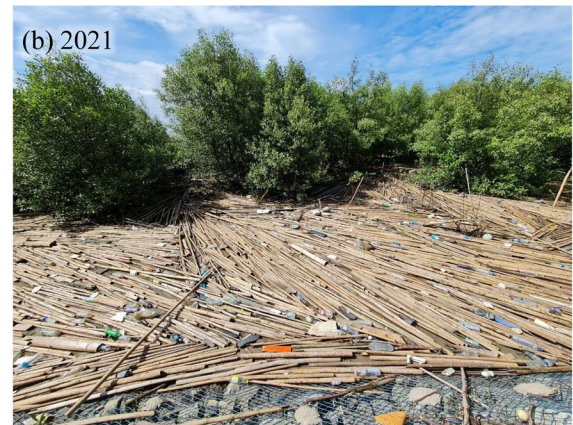
**Figure S5.** (a) Debris bamboo east of Ban Si Long after three years from construction. (b) Bamboo debris west of Ban Si Long three years after construction.

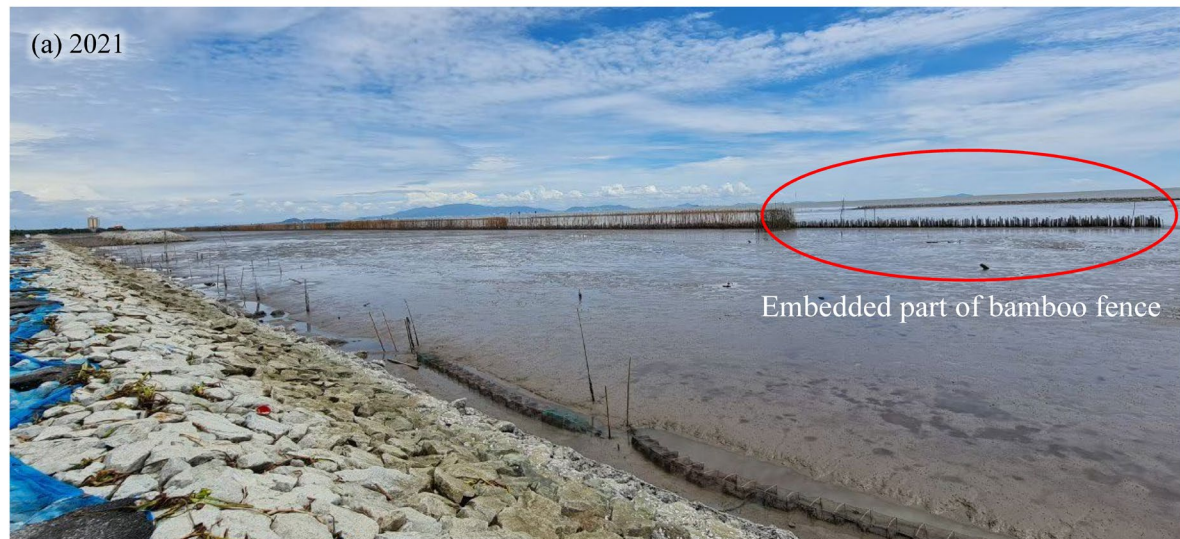
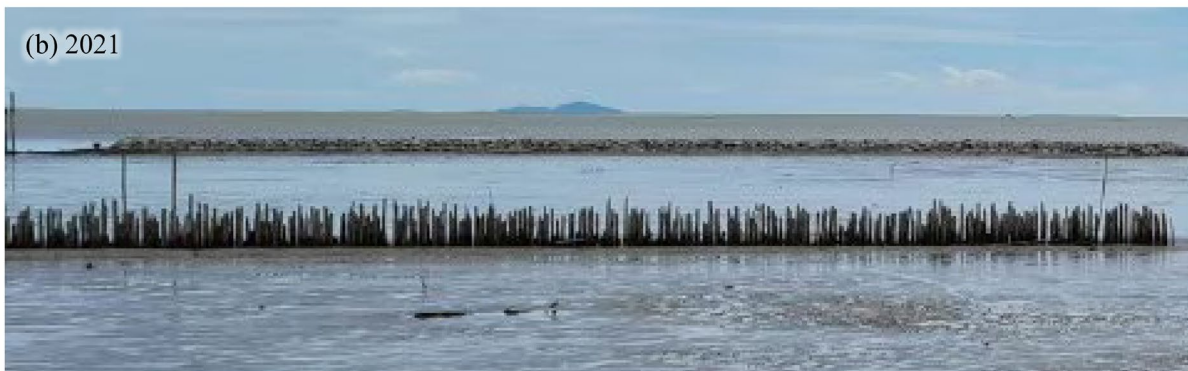
**Figure S6.** (a) Bamboo fence east of Ban Si Long between Sta.28+540 and Sta.29+500. As the bamboo normally breaks into two parts after 2–3 years from construction, the red ellipse shows the embedded part of the bamboo fence. (b) The embedded part of the

fence seems too short to dissipate the wave energy during high tide and obstructs coastal access.

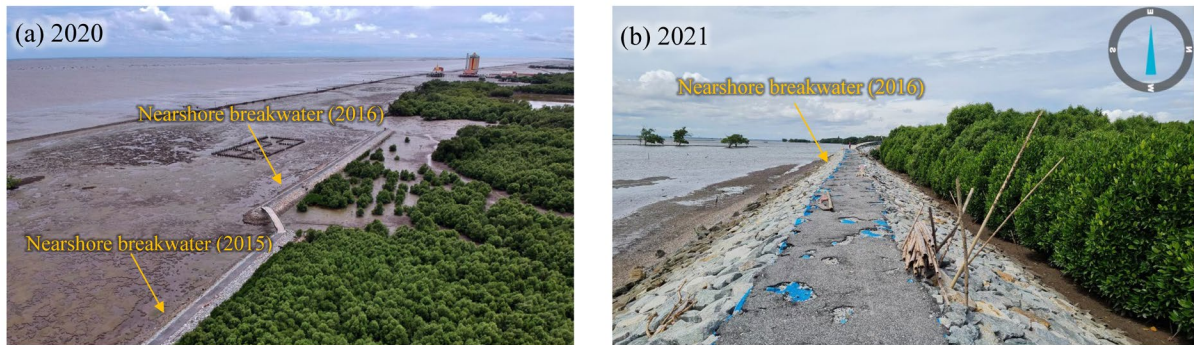
**Figure S7. (a)** Nearshore breakwaters constructed in 2015 and 2016 at Ban Khlong Hong Thong coastline (Sta.31+860–Sta.32+220) effectively trapped sediment behind the structures resulting in mangrove rehabilitation. On the other hand, these structures obstructed mangroves from colonizing further seaward. **(b)** Mangroves fully occupied the lee side of the nearshore breakwater constructed in 2016 within one year (2020–2021). The structure trapped approximately 1-m high sediment after five years from construction.
