Supplementary Information to: *Adaptive Multihazard Modeling Predicts Rainfall-Driven Dam Failure: A Case Study* — Mohammed Nasser, Eleyas Assefa, Siraj M. Assefa, Constantinos C. Sachpazis and Lysandros Pantelidis.

1. Location and Data Variability

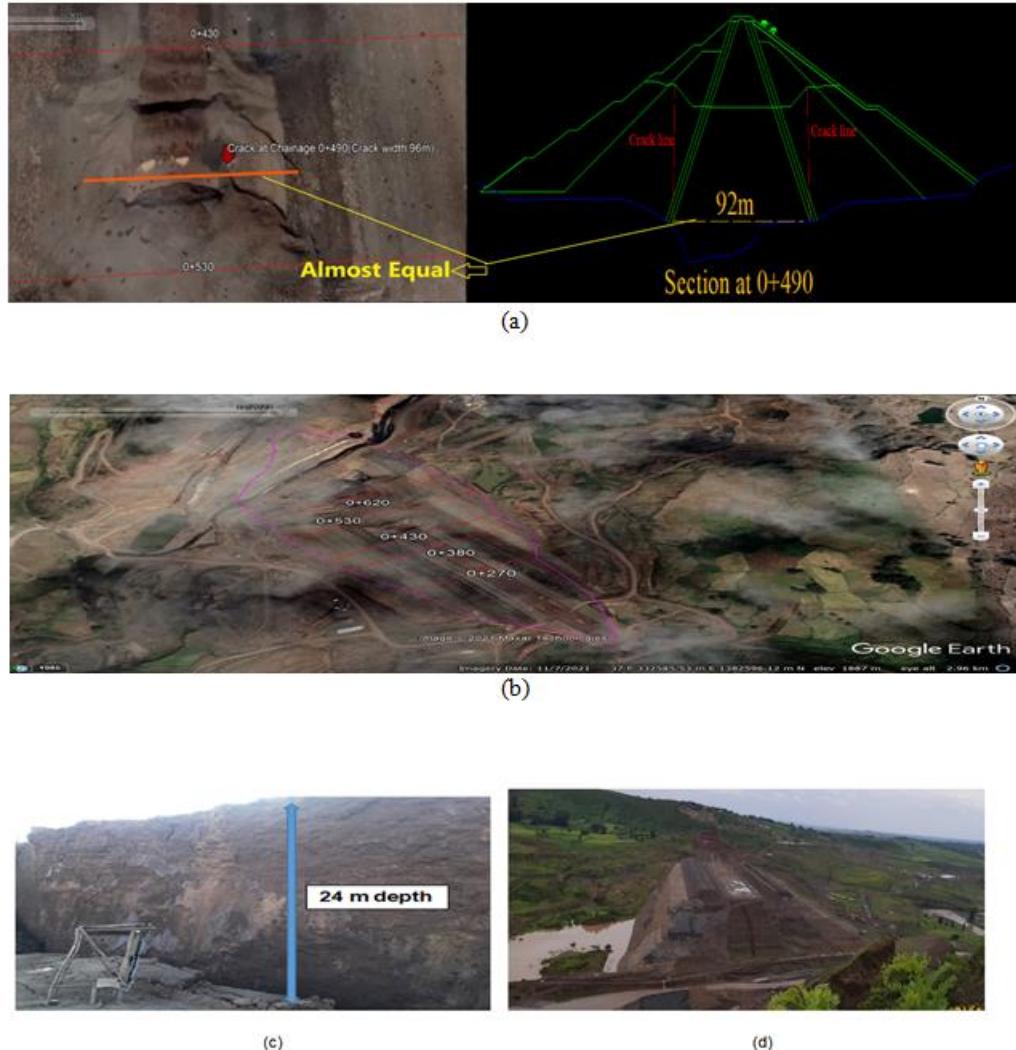
Figure S1: Field observations at Megech Dam showing progressive slope instability and corresponding mitigation efforts: (a) Stabilized clay core after 2020 tension cracks following >1,200 mm annual rainfall;; (b) Major 1.5 m-deep surface cracks on the core during the 2020–2021 wet season; (c) 2021 downstream slope slide displacing fill up to 3 m along chainage 0+420–0+640;d) 2022 emergency dyke diversion failed as reverse Megech River flow re-entered the embankment.
