# Geological, mineralogical, petrographic, hydrogeological, and environmental evaluation of a marble site: Could the water resource protection zone be damaged due to the site?

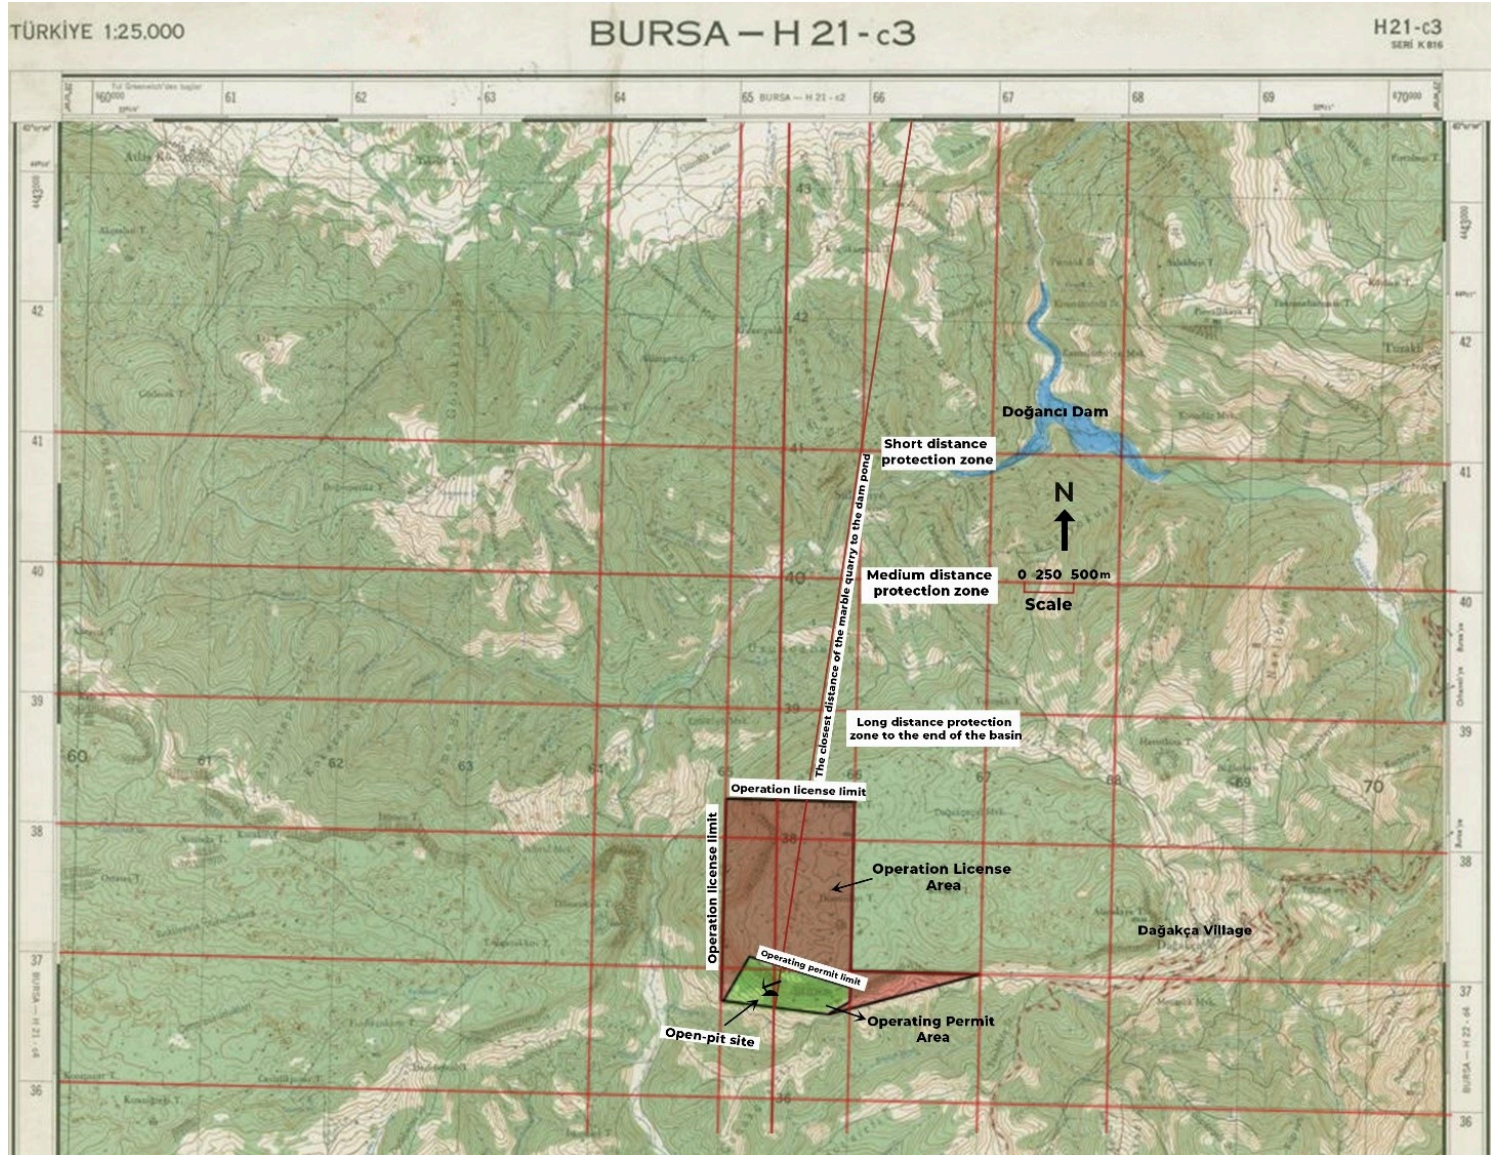
Figure 1

Map of the distances of the mining area to the Doğancı Dam protection area on a 1/25000 scale topographic map<sup>[4]</sup>.

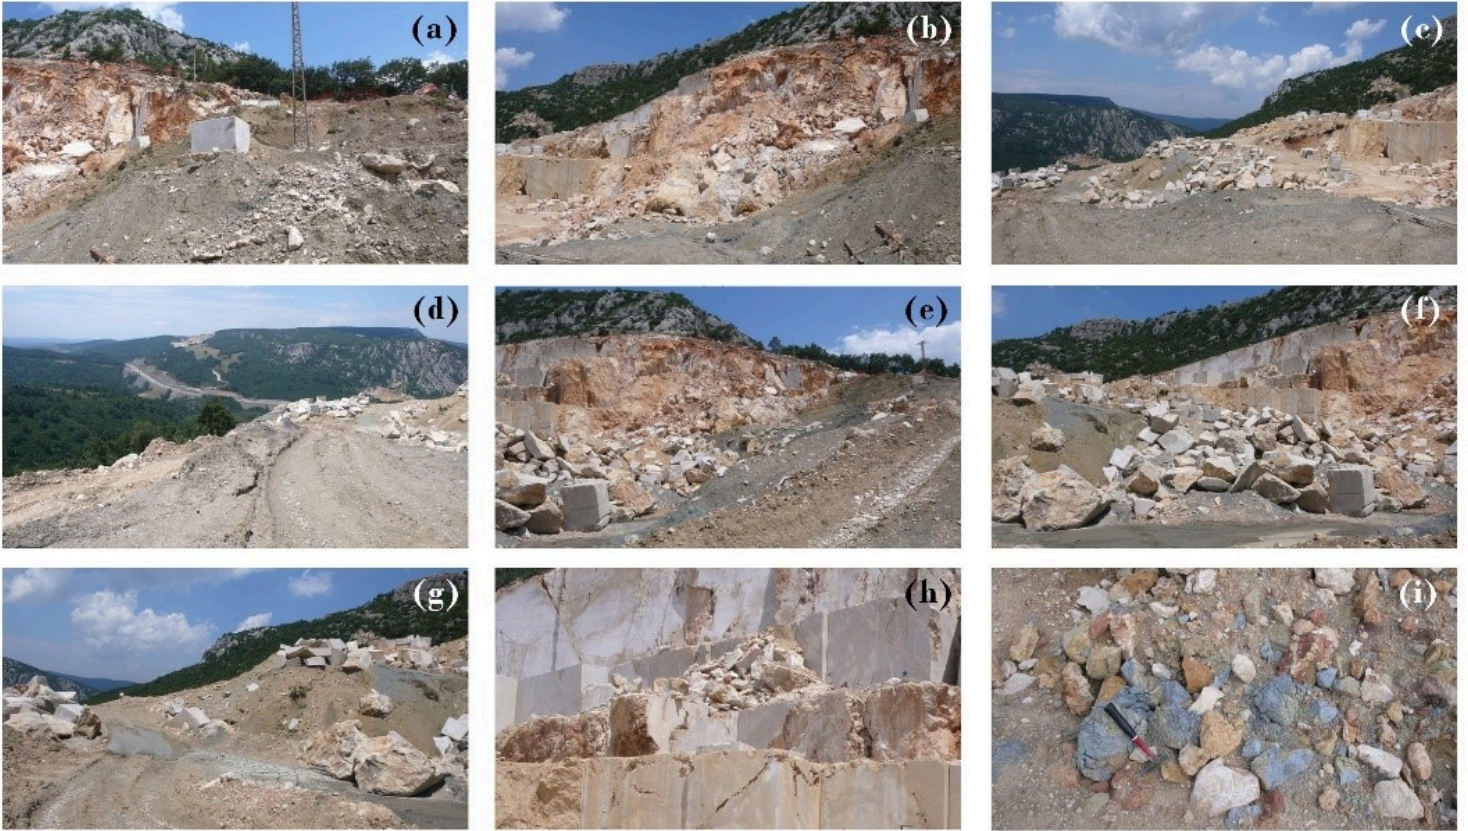
**Figure 5**

Open-pit-1, blocky-fragmented marble (rust), and the gray-colored metamorphic basement formation underneath are seen. (Fig. 7-b), similar to (Fig. 5g-h), shows the spoil and metamorphic units at the bottom. In (Fig. 5-i), karst construction, marble block stone production residues, and metamorphic schist units in the waste area can be seen. In open-pit-1, a rifted and crushed zone (Fig. 6-a) and intact marble levels and crushed units containing abundant hematite in the foreground (Fig. 6-b) are seen. (Fig. 6c-d) shows the marble outcrops and surface shapes that continue towards the top with Open-pit-1, and the block production and stock area from emperor-type brecciated carbonate neritic limestones produced at the bottom. Stalactite-stalagmite structures formed in karstic cavities and cracks with abundant iron-containing walls (Fig. 6e-f), rift, fracture zone, and karst structures (Fig. 6g-h), close view of the crushed and rift zone in Open-pit-1 is presented in (Fig. 6-i). Gray-colored metamorphic rocks or detrital carbonates and block stone-marble pieces are presented in (Fig. 7-a), and distant and close-up views of the opening of Open-pit-2, located in the western part of the operating permit area, are presented in (Fig. 7c-d). Although it is outside the study area, there is another marble quarry near this marble quarry. Open-pit-2 and blockstone marble stocks can be seen in (Fig. 7e-f). In Open-pit-2, clastic fragments and terra rossa formations are seen at the bottom as spoils. The marbled zone continues from Open-pit-2 to Open-pit-1 and towards the hill (Fig. 7g-h). In Open-pit-2, (emperor) marble is in (Fig. 7-i), in Open-pit-2, the opening and upper marble level of Open-pit-1 is in (Fig. 8-a), and in Open-pit-2, The blockstone exhibition area in front of pit-2 is presented in (Fig. 8b-c). (Fig. 8-d) shows block stone-marble and surrounding fields, and (Fig. 8-e) shows the partially forested and marble potential area in the western part. Marble pieces and terra rossa (Fig. 8-f), marble-forming limestones, and underlying metamorphic units (Fig. 8-g) are seen in the spoils. Orhaneli Road continuing towards the west, the gravel quarry of the General Directorate of Highways and Four-stage marble quarry in the background (Fig. 8-h), and the general view of the east of Open-pit-1 and Open-pit-2 from the south is presented in (Fig. 8-i).

**(a-b)** Open-pit-1 and its stages in the study area, **(c-d)** Other marble quarries on the Orhaneli road close to Open-pit-1, **(e-f)** View of Open-pit-1, **(g-h)** Open-pit, opening, stages, and cracked structures. (i) Spoils- residues, marble blockstone fragments, and metamorphic schist.

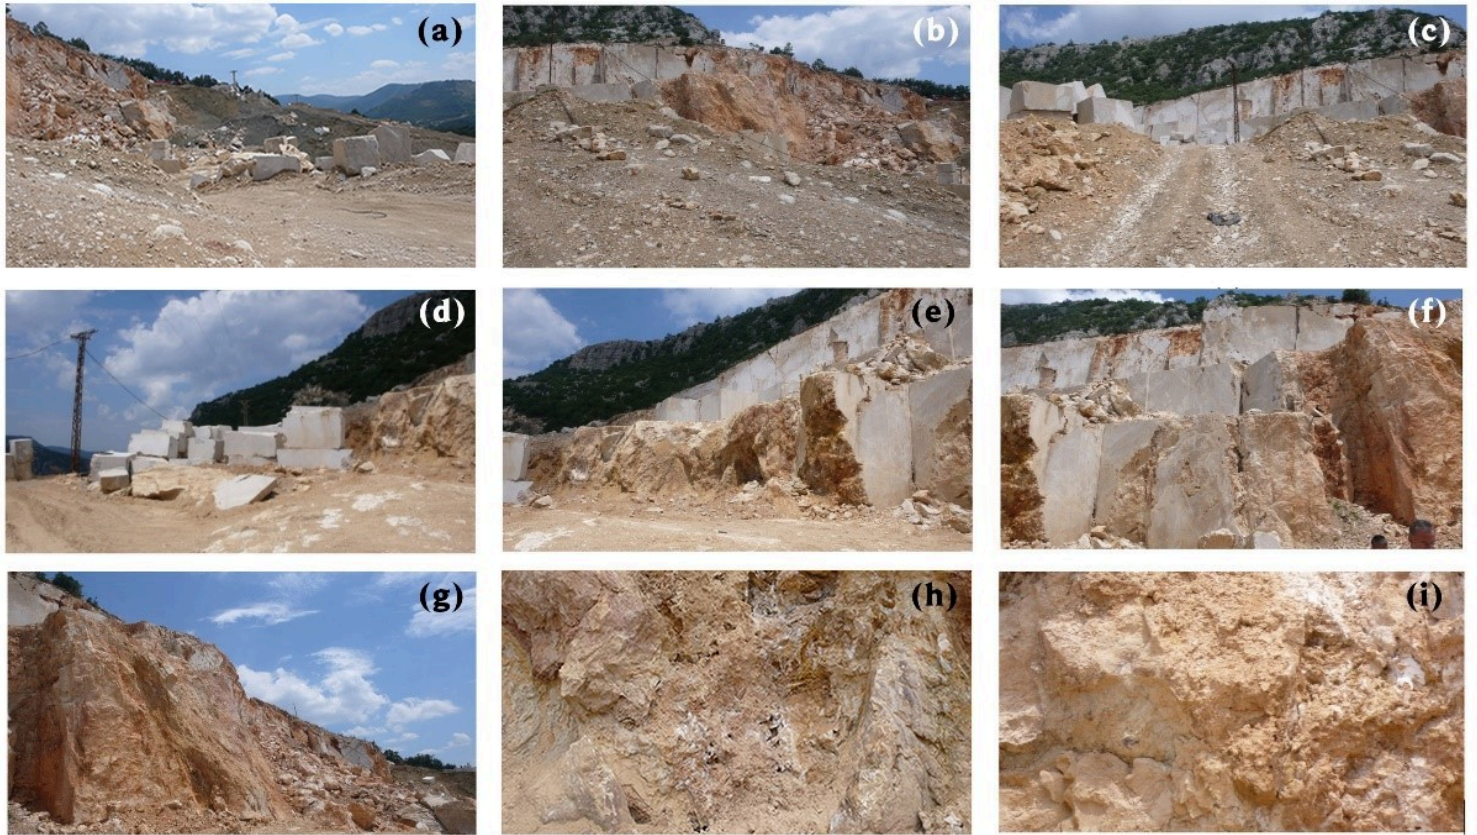
**Figure 6**

The layering in the open-pit pithead (K-1), determined by photographs in Fig. 5 (a-d) and others and shown in the measured geological cross-section in Fig. 9, is N35W/45SW. The location of the rift, which is ~ 1.5–5.5 m thick, has many cracks on the surface and cuts the pithead towards the south, has been determined as N45E/42SE. This rift zone is a very opaque and ferruginous zone with lots of cracks, and dents, and continues with parallel rifts. The limestones forming the marble blockstone shown in the sketch in Fig. 9 have a very fractured and crushed structure at the upper levels. The A-A geological cross-section in Fig. 10 was prepared based on the 1/25,000 scale topographic map (Fig. 1). As can be seen from the section, the operation license area and the operating permit area face south. There is no marble quarry facing Kapıkaya Stream to the north. There are metamorphic units on both slopes of the Kapıkaya Stream. The elevation of Dümenkırı Hill and Kocakır Hill, where marble-forming limestones are found, is ~ 982 m. In marble quarries, the limestone on the surface (Fig. 6c, e) is layered and abundantly cracked, showing characteristic melting surfaces. Kocakır, Dilmenkırı, Yapağıçam, and Alacakaya Hill and plains where limestones are seen are quite rugged and undulating. Here, water collection and discharge structures (dolins, stalactite-stalactite, and travertine-like formations) formed as a result of the limestone-water relationship are located (Fig. 6e-f). The metamorphic rocks that form the basement beneath the limestones are found in dark-colored "calcschist" and schist structures.

**(a-b)** Open-pit-1, view of the pithead and rift zone from the west, **(c-d)** Upper top part with marble level and levels separated by wire cutting, **(e-f)** Karst gaps in the pithead and stage gaps, **(g-h)** Rifts and crushes view of the zones, **(i)** Close-up view of the crushed rift zone in Open-pit-1.

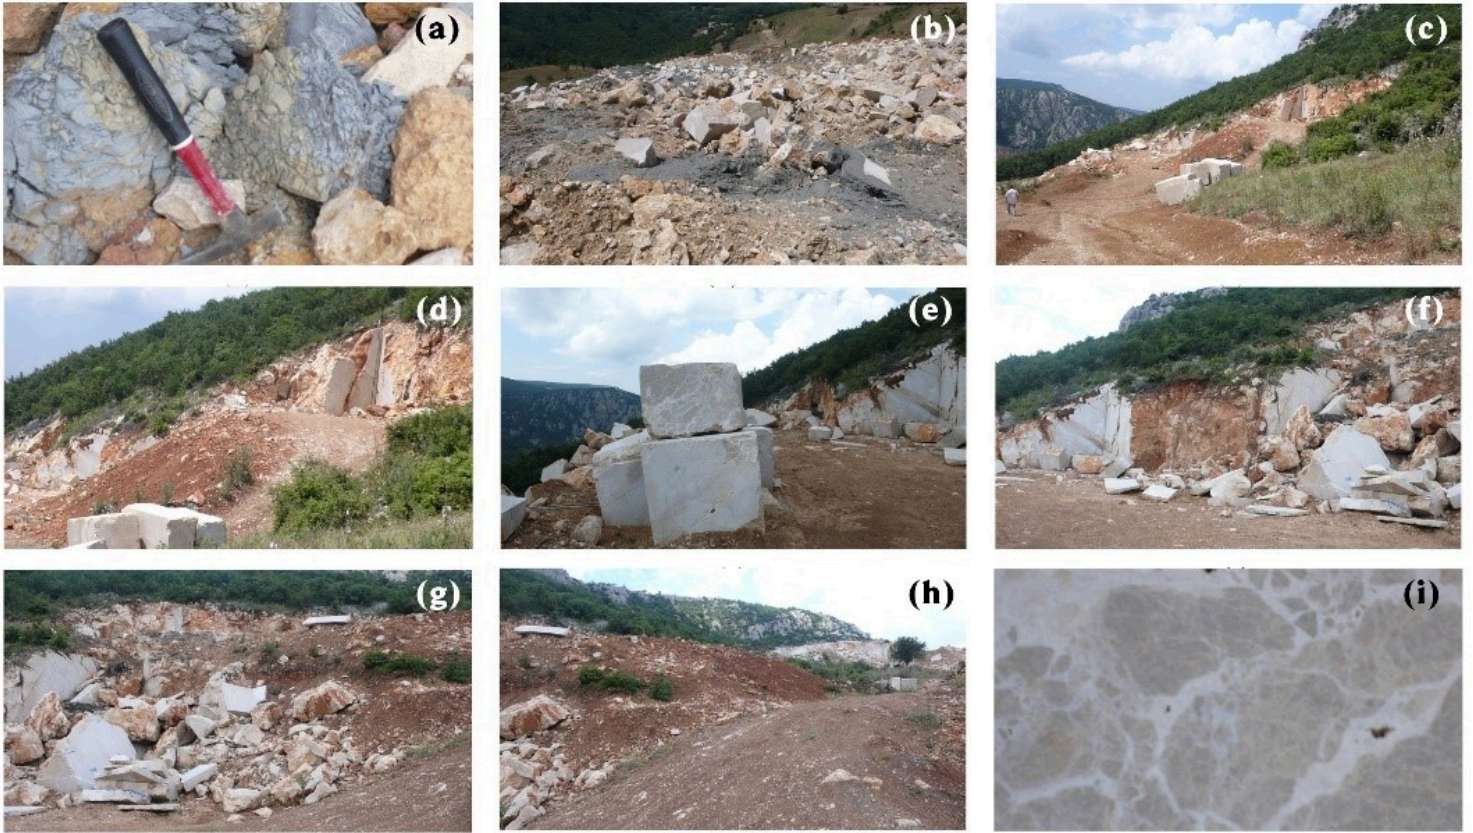
**Figure 7**

**(a)** Spoil material in front of the open-pit, **(b)** Blockstone waste material and small-sized material in Open-pit-1, **(c-d)** Pithead of Open-pit-2 in the western part of the operating permit area, **(e-f)** Close-up view of Open-pit-2, **(g)** Detrital fragment material as spoil in Open-pit-2, **(h)** From Open-pit-2 to Open-pit-1 and continuing towards the top marbled zone, **(i)** Close-up view of (emperor) marble in Open-pit-2.

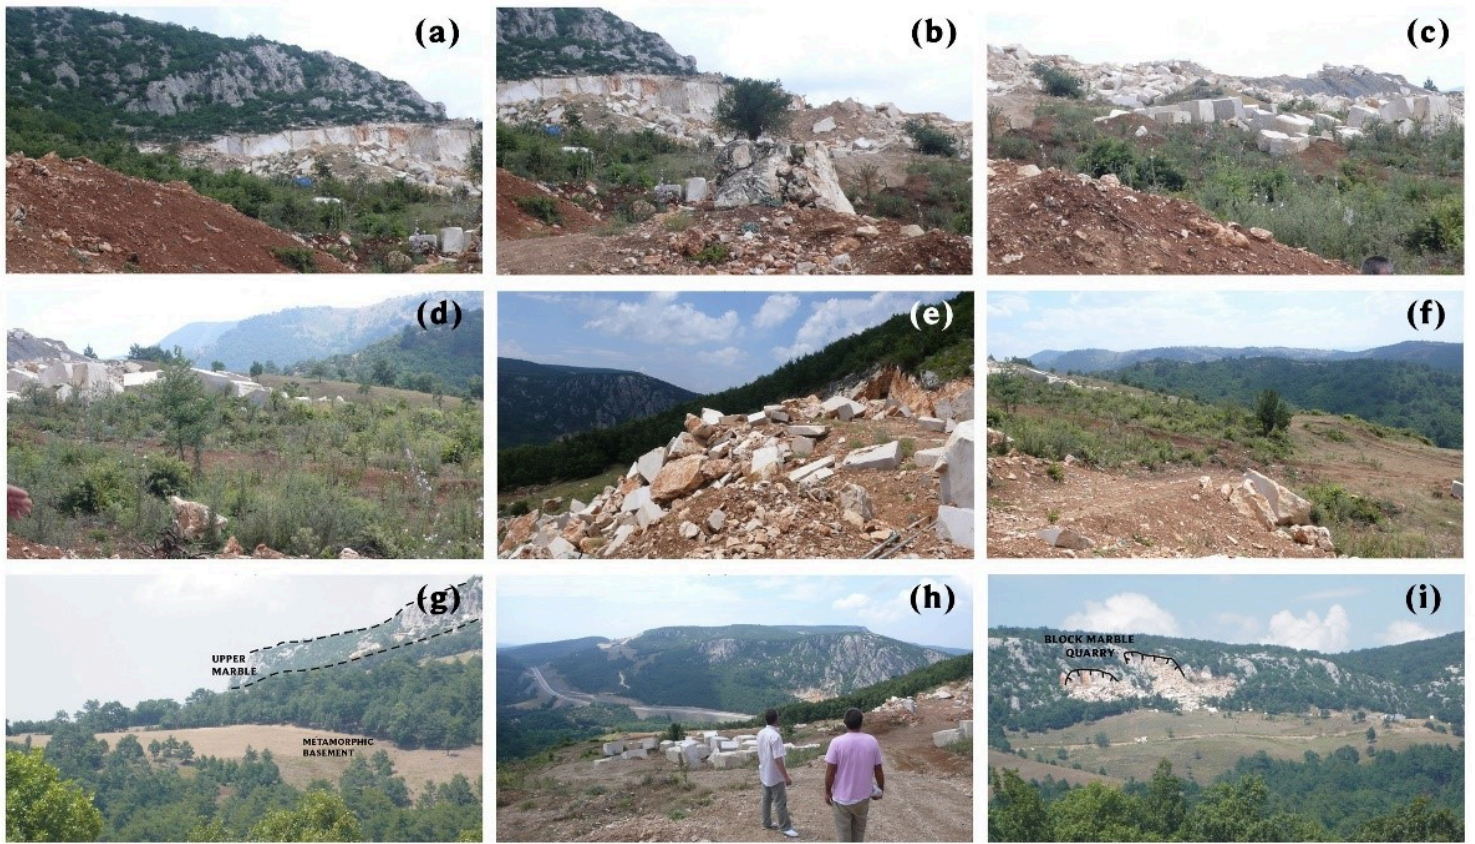
**Figure 8**

**(a)** View of Open-pit-2 and Open-pit-1 pithead and upper marble level. **(b-c)** Blockstone exhibition area in front of Open-pit-2 and Open-pit-1, **(d)** View of fields with blockstone-marble, **(e)** Field in the western part that is partly forested and partly has marble potential, **(f)** Basic metamorphic units in the southern part of Open-pit-2, **(g)** Marble zone at the top and appearance of metamorphics at the bottom, **(h)** Blockstone-marble products and basically metamorphic unit in the south of the marble quarries, **(i)** General view of the east of Open-pit-1 and Open-pit-2 looking south.

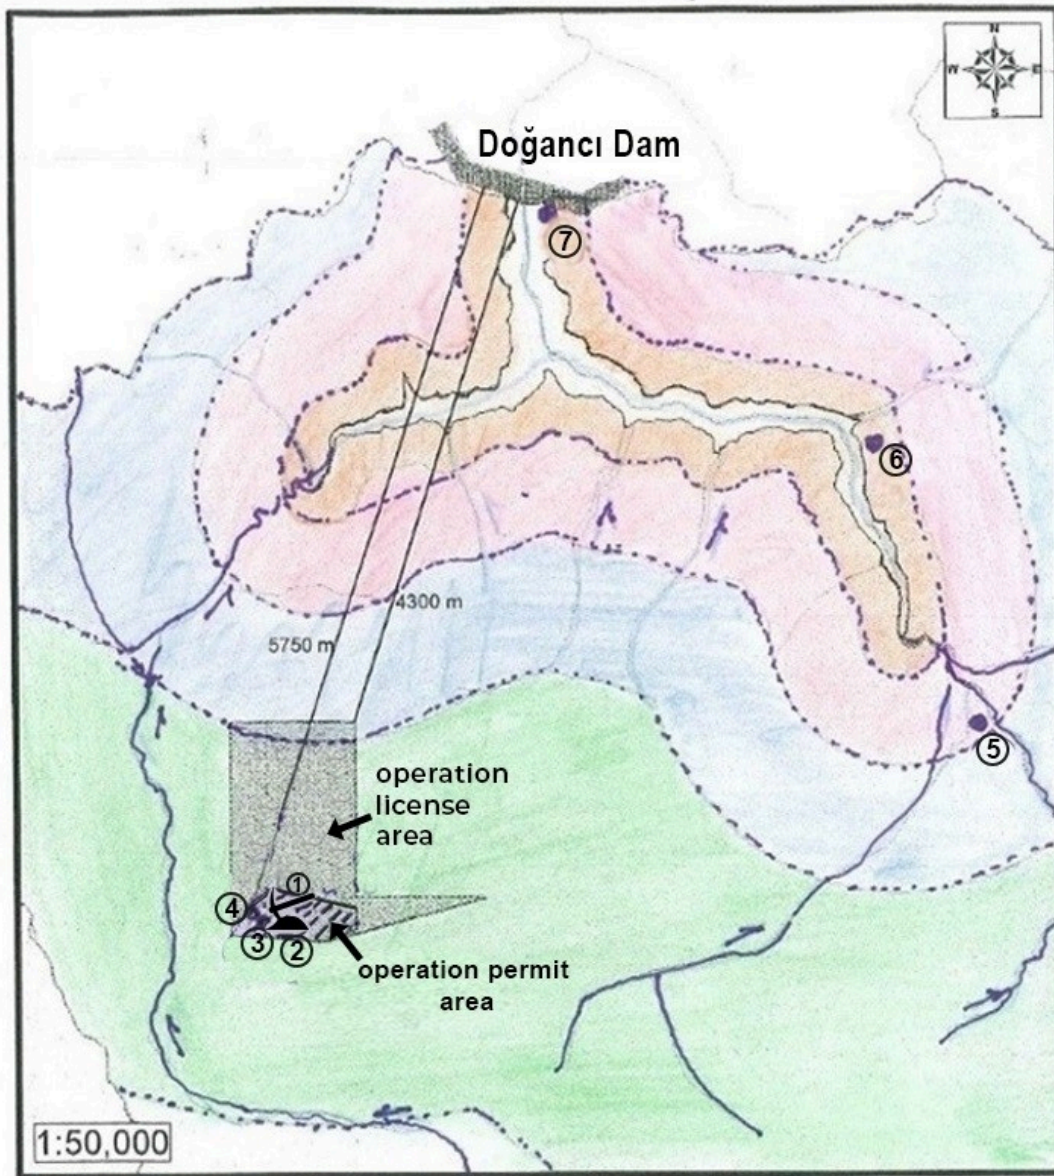
Figure 12

According to the protection areas determined by the SHW, the marble license area is in the LDPZ (Fig. 12). Marble, which has no health hazards and has a composition that will not harm the quality of existing water, consists of 97.5%  $\text{CaMg}(\text{CO}_3)_2$ . On the other hand, there are commitments to restore mining areas to nature if they are abandoned. It is stated in detail in WPCR and RPDPWB that operations that meet these conditions will be permitted (See Section 4). According to the article titled LDPZ of the Regulation, in cases where it is not technically and economically possible, discharge of wastewater into the basin may be allowed, provided that it is brought to 1st class water quality by using advanced technologies (Official Gazette, 2017b).

Location and characteristics of marble operating license & permit areas compared to Doğancı Dam protection areas (SHW, 2007).
