# Post-weld heat treatment of AA7075 friction stir welded joints manufactured under various tool rotation speeds and cooling conditions

## Research Article

Robert Kosturek\*, Janusz Torzewski, Krzysztof Grzelak, Tomasz Ślęzak

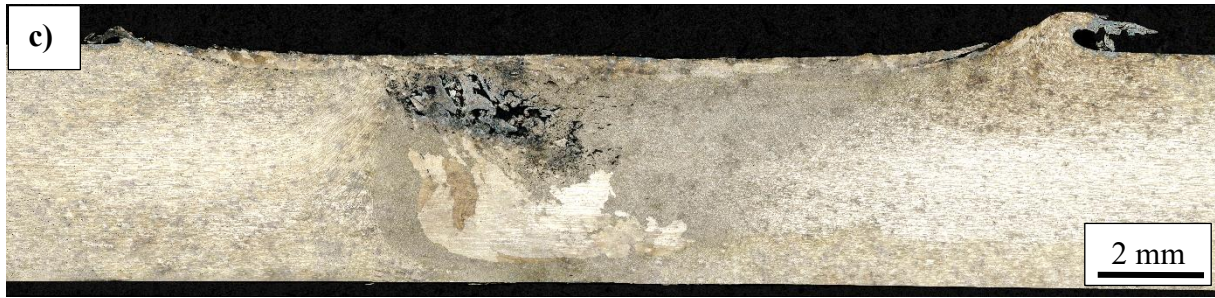
Fig. 2. Macrostructural images of selected samples: 600+HT (a), 1000+HT (b), 1400+HT (c).

Only the heat-treated specimens produced at tool rotational speeds of 600 rpm (Fig. 2a), 1000 rpm (Fig. 2b), and 1400 rpm (Fig. 2c) are shown in Figure 2, as they are sufficient to illustrate the trend identified in the present study. An important common feature is that, irrespective of the applied tool rotational speed, abnormal grain growth occurred in every specimen within the SZ formed by the action of the shoulder, i.e., the shoulder-driven zone (SDZ), as outlined for example in Fig. 2a. In contrast, no grain growth was observed in the pin-driven zone (PDZ) of the specimens produced at tool rotational speeds of 600 and 800 rpm. It was observed that the susceptibility to grain growth in the PDZ increased with increasing tool rotational speed, which can already be seen in the specimen welded at 1000 rpm (Fig. 2b). Approximately at mid-height of the joint, four grains about 500  $\mu\text{m}$  in size were observed, shifted toward the advancing side with respect to the central part of the SZ (marked with red arrows in Fig. 2b). A further increase in tool rotational speed, apart from leading to the formation of joint imperfections, resulted in even more pronounced grain growth during post-weld heat treatment. As can be seen in the 1400+HT specimen, grain coarsening covered the same region as in the 1000+HT specimen (Fig. 2b), while additionally extending markedly into the lower part of the SZ (Fig. 2c). These results are inconsistent with the observations of Panwariya and Dwivedi [14], according to whom increasing the tool rotational speed in friction-stir welded AA7075-T651 reduced the tendency for AGG during post-weld T6 treatment by promoting a more homogeneous stir-zone microstructure and a higher fraction of high-angle grain boundaries. This highlights the lack of consensus regarding the effect of welding parameters on the susceptibility to AGG and underscores the need for further research in this area. Microstructural images of selected regions of the analyzed specimens are shown in Figure 3a–f.

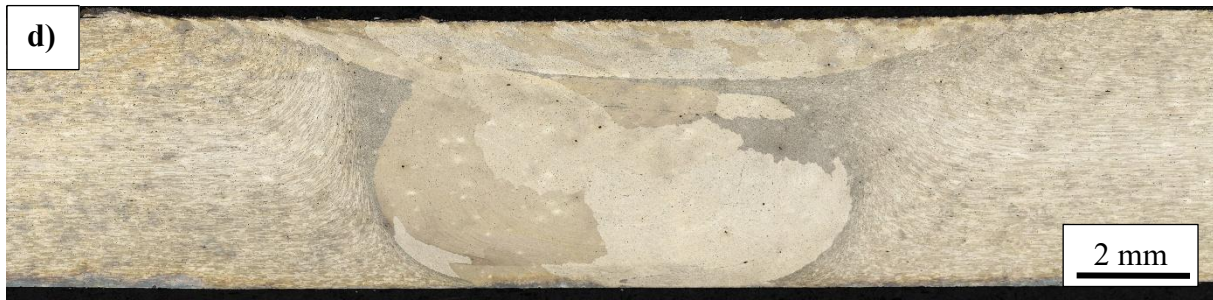
Fig. 4. Macrostructural images of selected samples: Air+HT (a), OH-70+HT (b), Water+HT (c), 10%CF+HT (d).

Similarly to the specimens produced at different tool rotational speeds, post-weld heat treatment also induced AGG in the SDZ in this case. Analysis of the macrostructure of the Air+HT specimen shows that, despite grain growth in the SDZ, the PDZ remained predominantly fine-grained, the only exception being a single large grain approximately 2 mm in size located in the lower part of the PDZ, close to the TMAZ on the retreating side (red arrow in Fig. 4a). Interestingly, the 600+HT (Fig. 3a) and Air+HT (Fig. 4a) specimens differ only in the applied welding speed (100 mm/min and 125 mm/min, respectively), as well as in the chemical composition (Tables 1–2) and temper condition of the alloy (T6 and T651, respectively). However, these seemingly subtle differences resulted in the occurrence of AGG in the PDZ of the Air+HT specimen. Although it is currently not possible to determine which of these factors was decisive for grain growth in the SZ, this observation is worth noting, as it illustrates how sensitive the PDZ is in terms of its susceptibility to grain growth during post-weld heat treatment. In the OH-70+HT specimen (Fig. 4b), although the PDZ retained its fine-grained structure, the applied heat treatment led to the formation of significant imperfections within the SZ. Numerous pores as well as clear delamination of individual material layers could be observed in the analyzed region. The arrangement of these imperfections corresponds to the successive layers of material mixed during joint formation; therefore, a possible explanation for the observed phenomenon is the thermal decomposition of quenching oil trapped in the material during the FSW process. Aluminum is characterized by high wettability by oil [17], and the short exposure time to FSW process temperatures (approximately 400°C) is likely insufficient to allow its evaporation from the edges of the joined elements, whereas prolonged exposure to the solution treatment temperature (470°C/2 h) may lead to its evaporation and potentially partial pyrolysis [18]. In addition, the thin oil film present between adjacent material layers likely contributed to weak bonding between them, which in turn facilitated their relatively easy separation during oil evaporation. Based on the observed macrostructure of the specimen, it may be concluded that the largest accumulation of quenching oil within the SZ was most likely located in its central lower part, close to the weld root. In both the Water+HT (Fig. 4c) and 10%CF+HT (Fig. 4d) specimens, AGG was observed throughout the predominant part of the PDZ. The only apparent exception seems to be the boundary regions between the TMAZ and SZ on both sides of the weld, which retained their fine-grained microstructure. These results are also inconsistent with literature reports, especially those of Ghazaei Najafabadi et al. [13], who found that underwater cooling in FSW AA2024/6061 lap joints increased the precipitate volume fraction in the SZ and significantly restricted grain growth during PWHT. By contrast,

in the present study, AGG was still observed in the predominant part of the PDZ, suggesting that the effectiveness of water-assisted cooling in suppressing grain growth during heat treatment is not universal and may depend on the specific alloy and welding conditions. Microstructural images of selected regions of the analyzed specimens are shown in Figure 5a–f.

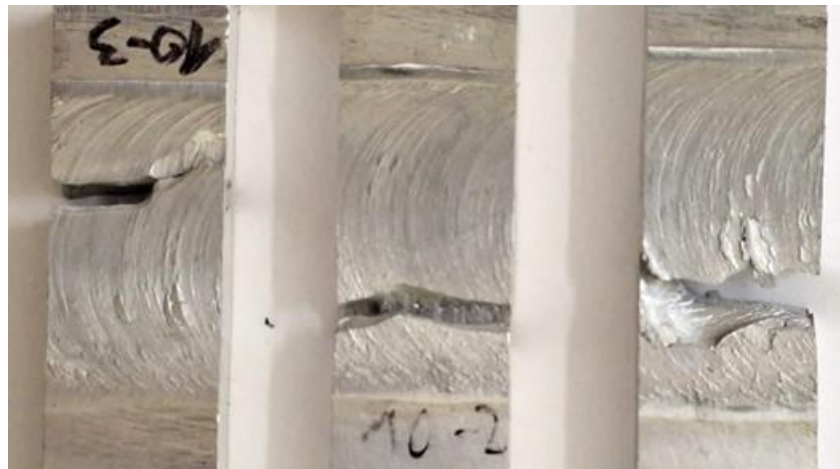
In the final stage of the study, a microfractographic analysis of the fracture surfaces was performed. FSW joints produced in air at a tool rotational speed of 600 rpm fractured outside the weld, within the HAZ on either the advancing or retreating side. Increasing the tool rotational speed to 1000 rpm shifted the fracture location toward the central region of the weld, although the fracture path remained slightly offset from the weld axis toward either the advancing or retreating side (Fig. 11). This change in fracture location is consistent with the tensile-test results, which showed a pronounced decrease in UTS with increasing tool rotational speed.

Fig. 11. Fracture locations of FSW joints produced in air at tool rotational speeds of 1000 rpm after static tensile testing.

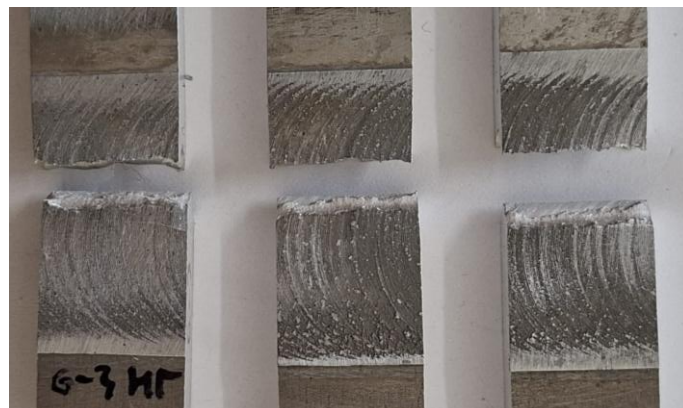
As demonstrated in the preceding section, post-weld heat treatment generally led to a significant improvement in the mechanical properties; however, it also altered the fracture behavior. Irrespective of the tool rotational speed, all heat-treated specimens fractured within the central region of the weld, with the fracture path slightly offset from the weld axis toward the retreating side (Fig. 13).

Fig. 13. Fracture location of the 600+HT specimen after static tensile testing.

The 600+HT specimen fractured within the SZ, slightly toward the retreating side, as shown previously in Fig. 13. In this condition, no AGG was observed in the PDZ, and the fracture therefore developed through the retained fine-grained structure. At lower magnification, the fracture surface exhibited a mixed morphology comprising relatively flat intergranular regions and rougher transgranular areas (Fig. 15a). Higher-magnification observations revealed fine dimples within the transgranular regions, confirming a local ductile contribution to the overall fracture process (Fig. 15b). This mixed morphology indicates the simultaneous operation of locally brittle and ductile fracture mechanisms despite the substantial increase in YS and UTS produced by post-weld heat treatment.
