# Towards a Policy Framework for Landslide Risk Management in the Western Himalaya: Site Specific Investigations from Ramban and Kishtwar Districts, Jammu and Kashmir, India

## Research Article

# **Towards a Policy Framework for Landslide Risk Management in the Western Himalaya: Site Specific Investigations from Ramban and Kishtwar Districts, Jammu and Kashmir, India**

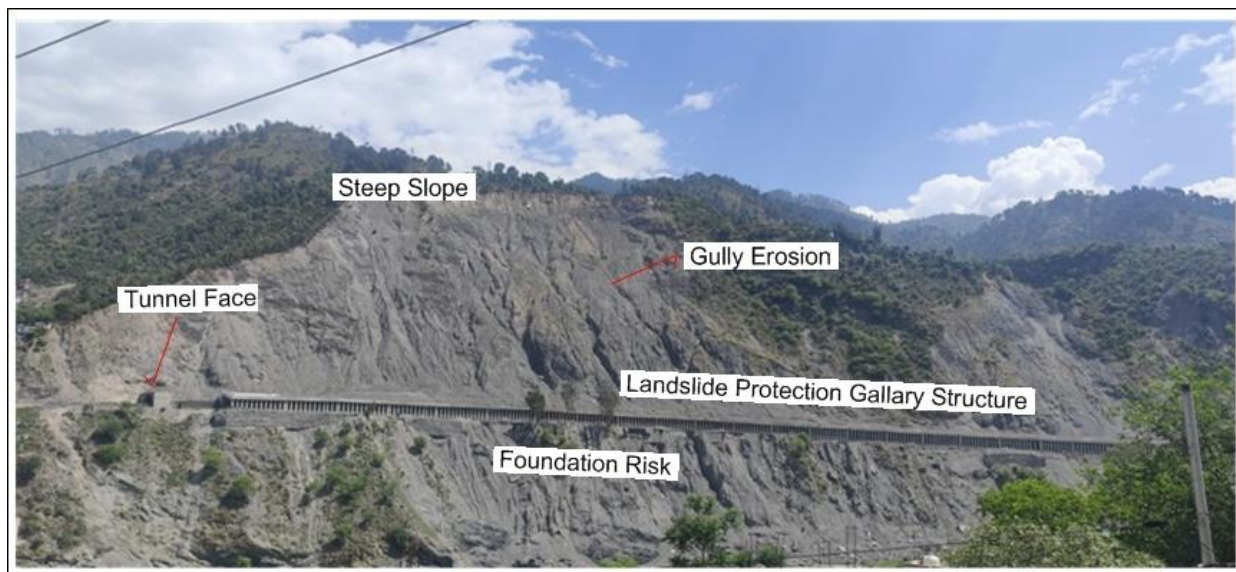
This is a cut-and-cover structure (artificial tunnel) built to maintain an important strategic stretch of the road and to ensure the safety of commuters. The design was adopted after repeated failures of open-cut road widening, which made tunneling necessary. The site lies on an old and complex landslide made up of rock and debris, in a highly fragile and water-sensitive geological setting. The slope is unstable due to heavily weathered and fractured rocks and probably has not been properly evaluated during the initial road widening works. The landslide zone is located along a major geological discontinuity called Murree Thrust (MT). Field observations show that the cut-and-cover tunnel does not have a proper drainage system. As a result, rainwater flows directly down the slope towards the Chenab side, causing severe erosion at the base and may wash away the supporting material (Fig.4). This uncontrolled water flow is weakening the foundation of the structure. If proper drainage and channelization are not provided, there is a high risk of serious foundation failure in the near future.

Fig.4. Photograph showing the Cafeteria Morh landslide and the associated engineering structure along a vital road connectivity corridor.

| <b>Cafeteria Morh Slide</b> | Poor drainage, foundation scouring, slope erosion | Lined catchwater drains; filling of scour holes with masonry/concrete; geotextiles, protective matting, and plantation; subsurface drainage (weep holes/perforated pipes); toe protection using pitching or gabions; temporary covers (tarpaulin/shotcrete) with monitoring |

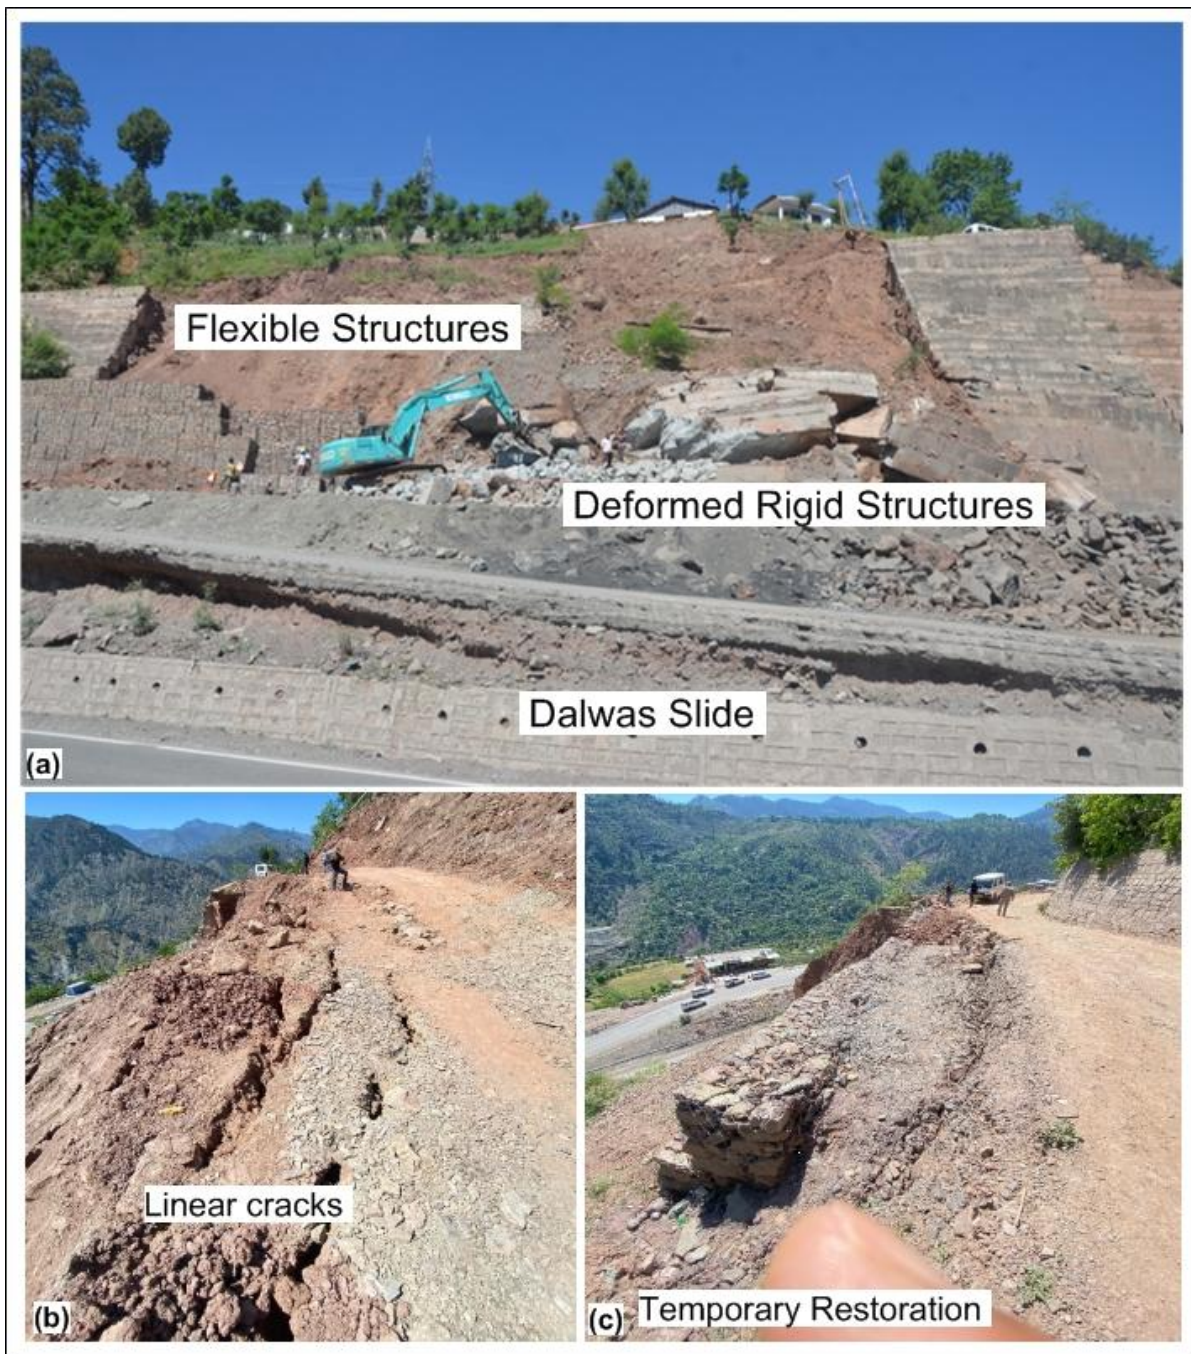
The slope is predominantly composed of clay-rich material, which exhibits low permeability and reduced shear strength under saturated conditions (Fig.6a-c). The presence of shallow aquifers has led to persistent subsurface saturation, further exacerbated by unscientific slope modifications that have disturbed the natural stability of the slope (Fig.6c). A concrete retaining wall constructed to stabilize the slope has become ineffective, as its weep holes are clogged with fine sediments, preventing adequate drainage (Fig.6a). This blockage has resulted in the buildup of pore-water pressure behind the structure, ultimately leading to its structural failure. The consequent instability has caused damage to the Dalwas-Karma road and has significantly increased the risk to residential buildings and adjoining cultivated land situated along the crown zone, placing them under imminent threat of further slope failure (Fig.6).

Fig. 6. Photographs showing (a) landslide along Jammu-Srinagar national highway at Dalwas, (b) linear cracks along the Dalwas-Karma Road, (c) temporary restoration works carried out on the Dalwas-Karma Road.

| <b>Dalwas Slide</b> | Poor drainage, hydrostatic pressure, clayey slope saturation | Clearing of clogged weep holes; top-slope drainage trench; sealing of cracks; restriction of wet agricultural practices; temporary tarpaulin cover on exposed clay; temporary toe support; regular inspection during rainfall |

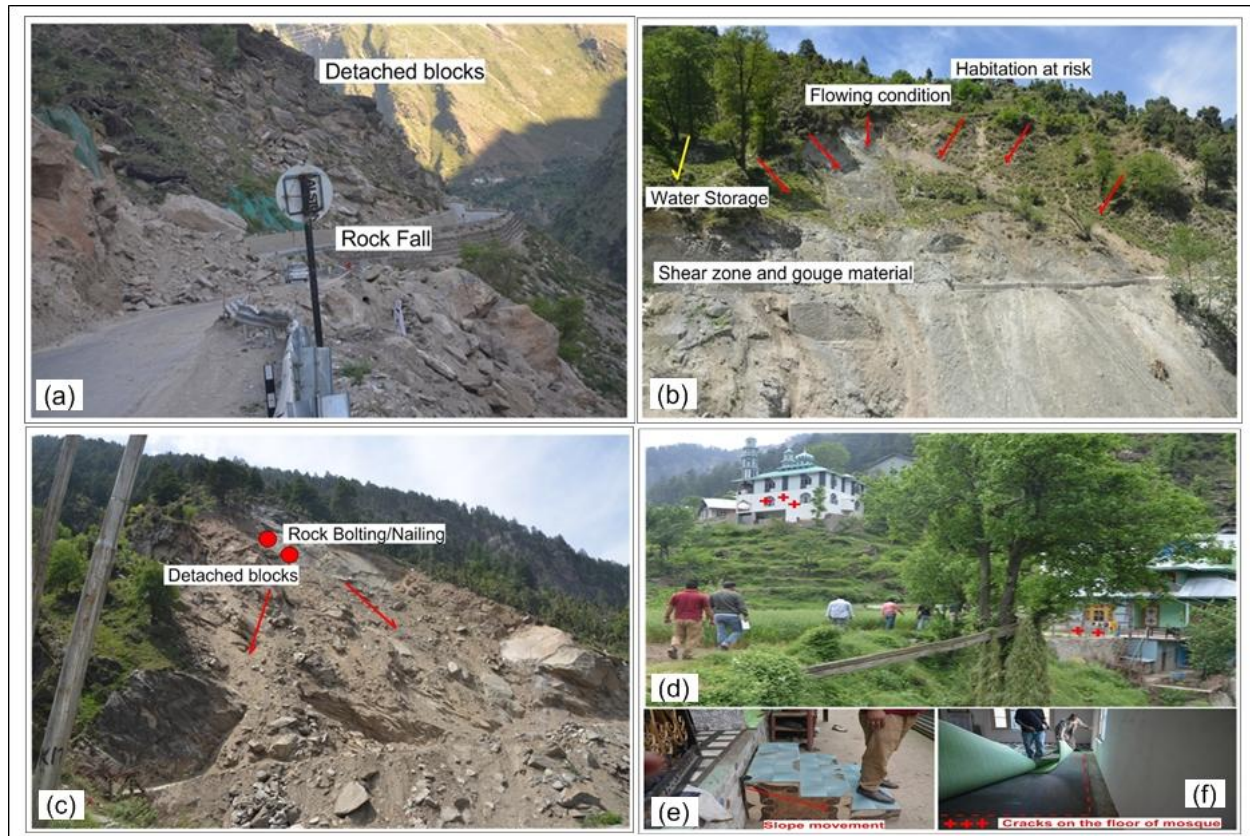
inspection, a large amount of loose debris and detached rock blocks were observed resting on steep slopes. These unstable rock blocks pose a serious rockfall hazard, especially when the slopes become saturated during prolonged or intense rainfall. In addition, the Chenab region is seismically active and experiences frequent seismic events. Even a moderate earthquake could trigger further slope failure or a major earthquake-induced landslide in this area (Fig.7a).

The landslide is located on the left bank of Noos nallah, where a large volume of material has moved downslope. The site is composed of fragile lithology, including phyllitic rocks, fault gouge material, shear zones and slope cracks (N325). This, combined with active water seepage (dripping conditions), has contributed to slope failures during the rainy season (Fig.7b). Notably, residential structures are located in very close proximity to the hazard zone, with a distance of only about 3.5 meters from the landslide crown. Due to these inherent geological weaknesses and ongoing water infiltration, the slope remains highly vulnerable to further failure, particularly during periods of prolonged rainfall.

The Pathar Nakki Slide, located close to the Kiru hydropower dam site, represents a significant geological hazard with active movement of material on both slopes of Payass nallah. Field observations show that the slope remains unstable due to very steep slope (Slope 65°/030) and the presence of detached rock blocks. The instability is further controlled by structural weaknesses, including a fault zone crossing the nallah, along with continuous water infiltration and cracks (N30°W to N45°W and having 2-5cm opening towards east) on the right bank of Payass nallah. The structural fabric of the granitic gneissic rocks, along with the slope gradient and orientation, is directed towards the road cut slope, creating favorable conditions for planar and rockfall failures towards the roadway (Fig.7c). Although mitigation measures such as rock bolting and rock nailing are currently being implemented, these interventions appear to require greater technical precision and improvement. Given its proximity of about 100 meters to the upcoming hydropower project area, the slide is highly vulnerable to extreme rainfall events as well as moderate seismic activity typical of the Kishtwar region. Therefore, additional short-term mitigation measures are required to strengthen the ongoing efforts by local agencies.

Dangdoru is located on the left bank of the Maru Sudhar River, close to the Dangdoru Hydropower project site. Field assessments indicate that there is no evidence of large-scale regional subsidence; however, minor localized subsidence has been observed in individual structures. These small cracks are mainly confined to the slope-facing sides of buildings and are primarily linked to inadequate household drainage system. At the base of the slope near the dam camp site, several structures show wider cracks associated with localized slope subsidence. This instability is largely driven by the continuous accumulation of water along the road and moisture infiltration from multiple sources. Blasting activities of high intensity, if being carried out in the vicinity, may also contribute to these minor impacts on the infrastructure by inducing vibrations that can weaken already fragile slope materials and exacerbate existing cracks and localized subsidence (Fig. d-f). Although some protective measures were implemented after earlier slope failures, significant drainage deficiencies still remain. These issues are further reflected in a

noticeable bulge in the toe-strengthening wall at the village base, along with poorly functioning drainage infrastructure along the adjacent roadway.

Fig. 7. Photograph showing (a) active landslide (rockfall) site at Drabshallah (b) landslide near Noos nallah, depicting downslope movement of material (c) rockfall at Pathar Nakki, where structurally controlled granitic gneiss slopes dip towards the road-cut, promoting planar failures and rock detachment (d) Dangdoru village along the Maru Sudhar River near the hydropower project site, (e-f) depicting localized minor structural subsidence, and deformation in the toe-strengthening wall.

| <b>Site / Landslide Zone</b> | <b>Key Problems Identified</b> | <b>Recommended Short-Term Mitigation Measures</b> |
|---|---|---|
| <b>Drabshallah</b> | Rockfall hazard, debris movement | Scaling and removal of unstable rock masses; surface catch drains above crown; toe protection; temporary concrete barriers/gabions; rockfall netting or draped wire mesh |
| <b>Pathar Nakki</b> | Tension cracks, seepage, rockfall risk | Improved surface drainage; sealing of crown cracks; identification and treatment of seepage zones; integration of rock nailing with weep holes; rockfall nets; traffic restriction during heavy rainfall |
| <b>Dangdoru</b> | Wastewater infiltration, seepage-induced instability | Proper wastewater drainage network; concreting of irrigation channels; surface and subsurface drainage; sealing of cracks in houses; regular monitoring during rainfall |
