# Nature-Based Solutions (NbS) for the Ecological Reclamation of Abandoned Volcanic Tuff Quarries and Flood Risk Mitigation: The Case of Artik, Armenia

## Research Article

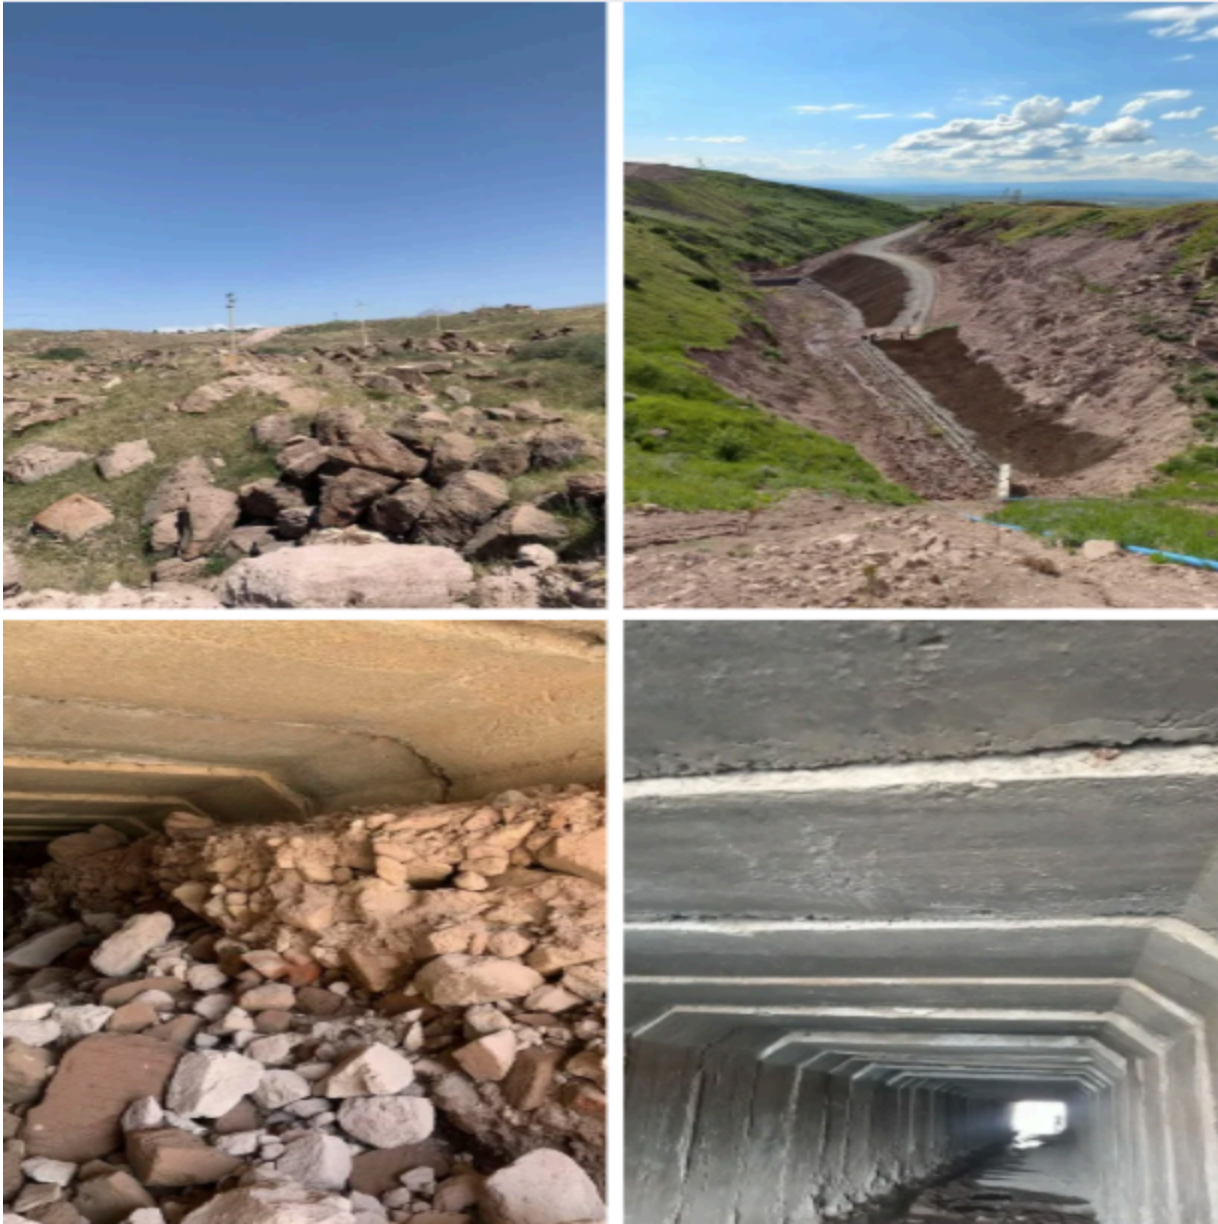
**Figure 2**

Biophysical transformations of the quarry landscape: (a) pre-restoration unstable vertical cliffs, (b) post-restoration terraced and stabilized slopes, (c) blocked concrete drainage channels with volcanic tuff debris, and (d) fully cleared and operational drainage channels.

The extreme contrast between the baseline degradation and the post-intervention biophysical outcomes is systematically documented in Fig. 2, showing both slope stabilization and drainage clearance.

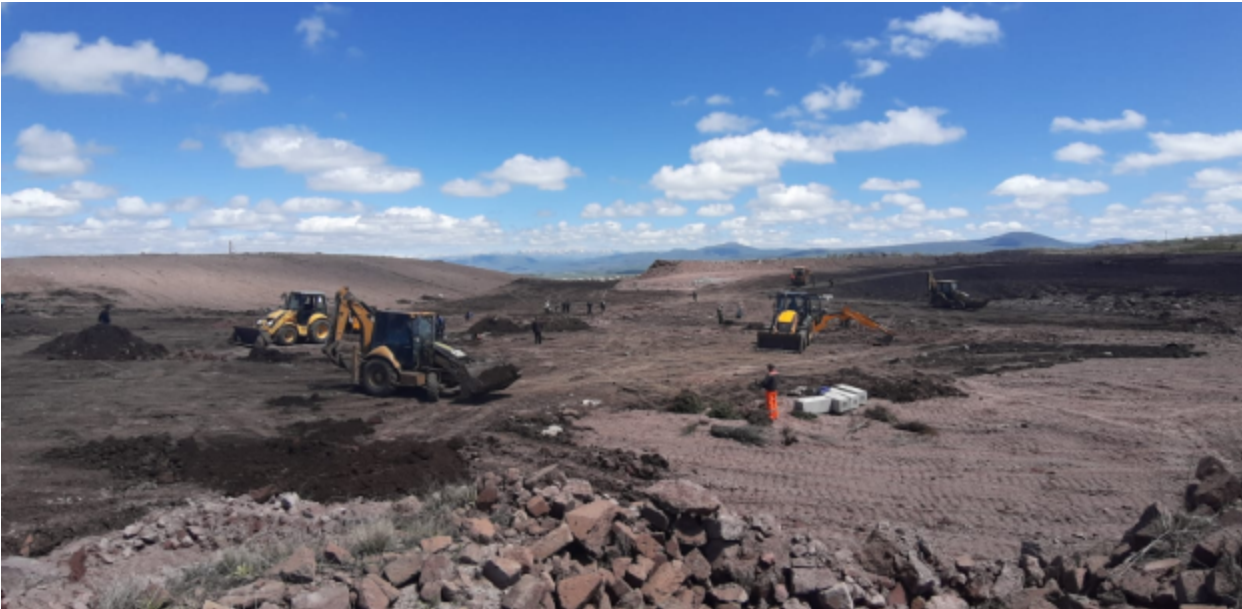
**Figure 3**

Macro-topographic modeling and terrace grading operations utilizing heavy machinery to reduce high vertical quarry cliffs into stable slopes.

The baseline technogenic landscape was highly unstable, characterized by steep vertical quarry faces (> 45°, up to 85°) left behind by industrial stone-cutting machinery. This topography posed ongoing landslide, collapse, and severe rill erosion risks. Earth-moving machinery (heavy bulldozers and excavators) executed macro-topographic remodeling, redistributing 60,498.5 m<sup>3</sup> of loose quarry waste, accumulated industrial overburden, and sub-economic volcanic tuff fragments. High vertical cliffs were cut back and graded to form a sequence of stable, terraced slopes with safe inclines ranging between 15° and 20°, establishing a suitable topographic foundation for subsequent bio-engineering and soil placement.

The initial mechanical step of reshaping the land using heavy machinery to establish stable terraces for soil placement is captured in Fig. 3.

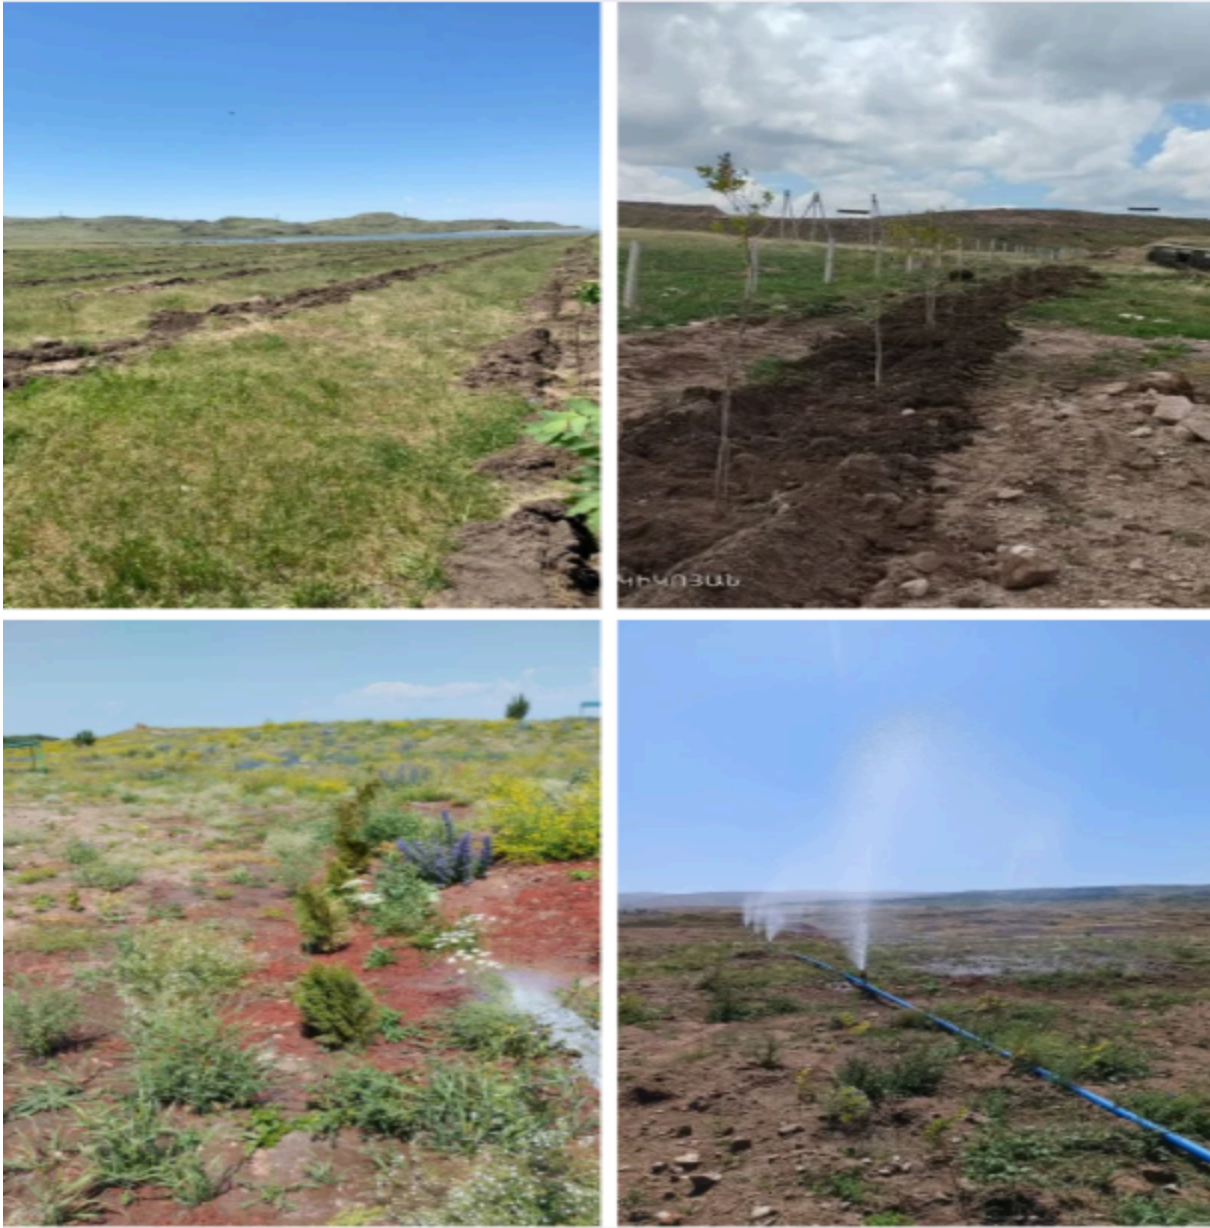
**Figure 4**

Chronological substrate engineering, showing soil placement, organic-mineral conditioning, and early-stage 2020 vegetative expansion on the terraces.

Because natural soil profiles were absent, a synthetic topsoil layer (20–30 cm thick) was laid down across the graded terraces. This topsoil layer utilized fertile soil material recovered from regional municipal construction excavations. To revitalize biological cycling and correct macronutrient deficits within the raw substrate, an aggressive two-stage melioration protocol was deployed in autumn 2019. Organic amendment consisting of well-composted, dry cattle manure was disked into the topsoil layer at an application rate of 25–30 t/ha. This organic base was supplemented with mineral fertilization supplying N90P90K60 kg of active ingredients per hectare.

As visualized in Fig. 4, the progression from raw substrate conditioning to early vegetation cover demonstrates the rapid response of the soil-plant system to edaphic melioration.

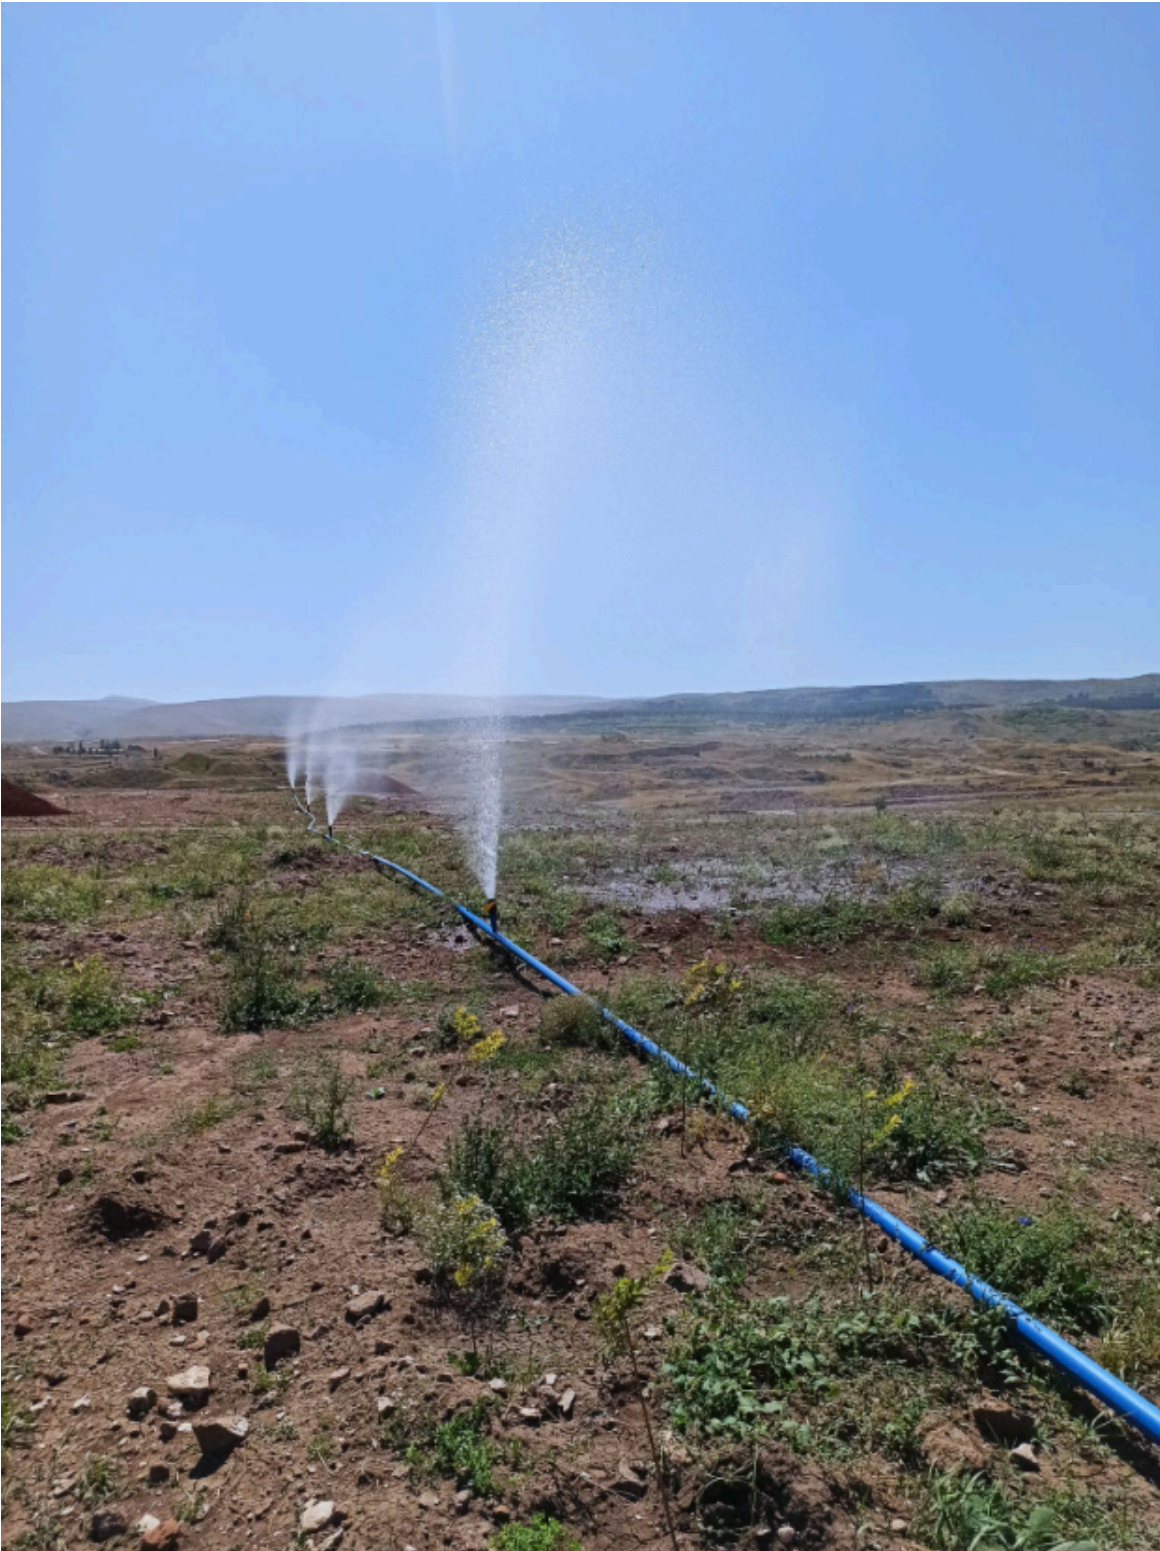
**Figure 5**

Implementation of the high-efficiency localized drip and sprinkler irrigation system designed to mitigate extreme summer evapotranspiration deficits.

To bridge the high summer evapotranspiration deficits during the critical establishment phase (2020–2022), a dedicated localized irrigation pipeline system was constructed and operated, delivering systematic water inputs based on weekly sapling transpirational demands.

The physical layout and operation of the localized watering infrastructure that supported the sapling establishment phase are illustrated in Fig. 5.
