# Engineering Geological Assessment of Recurrent Landslides at Chakki Moad Along NH-05, Solan District, Himachal Pradesh, India

# Abstract

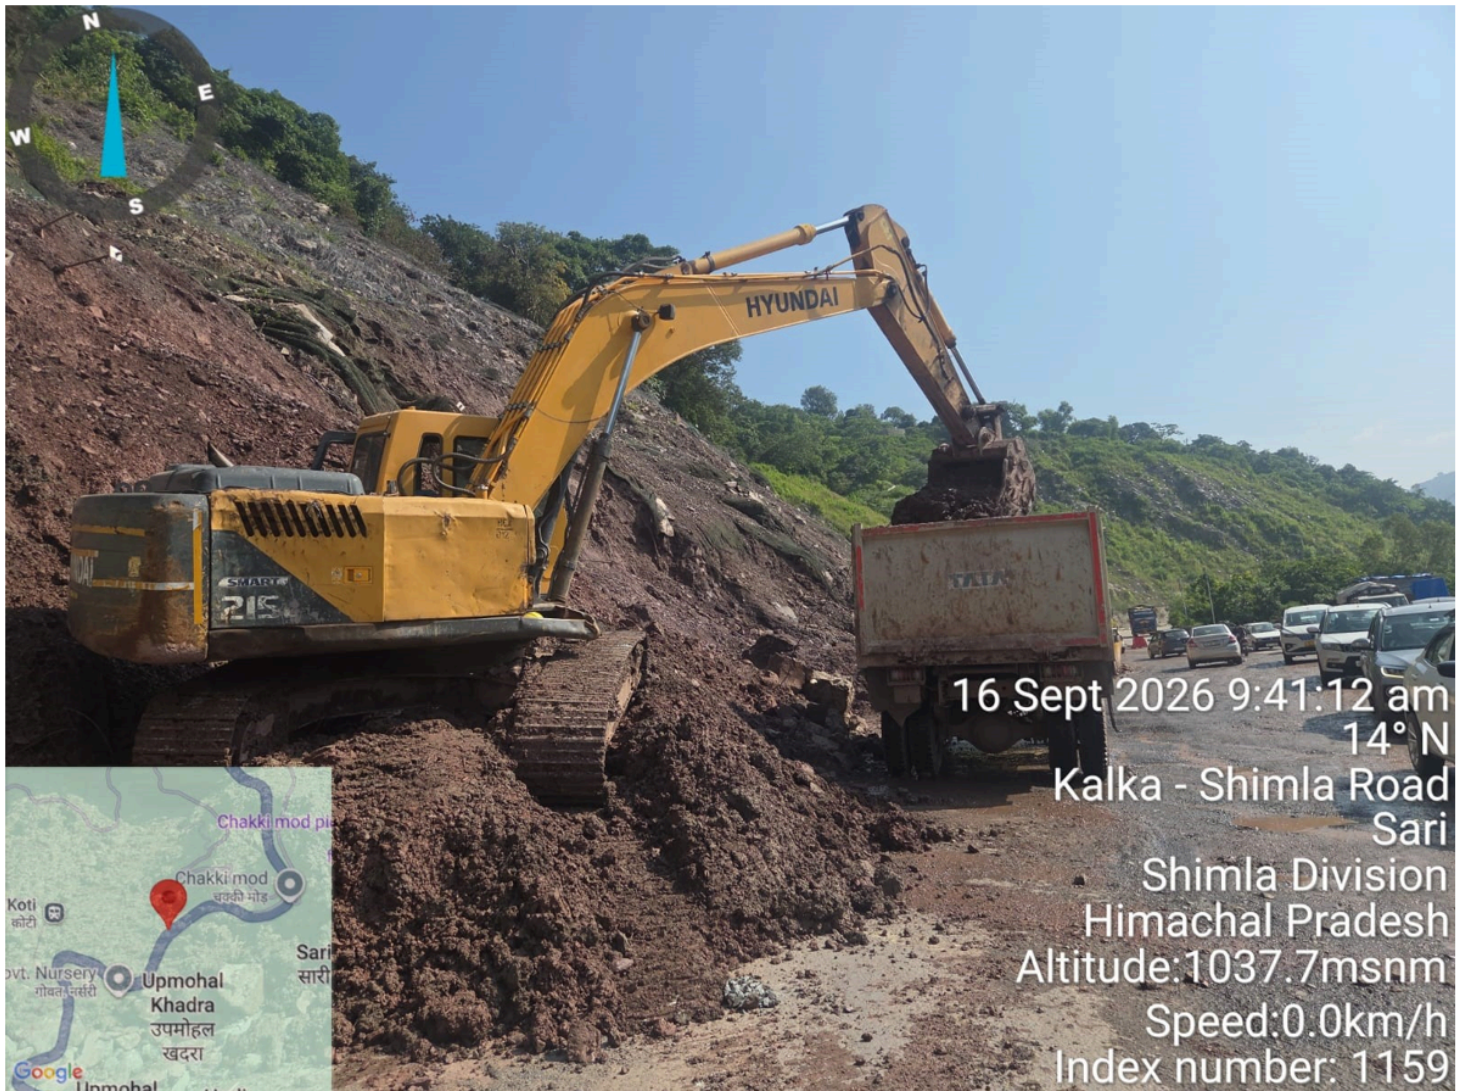
Figure 1

**Chakki Mod landslide zone** along the **Kalka-Shimla National Highway (NH-05)** in Solan District, Himachal Pradesh. A hydraulic excavator is engaged in removing freshly failed slope material and loading it into a dump truck for disposal. The landslide debris consists predominantly of highly weathered soil, rock fragments, and colluvial material derived from the cut slope.
