# Engineering Archives and Preventive Conservation of a Leaning Masonry Pagoda: Evidence from the Yunyan Temple Pagoda in Suzhou, China

**Keywords:** architectural heritage, masonry pagoda, engineering archives, deterioration diagnosis, preventive conservation

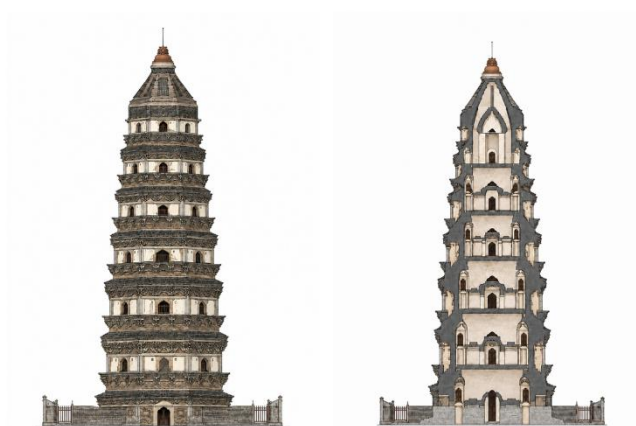
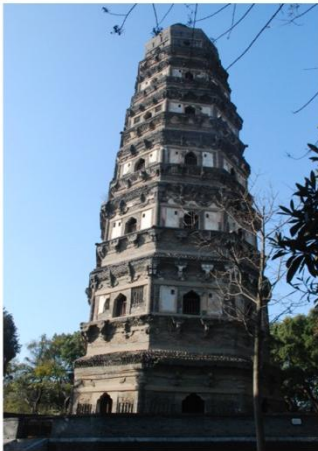
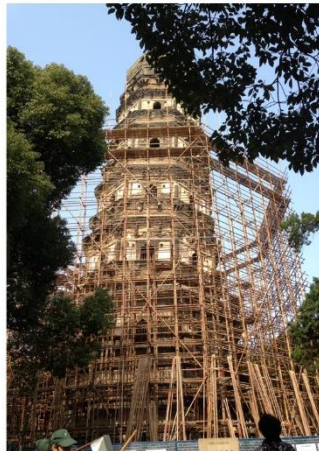
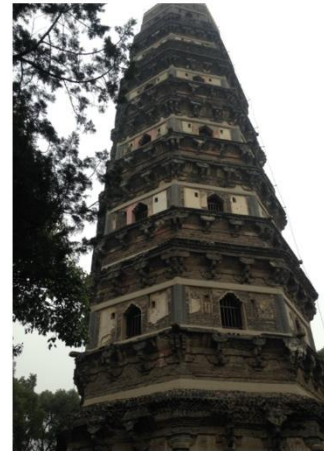
Fig. 1. Overview and architectural configuration of the Yunyan Temple Pagoda.

(a) redrawn plan, south elevation and vertical section of the octagonal masonry pagoda; (b) exterior view before maintenance; (c) temporary scaffolding erected for high-altitude maintenance work; and (d) present leaning appearance of the pagoda.

Fig. 1 summarizes the architectural configuration and documented condition of the pagoda, including the redrawn plan, south elevation, vertical section, pre-maintenance exterior condition, temporary scaffolding, and present leaning appearance.

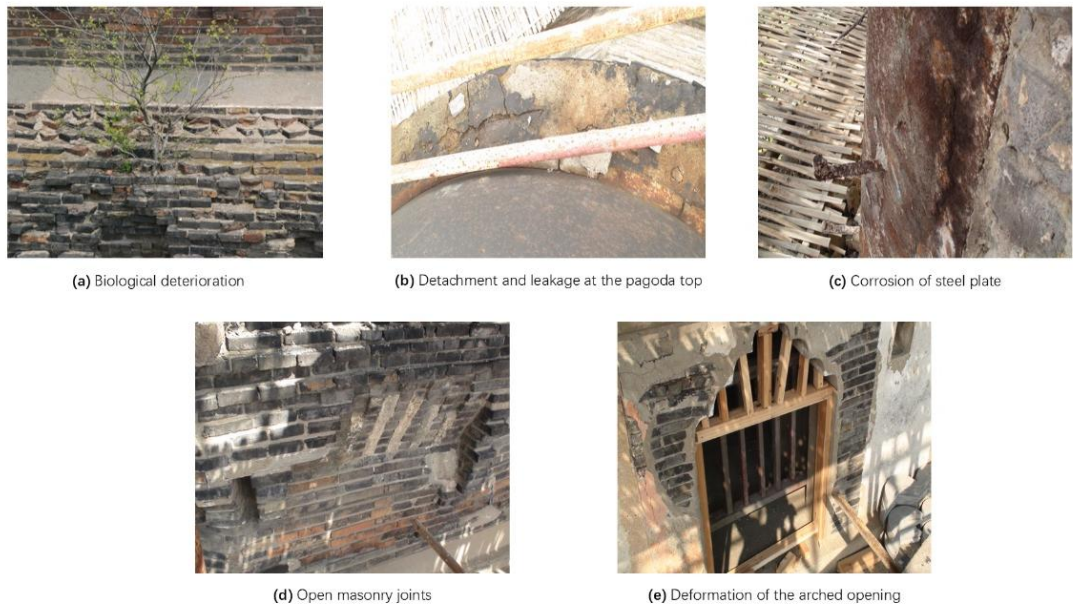
Fig. 3. Main deterioration types and representative pre-maintenance manifestations of the Yunyan Temple Pagoda:

(a) biological deterioration; (b) detachment and leakage at the pagoda top; (c) corrosion of steel plate; (d) open masonry joints; and (e) deformation of the arched opening.

Representative manifestations are shown in Fig. 3, including biological growth, leakage and detachment at the pagoda top, corrosion of embedded steel plates, open masonry joints, and deformation of arched openings. These observations provide the basis for the analytical classification used below and for linking diagnostic results with subsequent interventions and monitoring priorities.

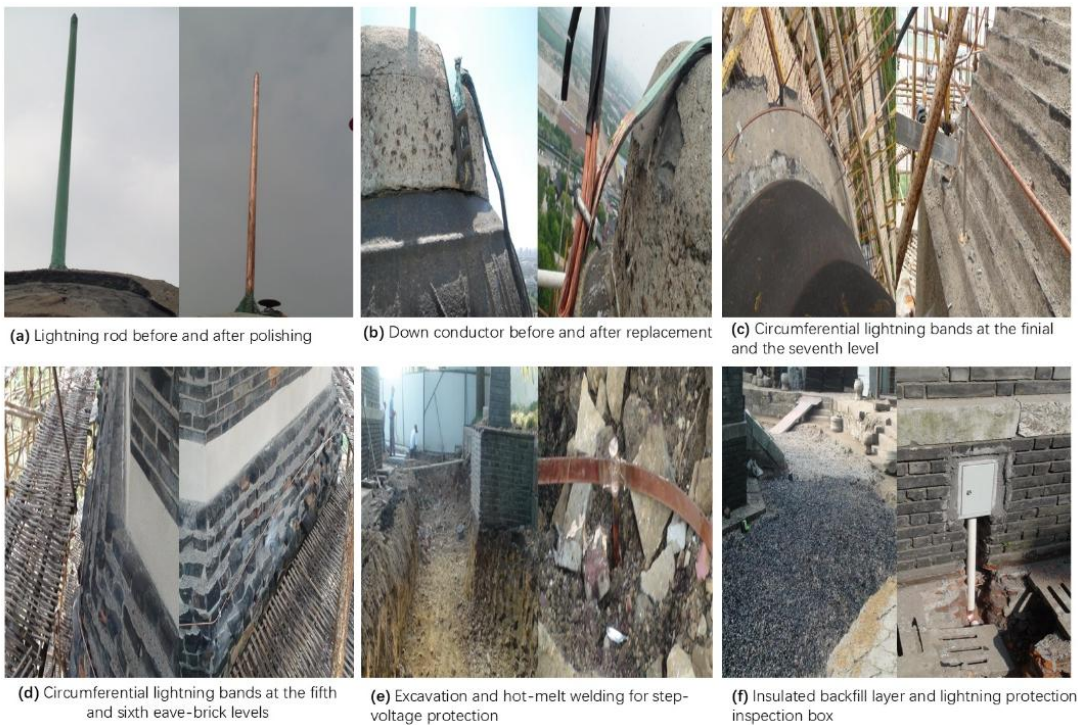
Fig. 4. Representative procedures for renewal of the lightning-protection system of the Yunyan Temple Pagoda.

(a) lightning rod before and after polishing; (b) down conductor before and after replacement; (c) circumferential lightning bands at the finial and the seventh level; (d) circumferential lightning bands at the fifth and sixth eave-brick levels; (e) excavation and exothermic welding for step-voltage protection; and (f) insulated backfill layer and lightning-protection inspection box.

The recorded work included treatment of the existing lightning rod, replacement of down conductors, installation of additional circumferential bands, and improvement of the grounding and inspection system. These measures were intended to improve system continuity, redundancy, and future inspectability rather than to repair an existing masonry defect.

The intervention demonstrates that preventive conservation includes low-probability but high-consequence hazards in addition to visible material deterioration. Representative procedures are shown in Fig. 4.

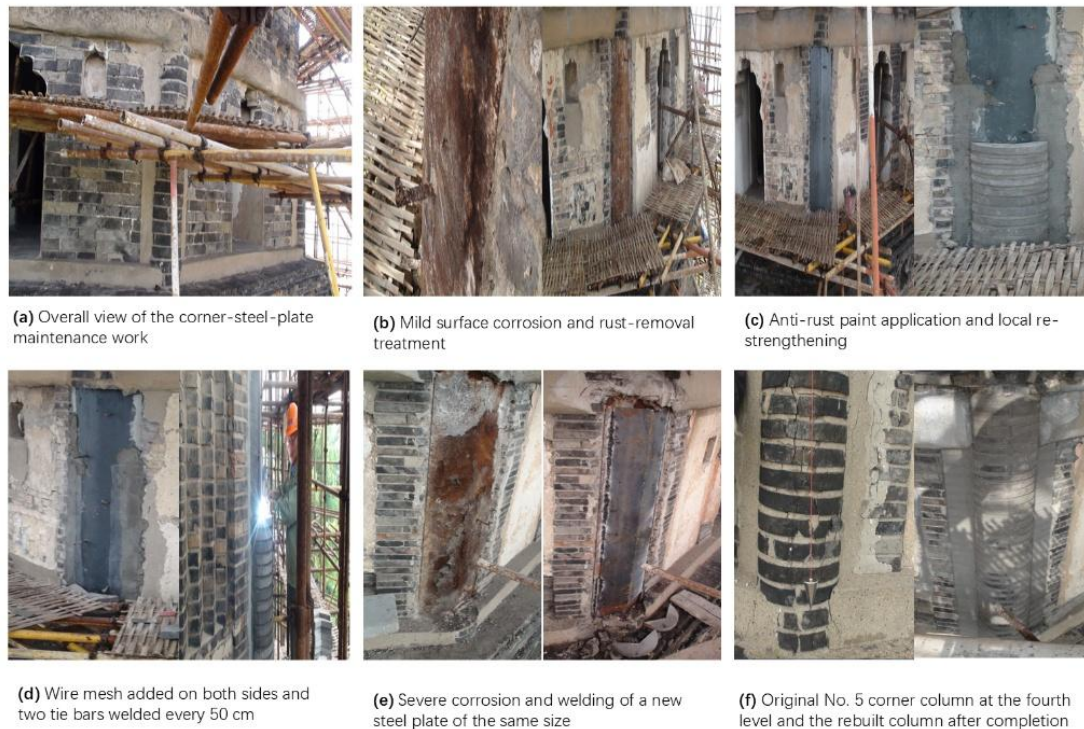
394 Fig. 5. Representative procedures for the treatment of corroded corner steel plates at the Yunyan  
395 Temple Pagoda

384 Connection and crack-control measures, including wire mesh and tie bars, were used  
385 during rebuilding to reduce recurrent cracking at the steel–masonry interface. Detailed  
386 dimensions and construction procedures are retained in Supplementary Table S3 and  
387 illustrated in Fig. 5.

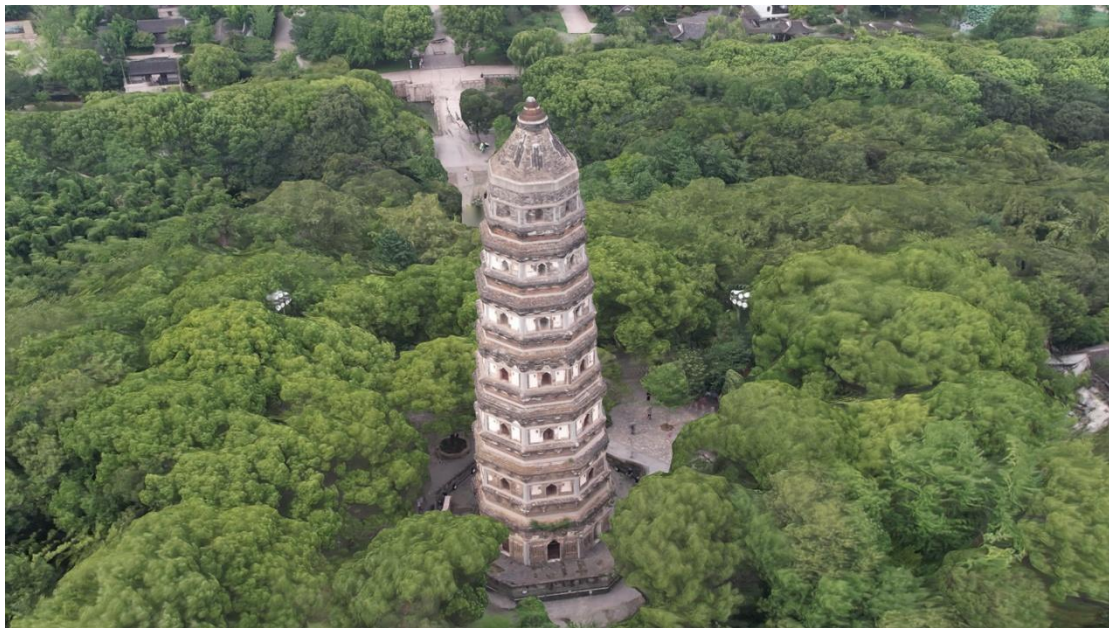
Fig. 8. Gaussian-splatting representation of the Yunyan Temple Pagoda and its surrounding landscape.
