Supplement 2. Pre- and post-SBRT images in all patients

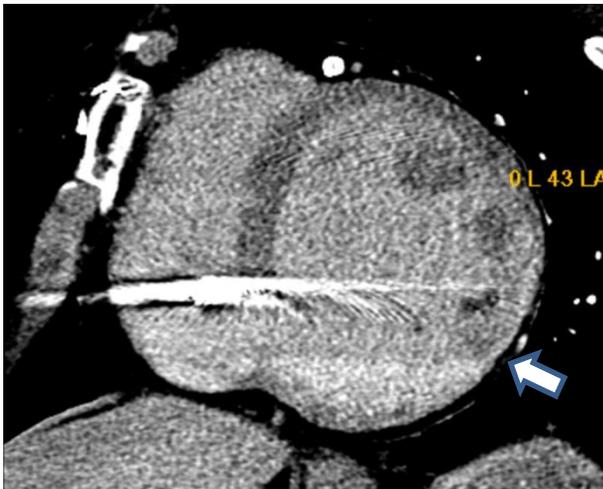
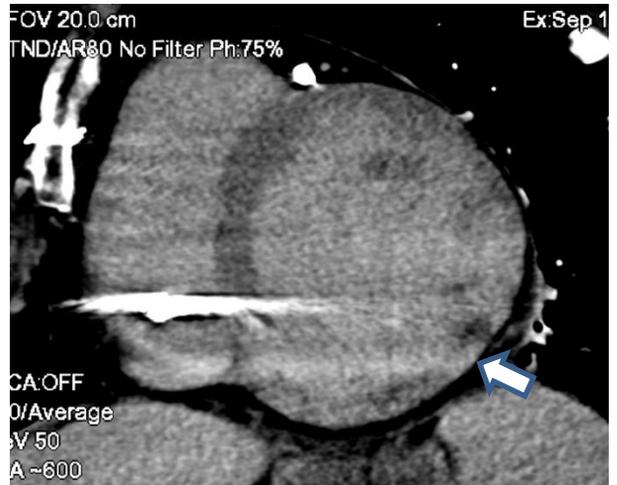
2.1 Pre- and post-SBRT CT in patient 1. Scar at infero-posterior wall increased after treatment.

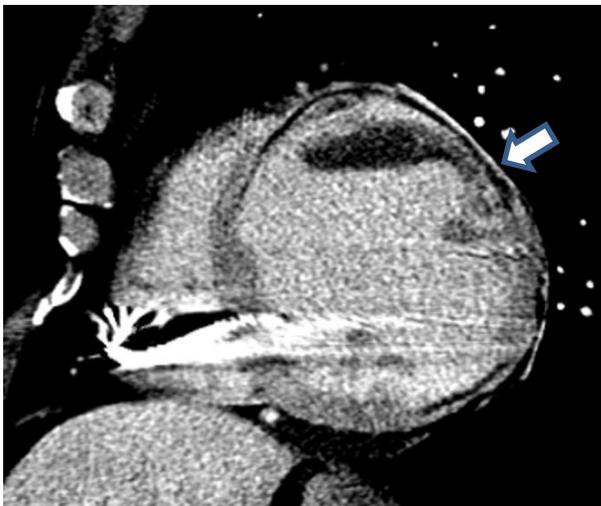
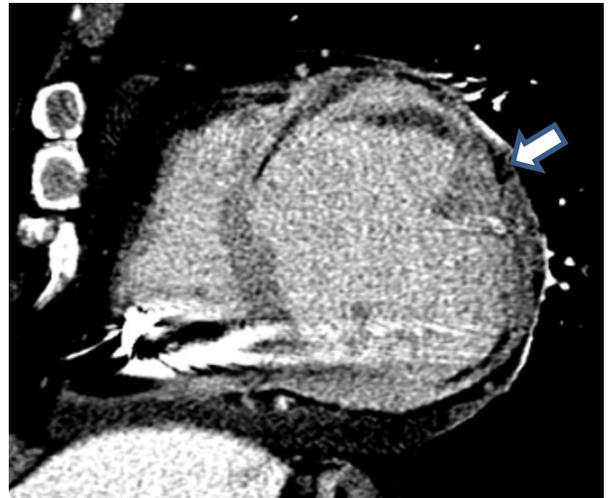
2.2 Pre- and post-SBRT CT in patient 2. Scar at anterior wall increased after treatment. LV thrombus decreased in size.

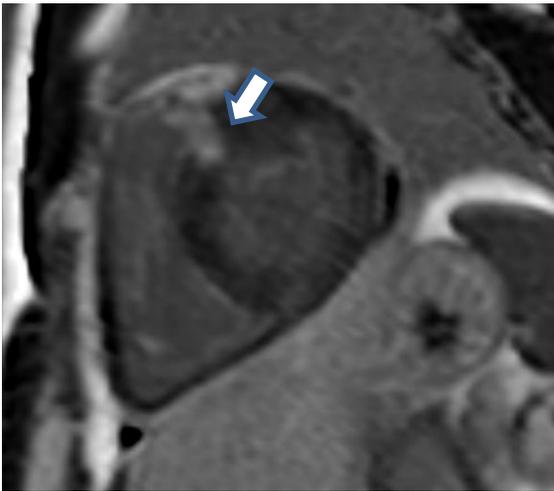
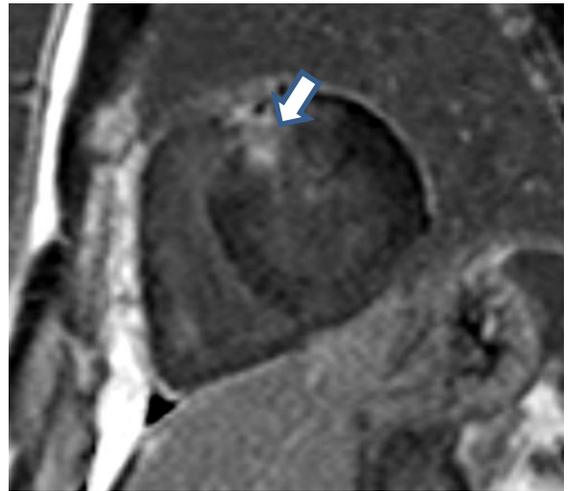
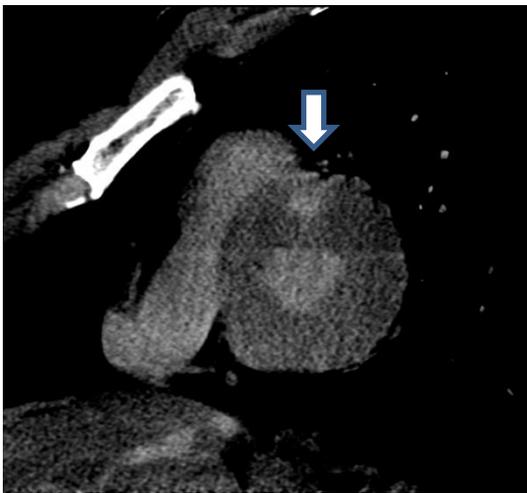
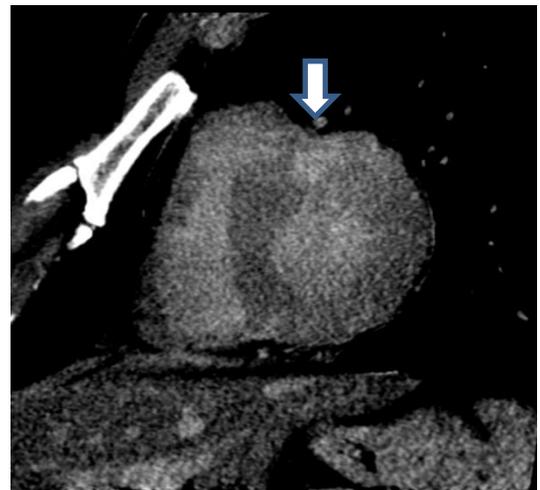
2.3 Pre- and post-SBRT MRI (upper part) and CT (lower part) in patient 3. Scar at basal antero-septum increased after treatment.

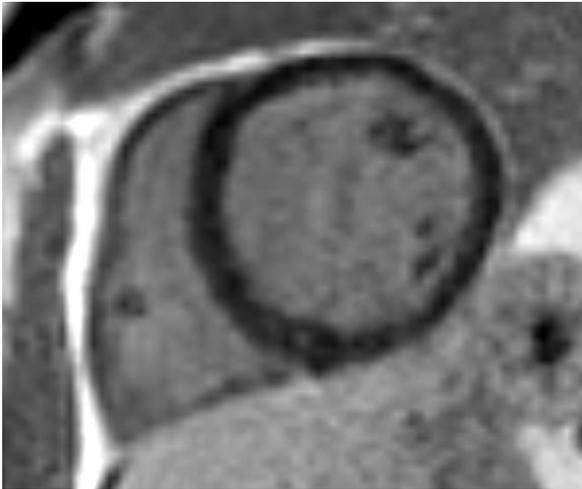
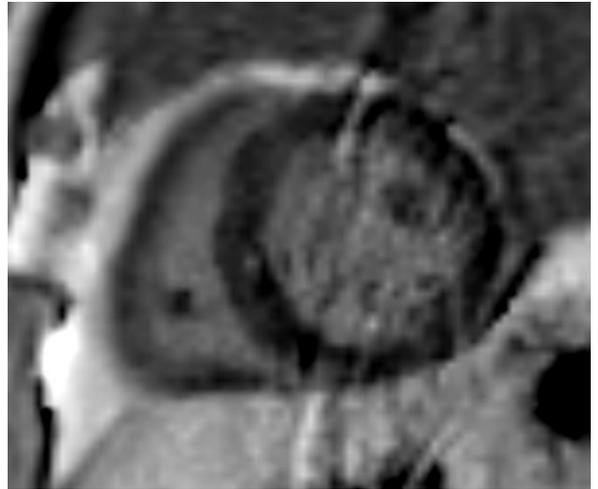
2.4 Pre- and post-SBRT MRI in patient 4. No scar was identified on either pre- and post-SBRT MRI.

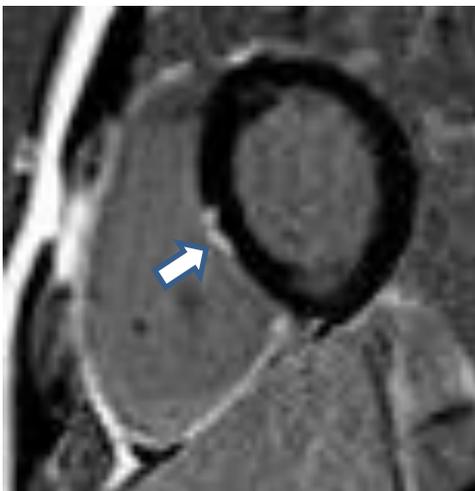
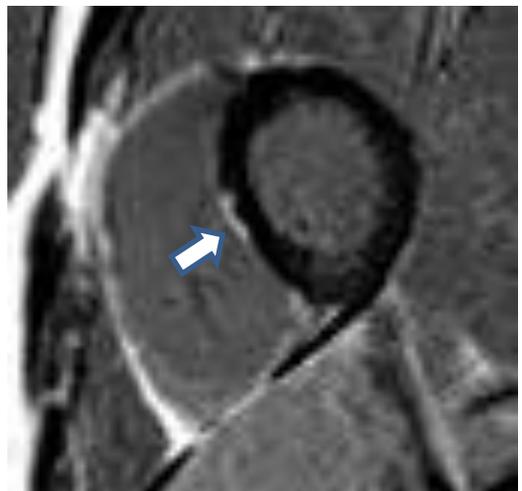
2.5 Pre- and post-SBRT MRI in patient 5. No scar enlargement over RV basal septum (SBRT target) was noted.

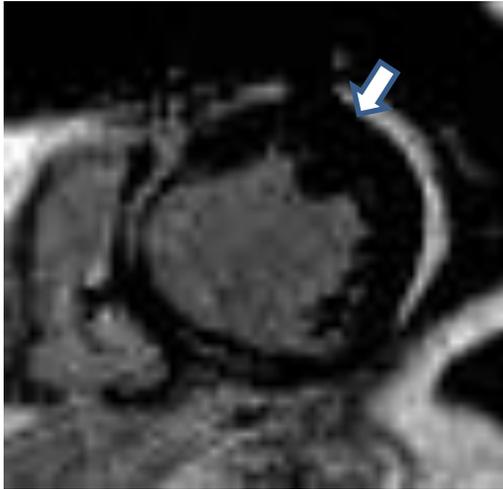
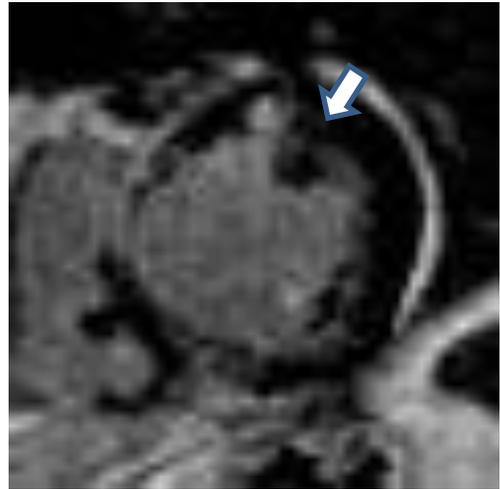
2.6 Pre- and post-SBRT MRI in patient 7. Scar at antero- to infero-septum increased after treatment.
