# Field survey of the 2025 Kamchatsk Tsunami on coasts of the Northern Kurilis, Russia (2d Kuril Strait)

On July 29, 2025, a strong earthquake near Kamchatka (Russia) generated the tsunami that spread across the entire Pacific Ocean. The tsunami had its strongest impact on the coast of the northern Kuril Islands (Paramushir and Shumshu), causing great destruction. During the first days after the earthquake, the field survey of tsunami traces on these islands was conducted in the area of the Second Kuril Strait (that divides these islands), and the boundary of land inundation by tsunami waves was outlined using GPS. Runup heights were determined using GEBCO\_2019 (grid with 15 arc-second resolution) topographic maps installed into Google Earth. The observation results are summarized in this paper.

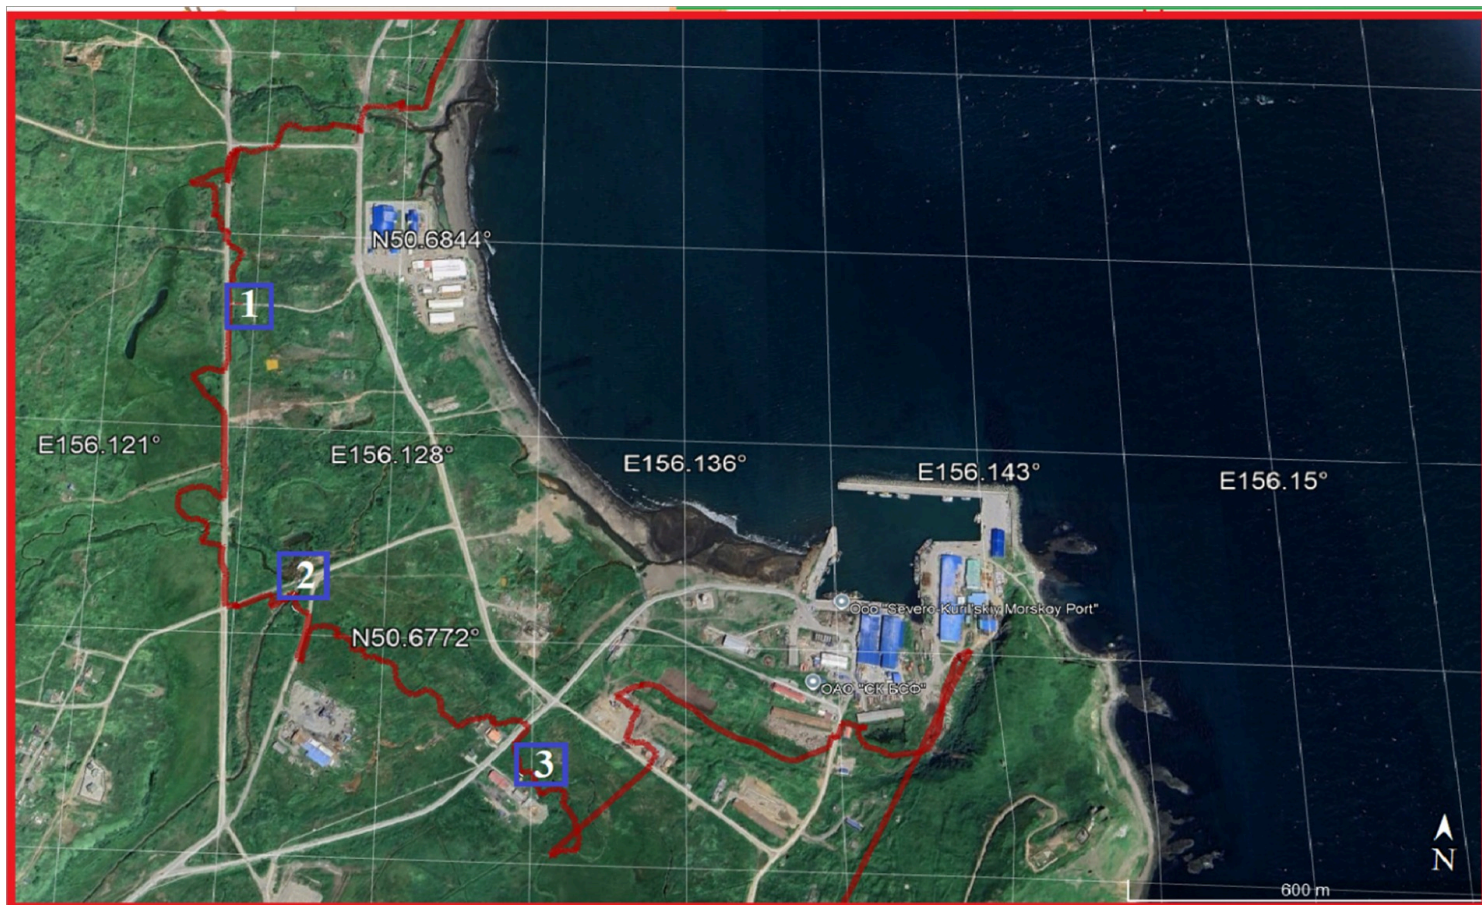
**Figure 2**

Severo-Kurilsk coastal zone. The red line shows the maximum splash line

The coastal zone map of Severo-Kurilsk is shown in Fig. 2. The red line on it shows the line of coast flooding by tsunami waves, outlined during the survey. Here are also the numbers of the points for which we will give more detailed information about the flooding.

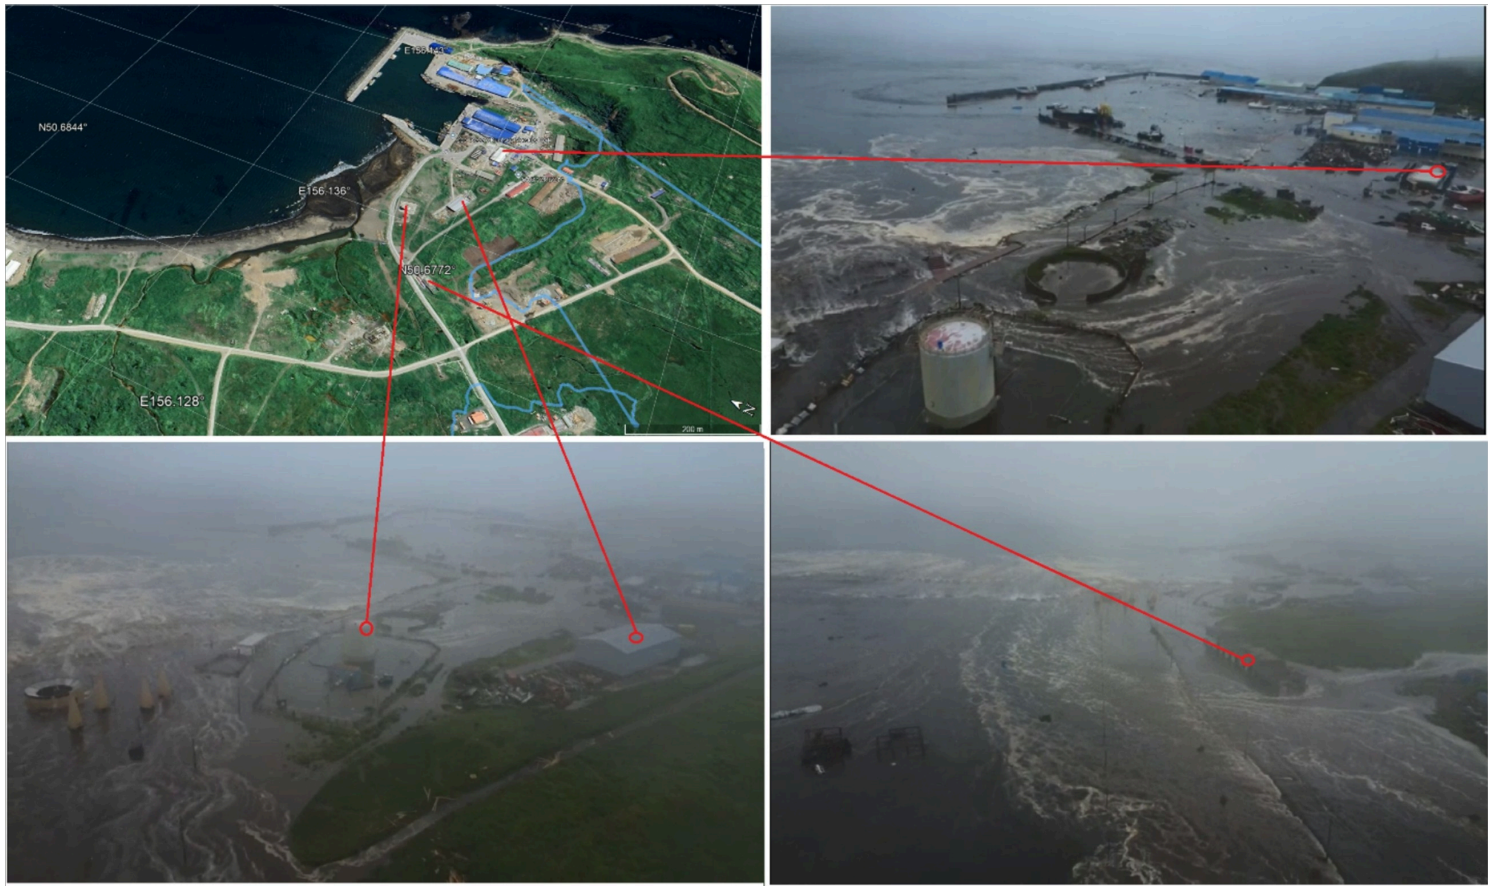
Figure 3

The flooding zone of the Severo-Kurilsk port according to video clips [GR RAS (Kamchatka branch)]

First of all, we will mention several flooding shots of the Severo-Kurilsk port taken from various video clips which appeared in large numbers on the Internet (Fig. 3). The characteristic points from these clips have been transferred onto the map (top left). Let us note that all the objects (hangars, barrels), which allowed us to determine the position of these shots on the map, are clearly visible in the shots.

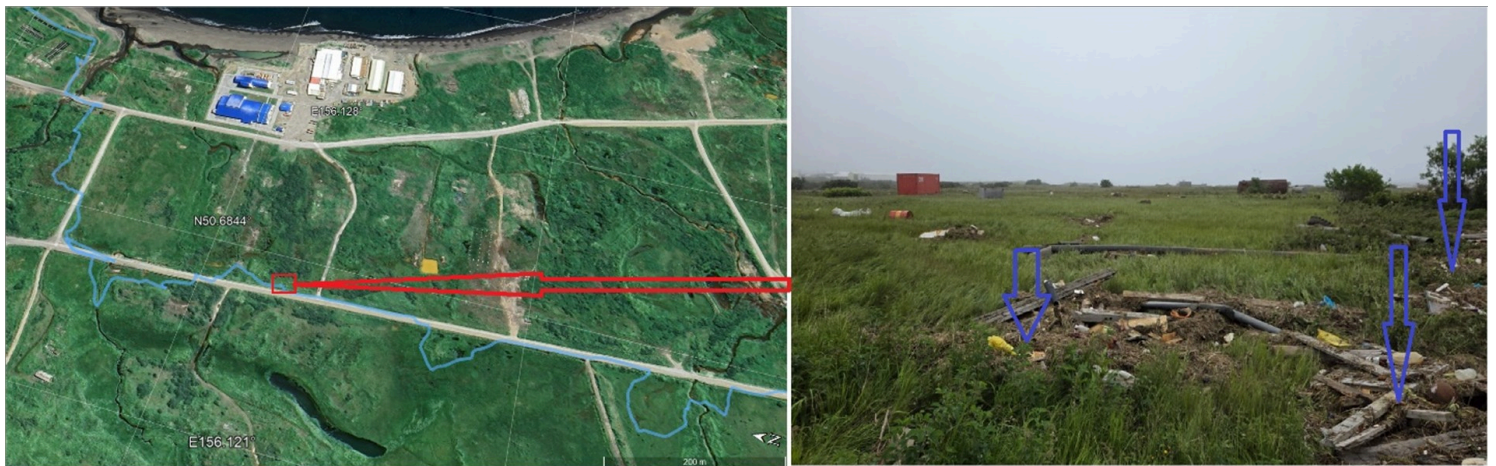
Figure 4

The height of this point relative to the sea level according to the topographic map is about 5m, the distance to the water edge is 450 m. The grass flattened by water and the garbage lane brought by water are observed in this place. The last line where the garbage was carried by the wave is clearly visible. It is worth noting that the road running parallel to the coast became an obstacle for the tsunami. The wave crossed it only in a few places where the road passes through streams.

Point 1 (50.683516°, 156.124325°)

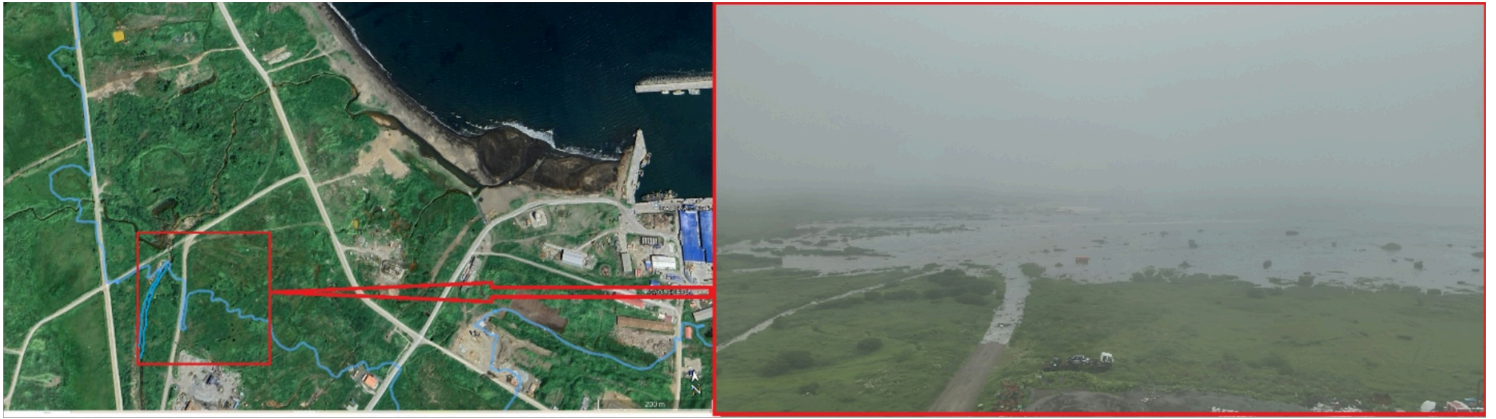
Figure 5

The height of this place relative to the sea level according to the topographic map is about 5m, the distance to the water edge is 550 m. The grass, flattened by water, is observed in this place. It is important to note that the river, along which the wave passed more than 650 m deep into the land, flows in this place. Visually, the width of the stream bed after the tsunami increased three-to-four times.

Point (50.677960°, 156.126235°)

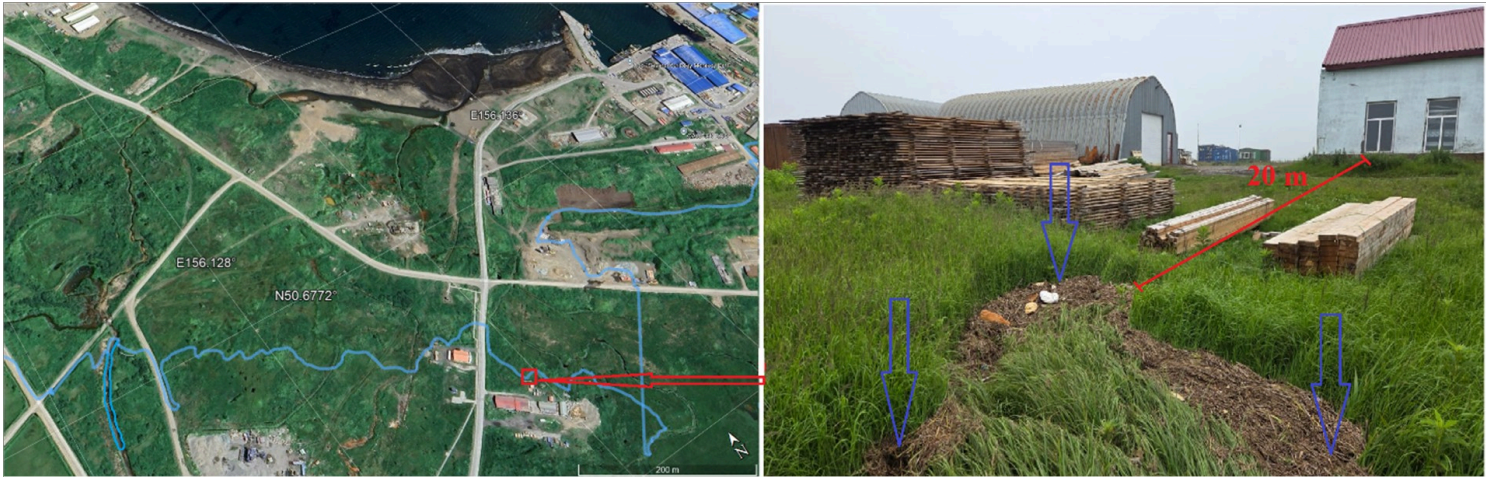
Figure 6

The height of this point relative to the sea level according to the topographic map is about 6m, the distance to the water edge is 550 m. The grass flattened by water and the garbage lane are observed in this place. The narrow tongue-like coastal flooding is clearly visible. The water did not reach the buildings by about 20 m.

Point 3 (50.675025°, 156.131761°)

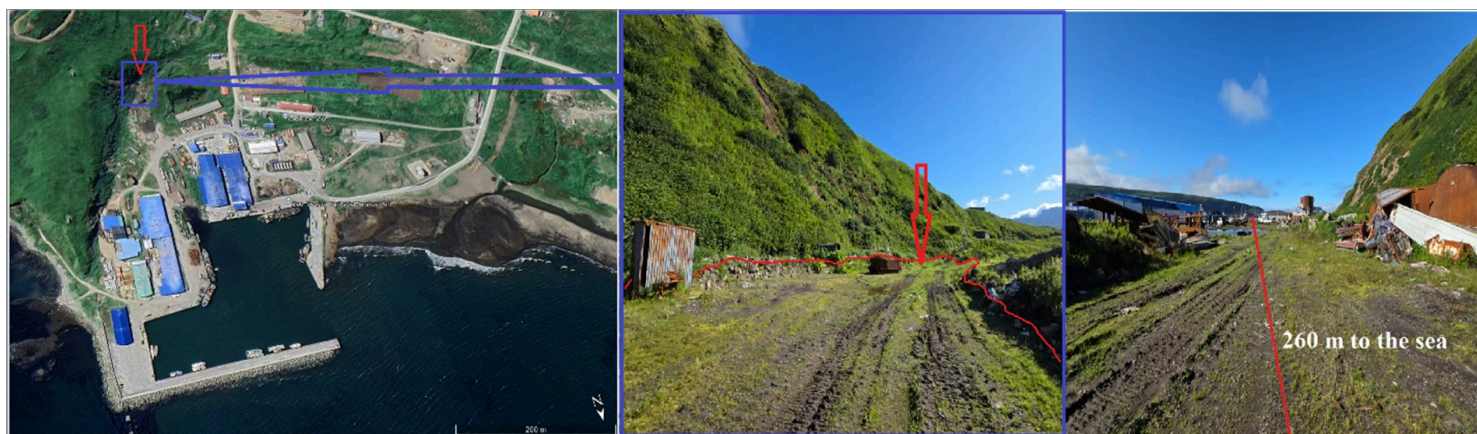
**Figure 8**

The summary picture of the Severo-Kurilsk flooding line is shown in Fig. 7 with the red line. The splash heights along this line are also shown here. As one can see, the maximum splash height was about 10 m. This place is shown in Fig. 7 with the vertical arrow and in more detail in Fig. 8. The coordinates of the place are: 50.675669°N, 156.14124°E and the distance from the shore is 260 m. Outside this place, the splash height is almost constant along the coast and on the left side of the port is 5 m. To the right of the port, the splash heights are higher and reach 7 m. The riverbed can be seen on the right side of the map. It is difficult to tell visually how far the wave traveled along the river, but garbage traces are visible at a distance of 100 m from the sea.

The view of the point with the extreme 10m splash height. In the middle is the view from the sea, and on the right is the view towards the sea.

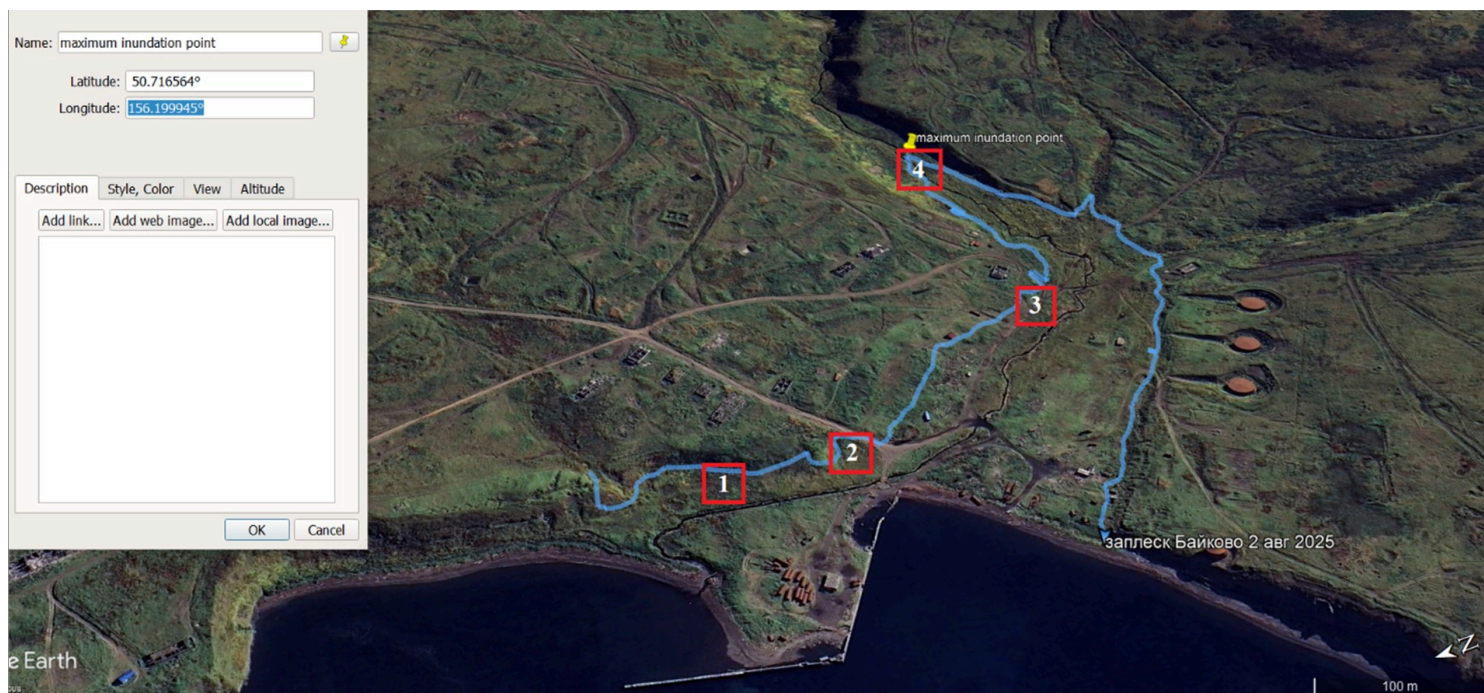
**Figure 10**

In Fig. 9a wide tongue-like area where the wave passed far along the shore can be seen; see also Fig. 10. The Nikolaevka River, about 2m wide flows in the lowland here. The water spread to the width of about 150m, maximum 170m.

The area of the coast flooding in the area of the Nikolaevka River (see Fig. 9)

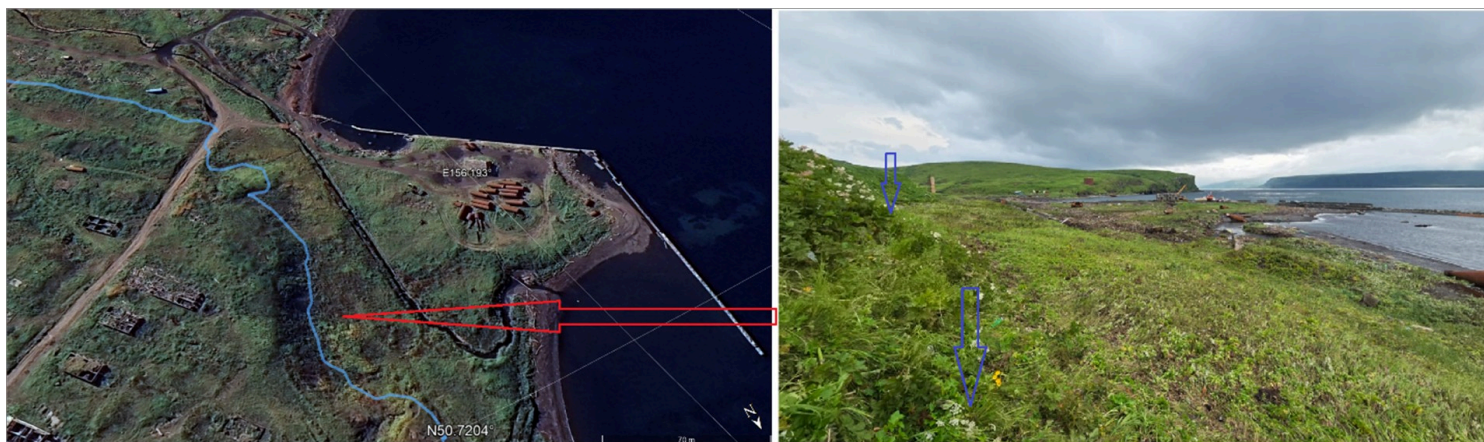
**Figure 11**

The height of this point relative to the sea level according to the topographic map is about 10m, the distance from the edge is 110 m. In this place, the grass flattened by water is observed, and the flood line is clearly visible.

Point 1 (50.719872°, 156.194949°)

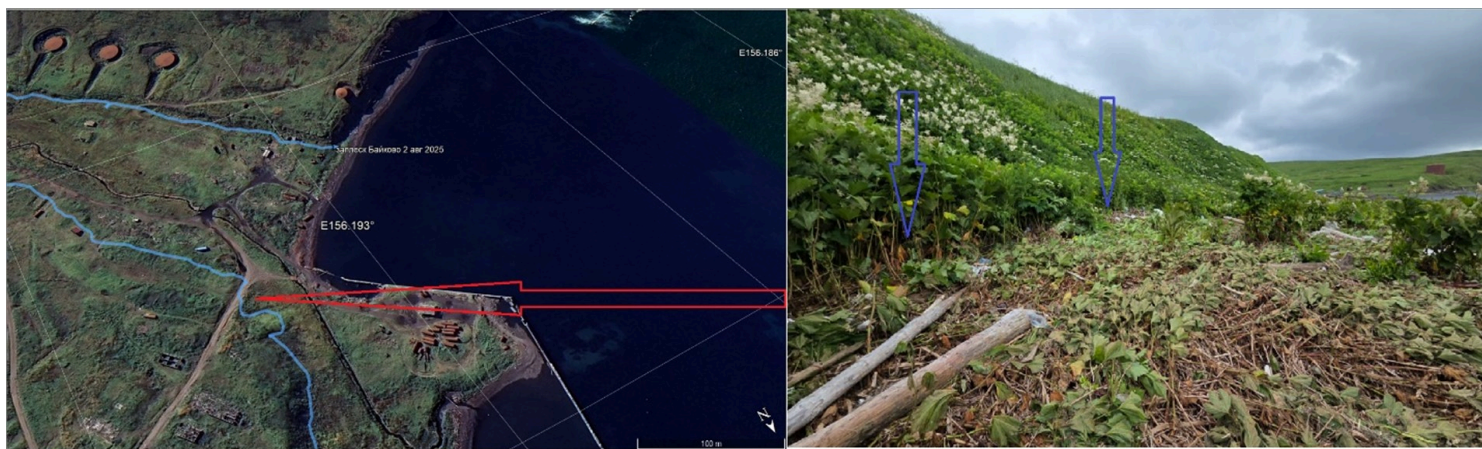
**Figure 12**

The height of this place is about 8m, the distance from the edge is 80 m. In this place, the grass flattened by water and pieces of wood brought by water, are observed. The flood line is clearly mapped.

Point 2 (50.718680°, 156.194824°)

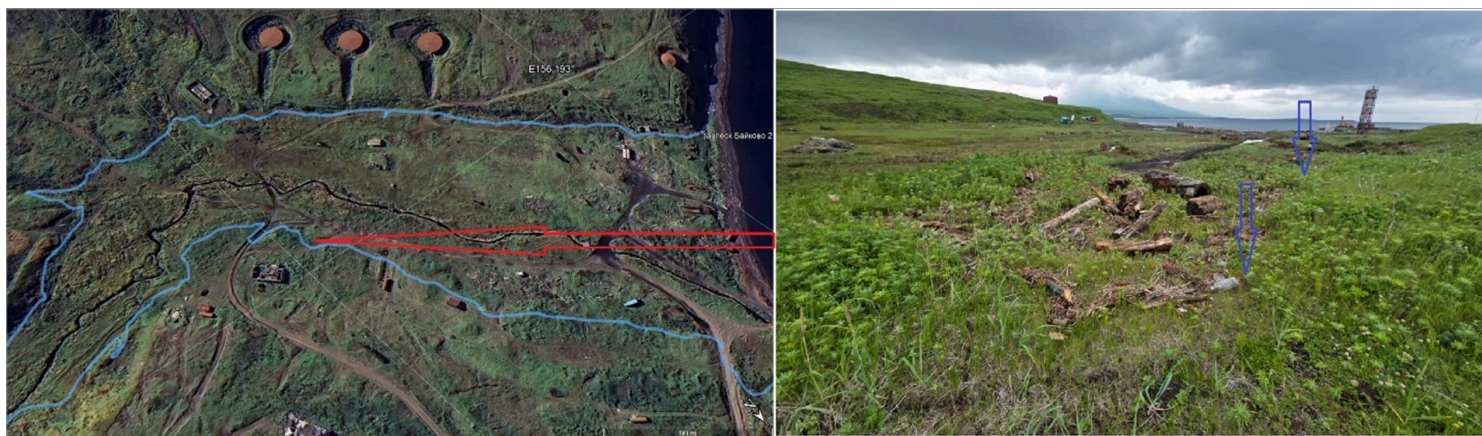
**Figure 13**

Its height relative to the sea level is about 8m, the distance from the cut is 290 m. In this place, the lane of the garbage, brought by water, tracing the flooding line is clearly visible,.

Point 3 (50.716590°, 156.196533°)

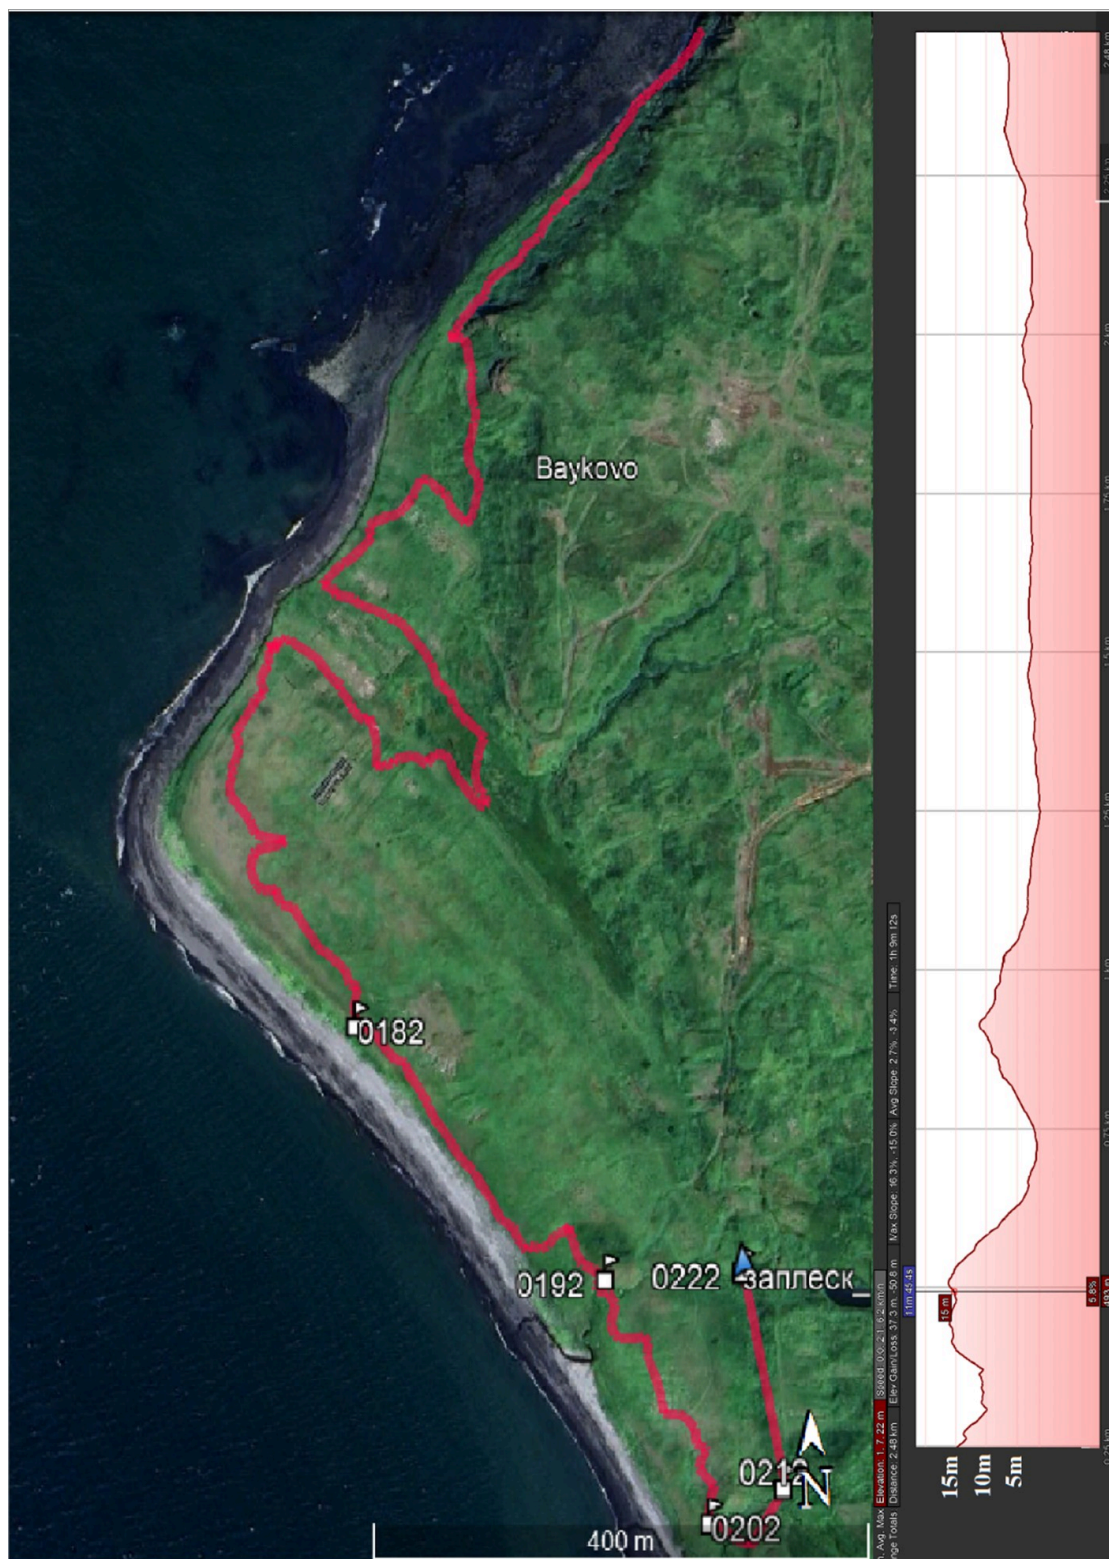
**Figure 15**

Similar measurements were made in the area of Kozyrevsky settlement (also currently uninhabited). The survey was conducted in the area of this settlement ledge into the strait (see Fig. 1 on the right). The flooding coast line along the ledge is shown in Fig. 15. The maximum wave height here reached 15 m at a distance of 250 m from the shore (this point is shown by the arrow in the figure). In the figure, between the cape and the greatest splash point, a lowland area is visible, where the wave penetrated far to the shore.

The track of the tsunami flood line (the blue line) in the area of Kozyrevsky settlement and distribution of splash heights along it.

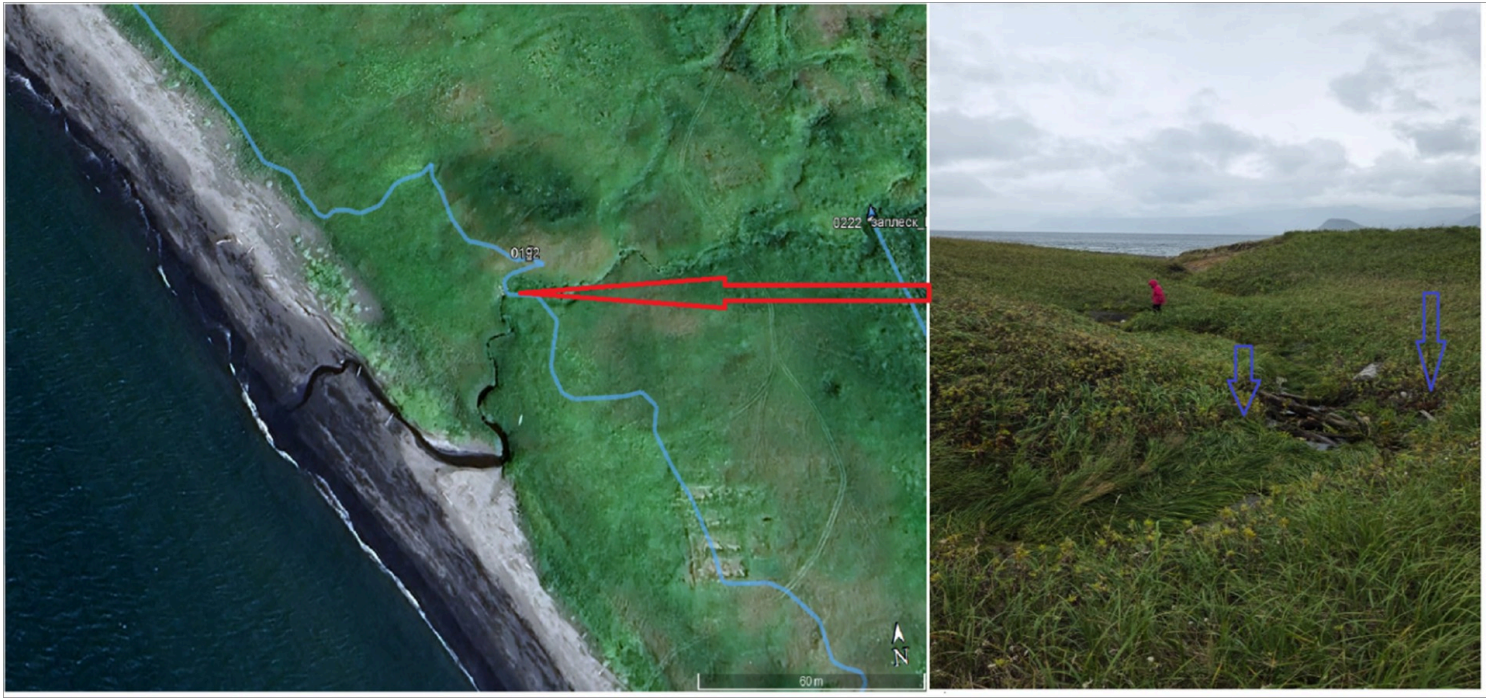
Figure 16

The wave entry point along the creek-bed ends with the debris lane brought by the tsunami. Flattened grass is also visible. This point height is about 4 m, the distance from the water edge is 85 m.

Point 5 (50.703663° 156.178119°)

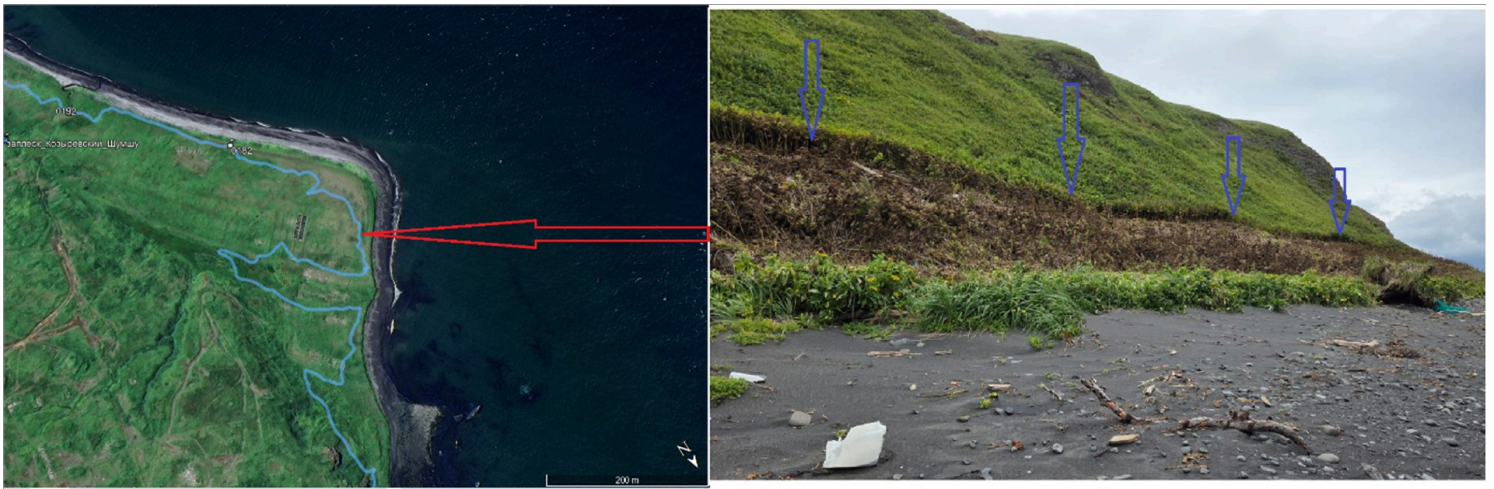
Figure 17

The run-up line along the coast is clearly visible. The grass is dry and flattened, and small washouts are also visible. This point height is about 2 m, the distance from the shore is 55 m.

Point (50.707642° 156.178119°)
