## Supplementary Information

### Drone-Based AI for Automated Bridge Defect Detection and Condition Assessment

14 **Supplementary Table 4.** Visual Characteristics, Causes, and Examples of Concrete Defects  
15 Considered in the SMART Stage 1 AI Inspection Project

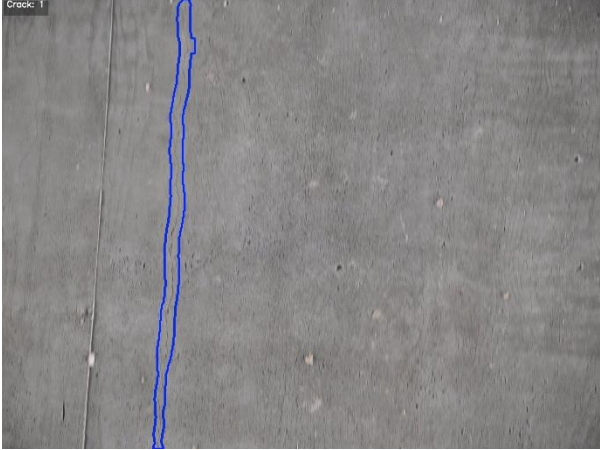
Type of Defect	Definition	Causes	Visual examples
Crack	Separation or fracture in concrete that may occur before or after hardening, often appearing as visible lines of varying length and depth.	Plastic shrinkage due to rapid water loss, settlement over embedded items, drying shrinkage, thermal contraction, subgrade settlement, overloading, or long-term deterioration from freeze–thaw cycles, alkali–aggregate reactivity, sulfate attack, or reinforcement corrosion <sup>3</sup> .

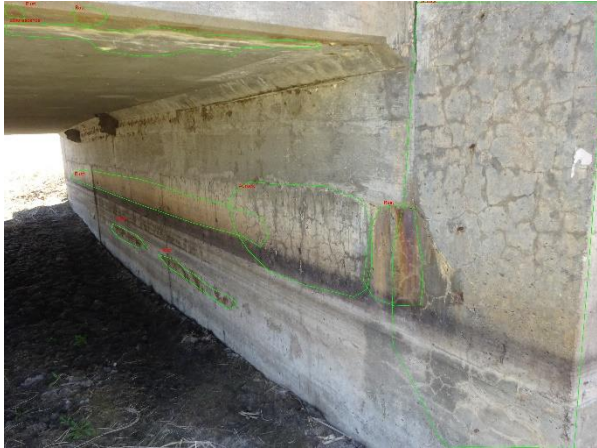
Alligator Cracks (ACrack)	A network of fine, shallow surface cracks forming a chicken-wire or map-like pattern;	Minor surface shrinkage due to rapid drying, low humidity, high temperature, direct sun, or

typically cosmetic rather than structural.	wind; poor curing practices; or surface treatments (e.g., dry cement dusting) that accelerate drying <sup>3</sup> .

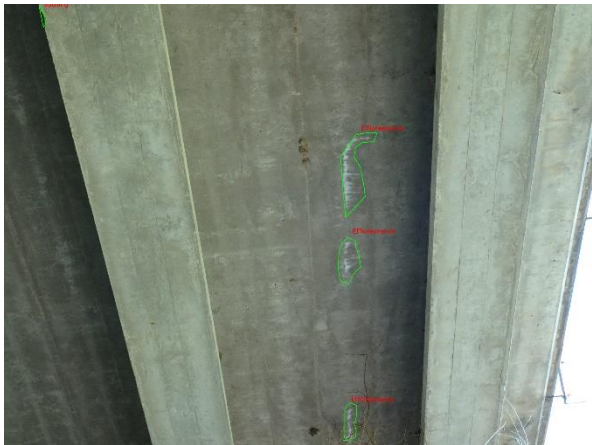
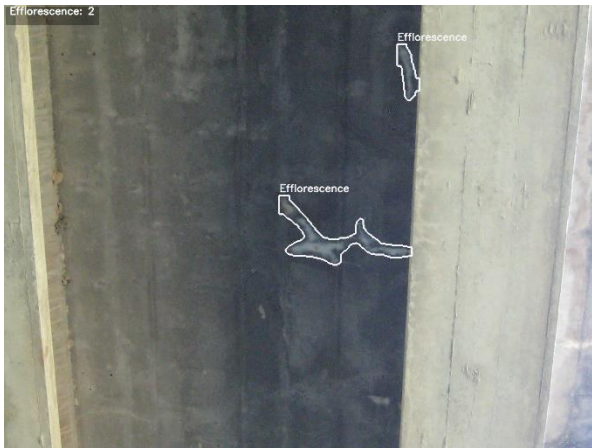
Efflorescence	A whitish crystalline deposit that appears on the surface of concrete, typically soon after construction; usually aesthetic rather than structural <sup>4</sup> .	Migration of soluble salts dissolved in moisture within the concrete to the surface, followed by evaporation of water; influenced by salt content in materials, moisture penetration, and drying conditions (temperature, humidity, wind) <sup>3</sup> .

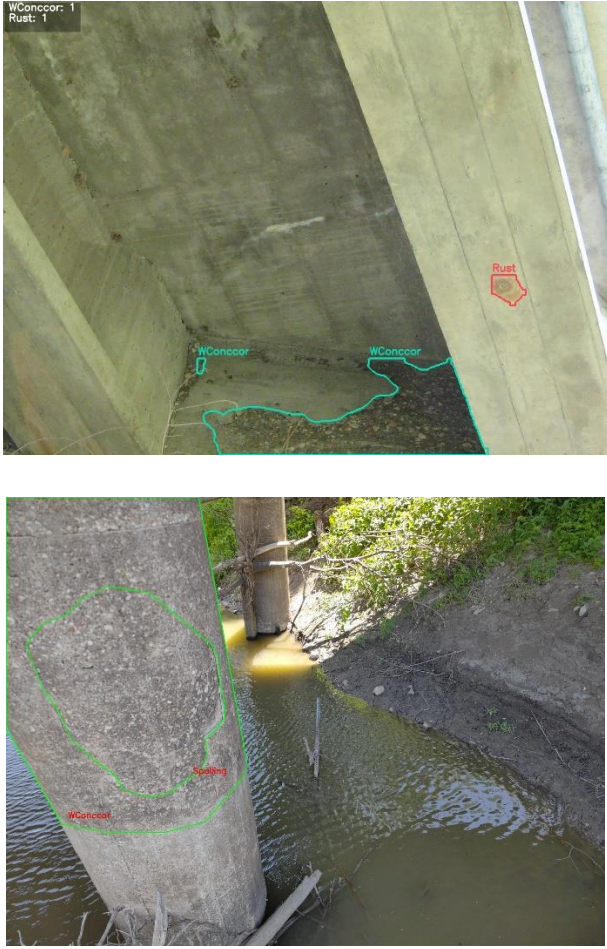
<p>Water-concrete Corrosion (WConccor)</p>	<p>Surface damage to concrete that appears as erosion, abrasion, or general material loss, often presenting as washouts or planar corrosion defects that are visually difficult to distinguish.</p>	<p>Continuous exposure to running water (e.g., at bridge piers or abutment walls), freeze-thaw cycles, chemical attacks (acids, salts), or mechanical abrasion, all of which gradually wear away the concrete surface<sup>5</sup>.</p>

<p>The top photograph shows a close-up of a concrete surface. A green outline labeled 'WConccor' highlights a large area of surface erosion. A red outline labeled 'Rust' highlights a small area of rusted reinforcement. The bottom photograph shows a concrete pier in a river. A green outline labeled 'WConccor' highlights a large area of surface erosion. A red outline labeled 'Spalling' highlights a small area of spalled concrete.</p>

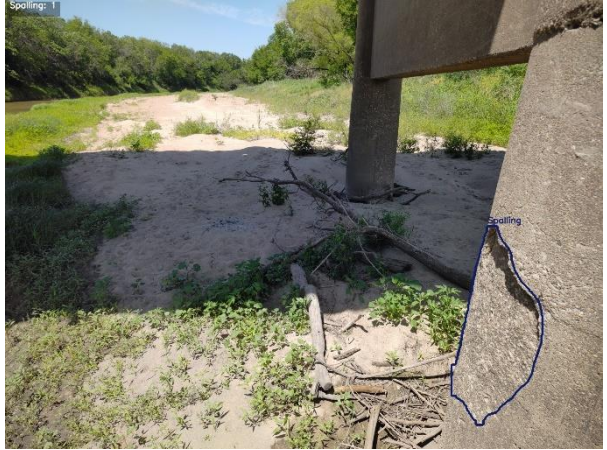
<p>Spalling</p>	<p>A deeper surface defect of concrete characterized by localized breaking, flaking, or depression of the surface, often forming circular, oval, or elongated cavities.</p>	<p>Internal pressure or expansion within concrete, freeze-thaw cycles, chloride-induced corrosion of reinforcing steel, improper joint design or construction, bond failure, mechanical impact, or fire</p>

<p>The photograph shows a concrete pier with a blue outline labeled 'Spalling' highlighting a large area of spalled concrete. The pier is located in a river with a sandy bank and some vegetation in the background.</p>

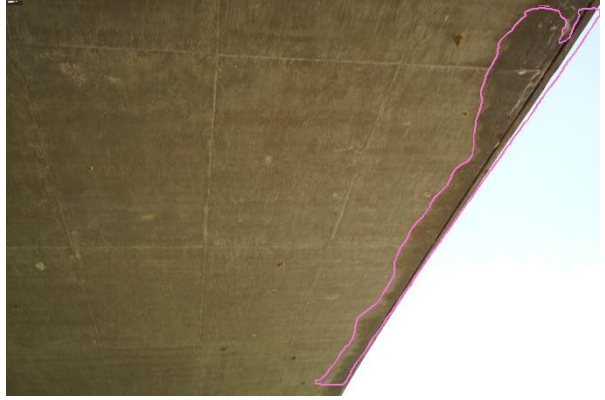
and weathering effects <sup>3</sup> .	
Wetspot	A darker or moist area visible on the concrete surface where water accumulates or fails to drain properly; may indicate potential deterioration zones.	Blocked or damaged drainage, leaky joints, cracks in the deck, or retained water from recent rainfall. Persistent wet areas can accelerate damage by carrying deicing salts and increasing exposure to carbonation and chloride penetration <sup>5</sup> .

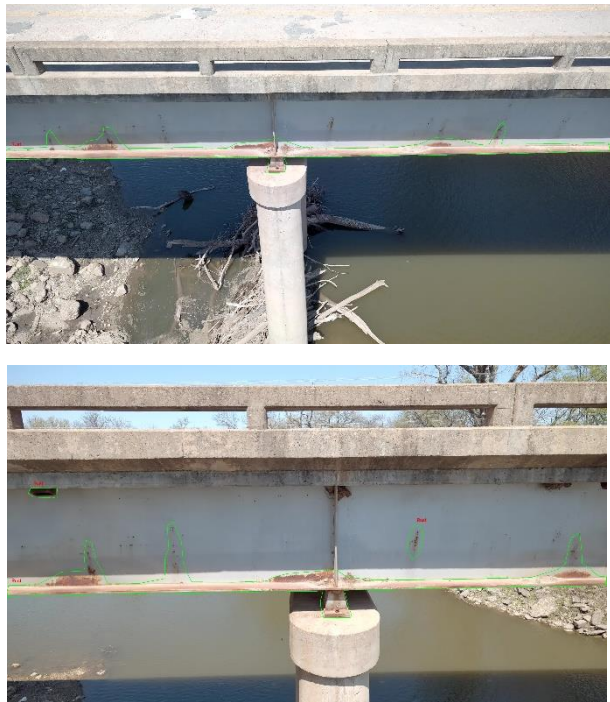
Rust	A reddish to brownish discoloration on concrete surfaces caused by the oxidation of embedded reinforcement bars or nearby metallic elements.	Loss of the protective alkaline environment ( $\text{pH} > 9.5$ ) due to carbonation, ingress of water and carbon dioxide through cracks or porous concrete, and chloride attack from deicing salts or marine exposure. These processes

depassivate the steel, leading to oxidation and rust staining on the surface.	
Exposed Rebars	Reinforcing steel that has become visible and unprotected due to spalling or loss of concrete cover, leaving it directly exposed to the atmosphere <sup>6</sup> .	Concrete spalling from reinforcement corrosion products, carbonation, or cracking; chloride penetration in coastal or deicing environments ; inadequate cover thickness; and environmental factors (temperature, humidity, marine salts) that accelerate uniform corrosion and mechanical property degradation of the steel <sup>5</sup> .
