# Experimental and Numerical Analysis of Out-of-Plane Behaviour of Dry-Joint Stone Historical Walls

**Abstract.** Numerous dry-joint stone walls worldwide represent important historical and cultural heritage. These walls are particularly susceptible to out-of-plane loads, such as those due to seismic activity, which can lead to overturning failure. One way to evaluate these structures is to use numerical models, which must be validated with experimental data to ensure accuracy. For this reason, this research introduces a novel approach to evaluate the structural response of dry-joint stone construction, which uses rigid body numerical modelling, validated through experimental analysis of replicas that closely reproduce the properties of heritage structures. For this purpose, a reproduction of a dry-jointed stone wall of the Coricancha Temple in Cusco, Peru, was tested in order to validate the numerical models of the structure based on the finite element method and rigid-body mechanics. Three 1:2-scale concrete block walls were constructed on a tilting table. These walls were built with characteristics very similar to those of the original heritage structure and then tested under a

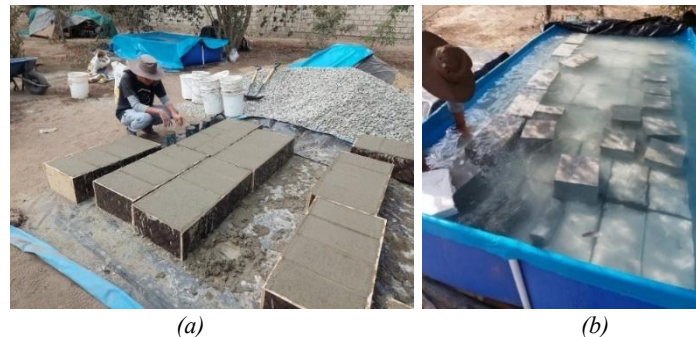
**Fig. 7** Concrete blocks: (a) Making blocks, and (b) Curing of concrete

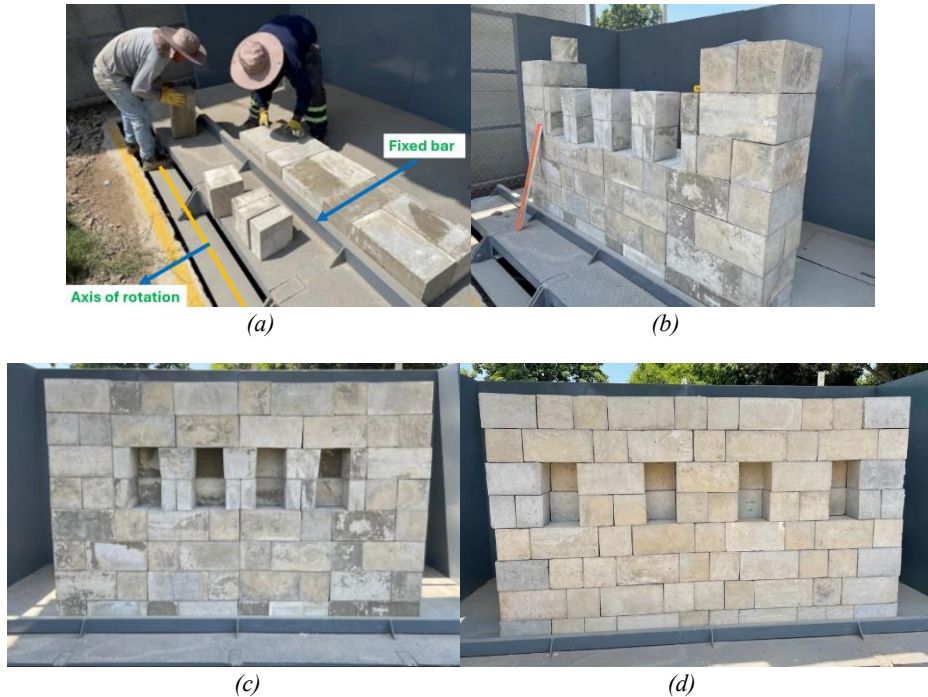
**Fig. 9** Construction of the walls: (a) Placing the first course, (b) Arranging the upper blocks, (c) Wall A-1 completed (model A), and (d) Wall B-1 completed (model B)

*Fig. 9a* and *Fig. 9b* illustrate the construction of Wall A-1. To mitigate sliding during overturning tests, the initial course of each specimen was placed on a horizontal surface adjacent to the fixed bar (*Fig. 9a*). Verticality was controlled after each course was placed using a plumb bob. *Fig. 9c* and *Fig. 9d* show the completed configurations of Wall A-1 and Wall B-1, respectively. Construction proceeded sequentially: Wall A-1, Wall B-1, and Wall B-2. Note that some blocks from Wall A-1 were reused to construct Walls B-1 and B-2. One significant finding was that, despite the construction blocks being intended to be as regular as possible, they did not achieve a perfect fit during wall construction.

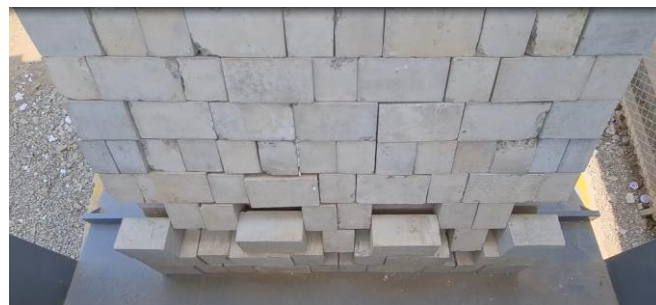
**Fig. 17 Views of Wall B-2 between 10 and 11° of rotation:**

(a) Approximately 10.55°, (b) Approximately 10.65°, (c) 11°, and (d) Approximately 10.65°

*Fig. 17* illustrates the wall just before reaching 11°. Wall B-2 exhibits a failure mechanism comparable to Wall B-1, characterised by a global collapse of the superstructure above the 1<sup>st</sup> course. *Fig. 17a* highlights (with blue outlines) minor crushing damage that occurred during the collapse, specifically along the upper edge of several first-course blocks. *Fig. 17c* shows the final, nearly symmetrical state of the structure, closely resembling the post-collapse condition of Wall B-1. Finally, *Fig. 17d* depicts the almost symmetrical collapse of the wall's rear section.

that mirrors the experimental behaviour (*Fig. 15b* and *Fig. 17b*). Finally, *Fig. 25e* depicts the remaining blocks on the platform post-collapse, which is also very similar to the experimental outcomes for Wall B-1 and Wall B-2 (*Fig. 15c* and *Fig. 17c*, respectively).
