# Supplementary Information

## **Introduction to Yunyan Temple Pagoda**

## **Background of the Yunyan Temple Pagoda Restoration**

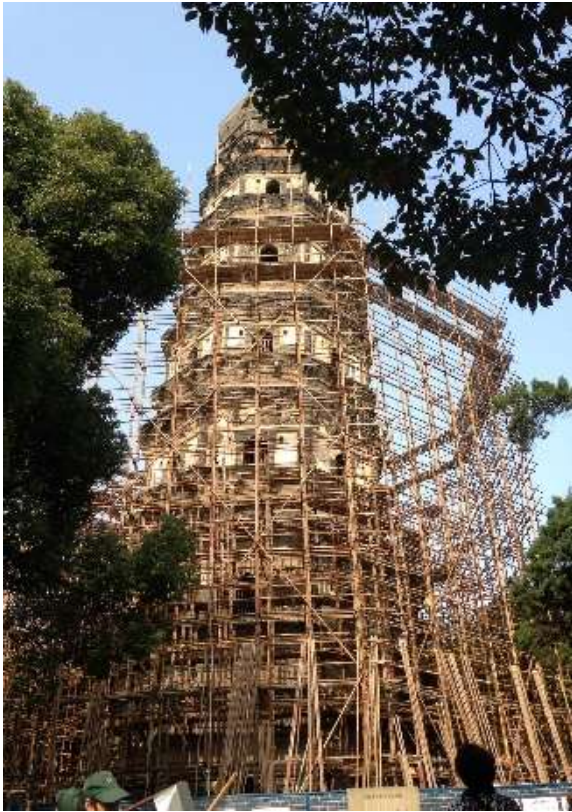
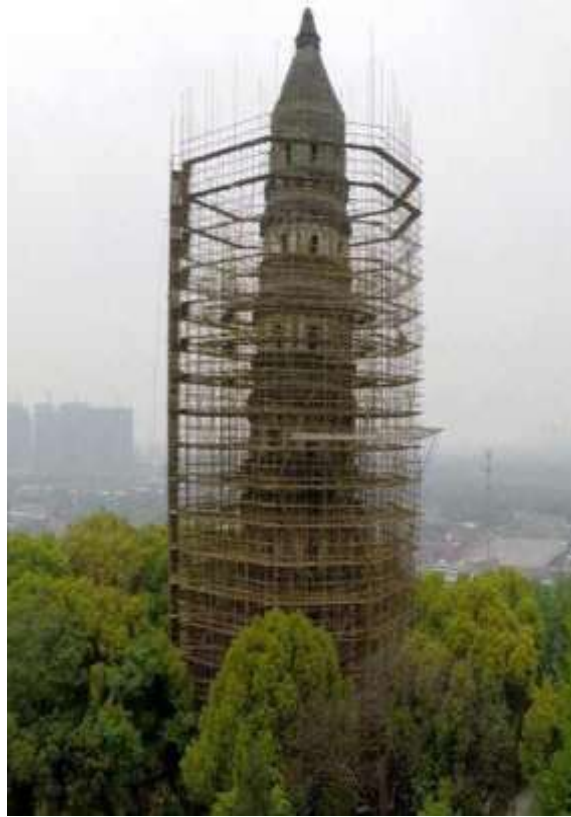
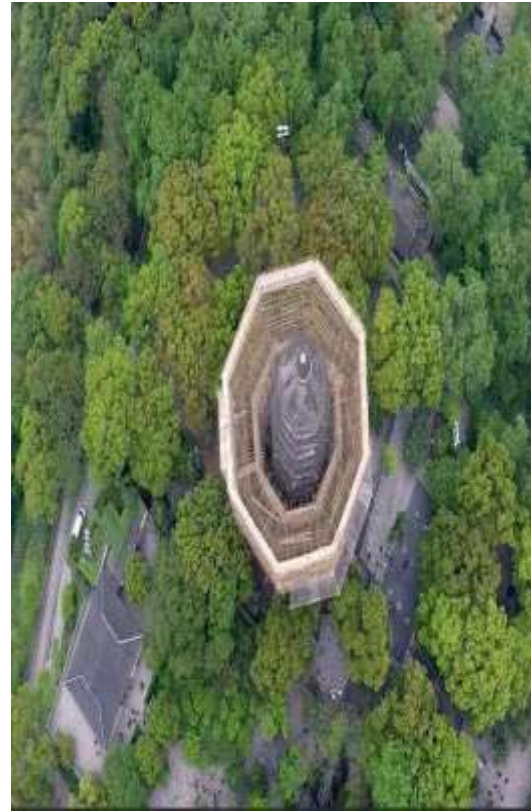
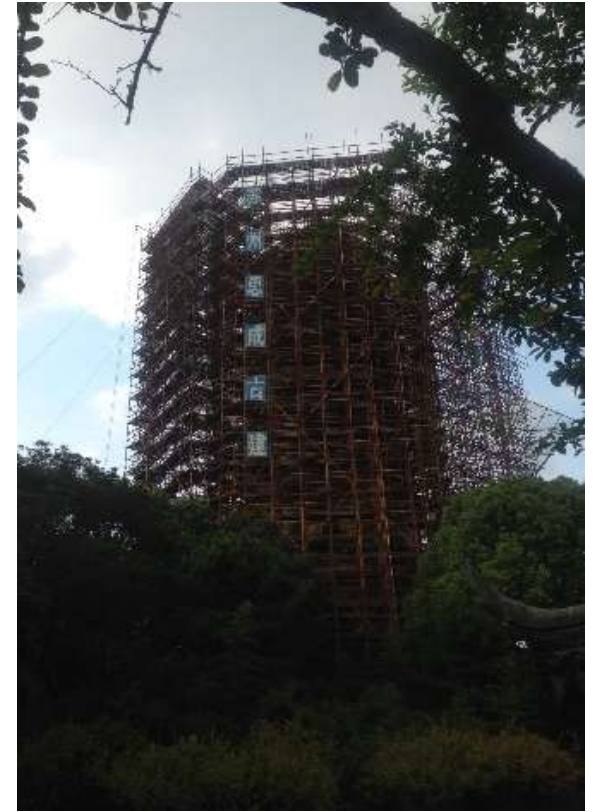
Owing to the pronounced inclination and octagonal geometry of the Yunyan Temple Pagoda, a project-specific scaffolding system was designed by specialist engineers. The leaning profile increased the complexity of scaffold erection and required substantially more structural members than would normally be necessary for a vertically aligned pagoda.
