# Geological, mineralogical, petrographic, hydrogeological, and environmental evaluation of a marble site: Could the water resource protection zone be damaged due to the site?

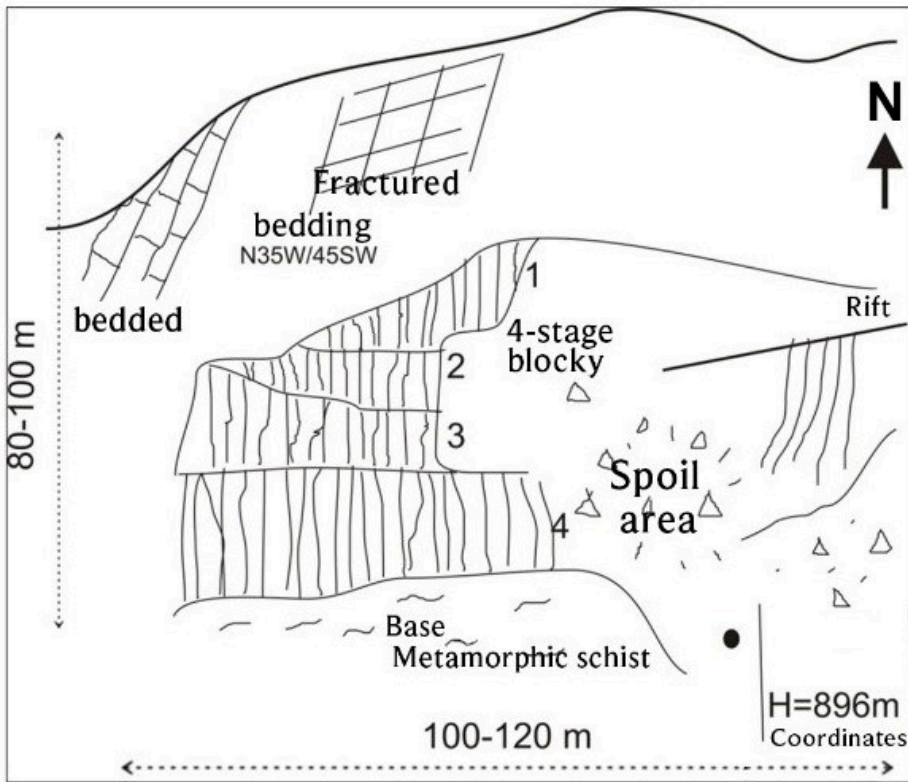
Figure 9

Non-scale view of the Four-stage marble quarry that is operational in the study area.

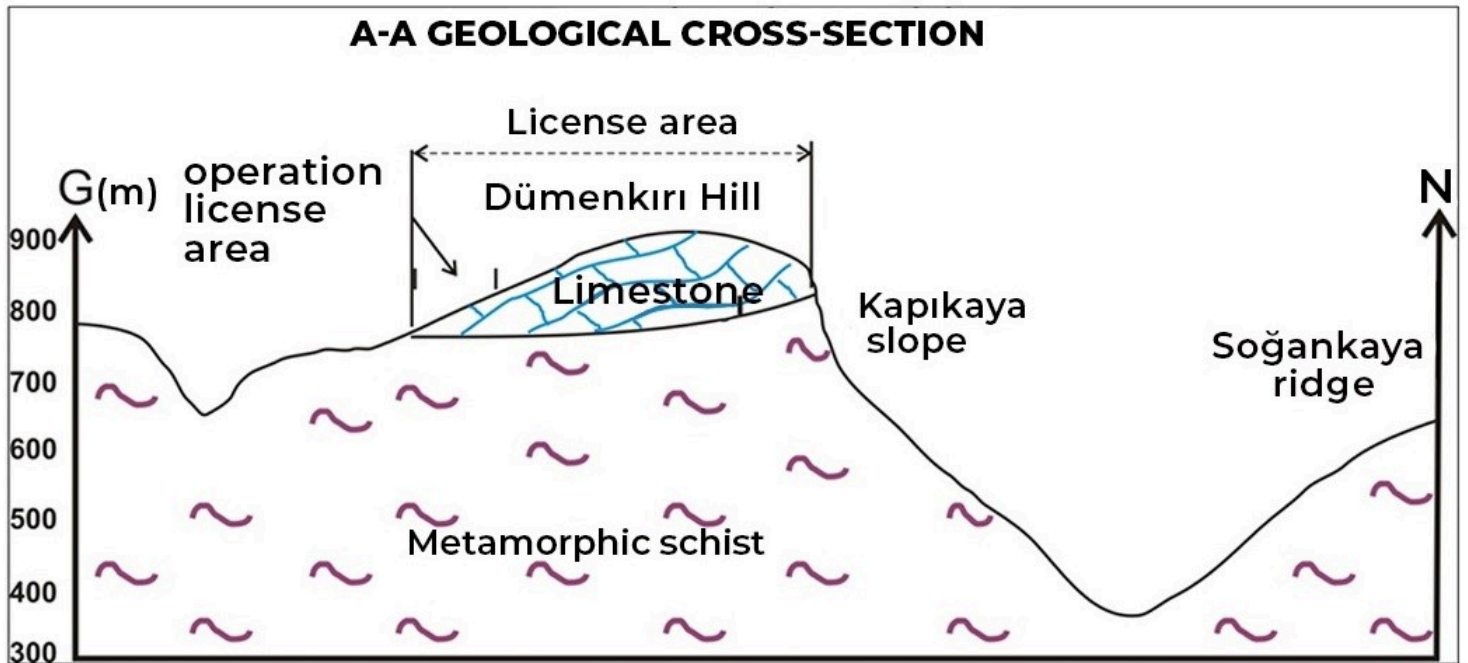
Figure 10

As can be seen in the geological cross-section in Fig. 10, limestones have a 70-meter-thick hat-like position on top of metamorphic schists. Metamorphics have a slope of 10–15 degrees. Değirmen Stream is a waterless stream that merges with the watery Kapıkaya Stream on the Orhaneli road and enters the pond area. There are also irrigated and dry streams coming from the marble quarries area in the western part.

As can be seen in Fig. 10, the most prominent areas in and around the study area are the operation license area and Doğancı Dam. In terms of geological formations, the license area is "limestone-marble" and there are metamorphic units of different ages - that is, Paleozoic age - under this 70-meter Jurassic-aged limestone. In this regard, the Doğancı Dam feeding area basically consists of schists and limestones, especially Kapıkaya Stream (Fig. 4). There are limestones, which are carbonate rocks, at the base of the drinking water dam and especially in the feeding area. In this context, the rocks in the pond inevitably contain  $\text{CaCO}_3$  along with the water coming from the adjacent streams due to these formations.

- The marble operation license area and operating permit area are not directly within the Doğancı Dam feeding area (Fig. 10).
- Doğancı Dam is mainly fed by the limestones and Dolin structures in and around Kocakır Hill in the north of the license area and the limestones (marble) in Kapıkaya Stream (Fig. 10).

Cross-section of the study area in N-S direction.
