# Supplementary File

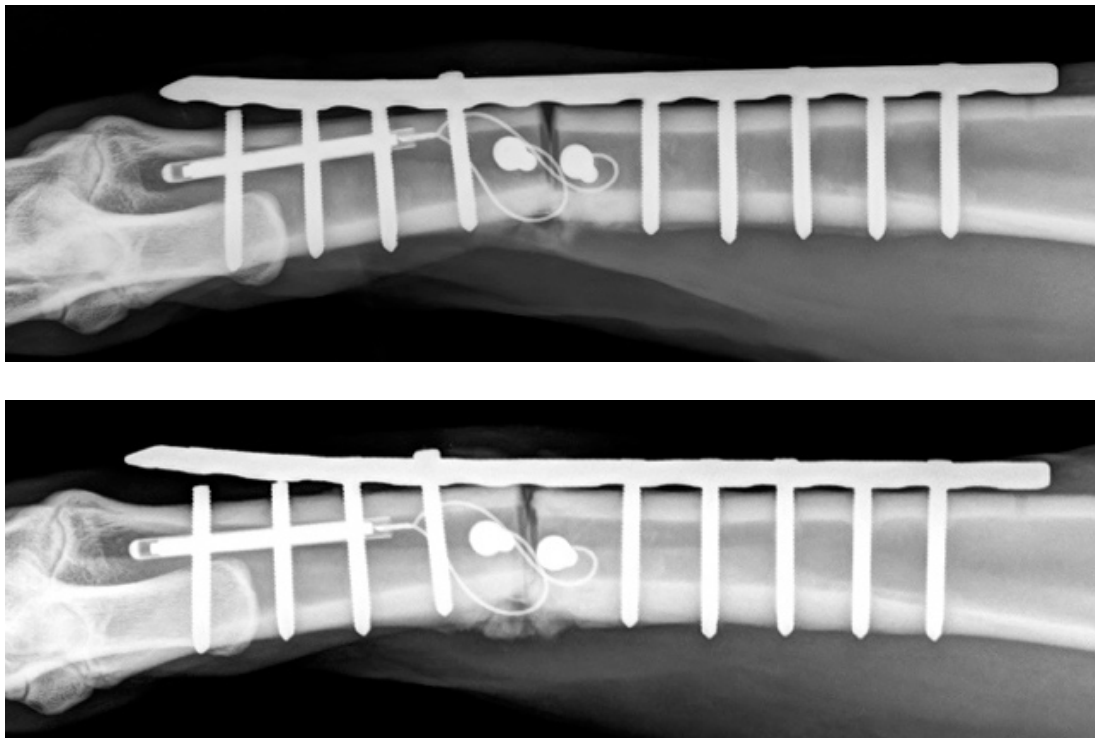
**Figure S1: Excluded Animals**

**Animal 86.01, top radiograph 3 weeks post-surgery, bottom radiograph 5 weeks post-surgery, collapse of fracture gap due to implant failure, after 3 weeks one broken screw visible, after 5 weeks two (11+12) and dislocation of screw 9.**

**Animal 86.01 (CEMF group, 3mm gap model)** had to be excluded from the group analysis due to implant failure of the internal fixation. A complete collapse of the fracture gap laterally at the trans cortex was already detected 3 weeks post-surgery during radiographic examination. The two most distal screws (hole 11 and 12) were broken and the screw in hole 9 (closest to the distal end of the defect) was displaced and bent). The sheep showed a very nervous, anxious and uncooperative behavior jumping a lot trying to escape. This was likely the primary cause of the fixation failure.

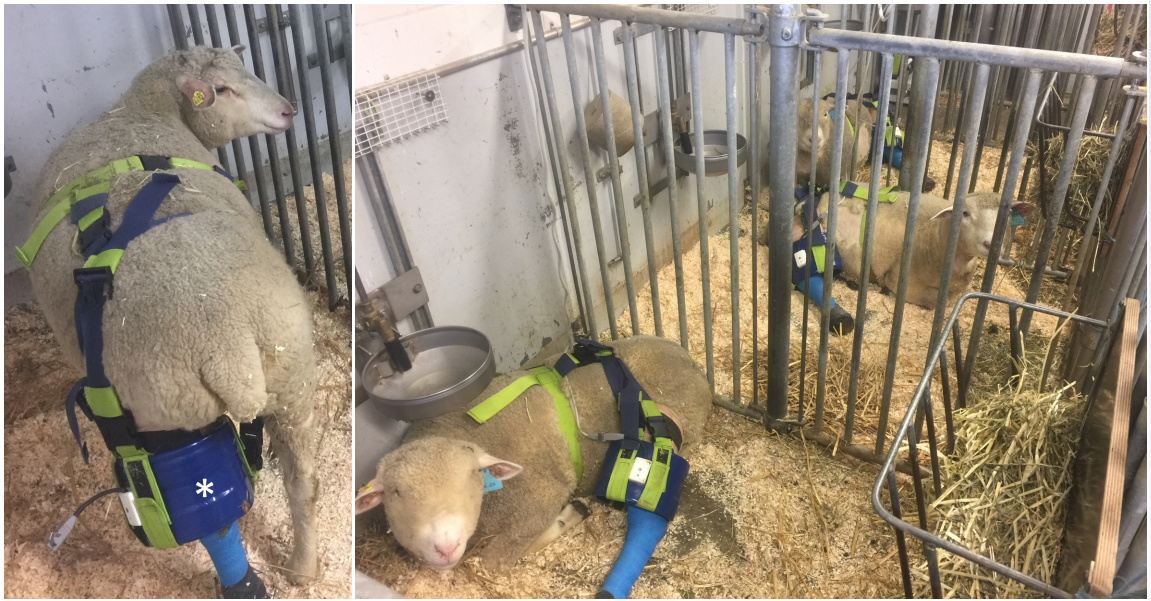
**Figure S2:** The external CEMF coils and straps.

Sheep were fitted with an outer coil (white asterisk, left panel), custom shaped to fit a casted sheep hindlimb, for 90 mins, twice per day, starting day 4 after surgery until sacrifice. Custom straps were designed to allow ease of handling, ensuring sheep would be minimally disturbed without compromising the animal's ambulation and distributing the weight of the coil on the lower back of the sheep.

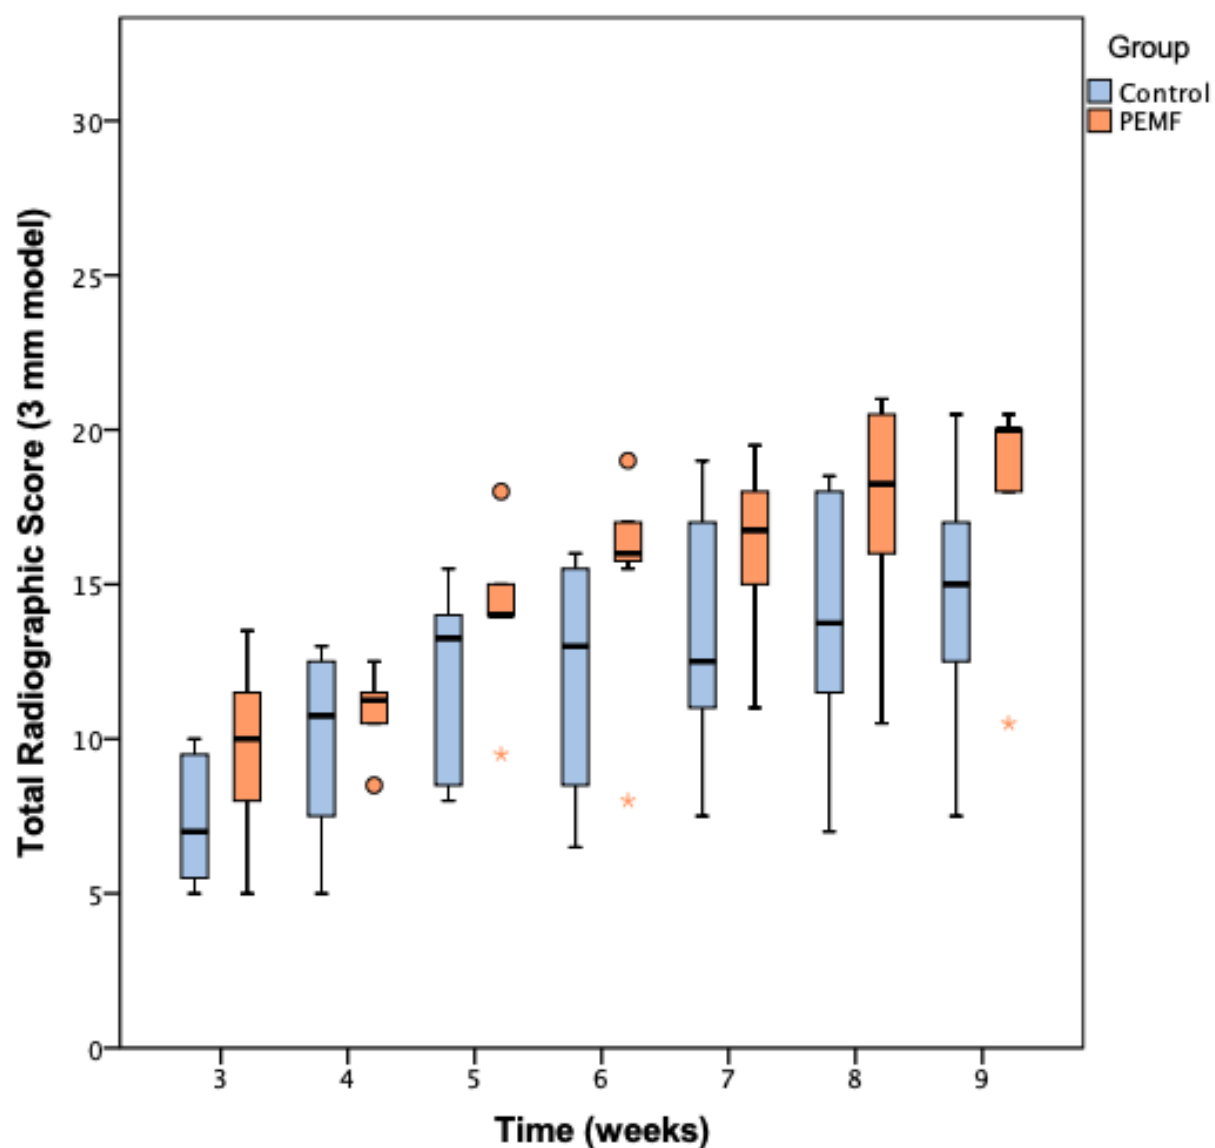
**Figure S3:** Box plot showing total radiographic scores (range 0 – 30) from all 3 mm model sheep from week 3 to week 9.

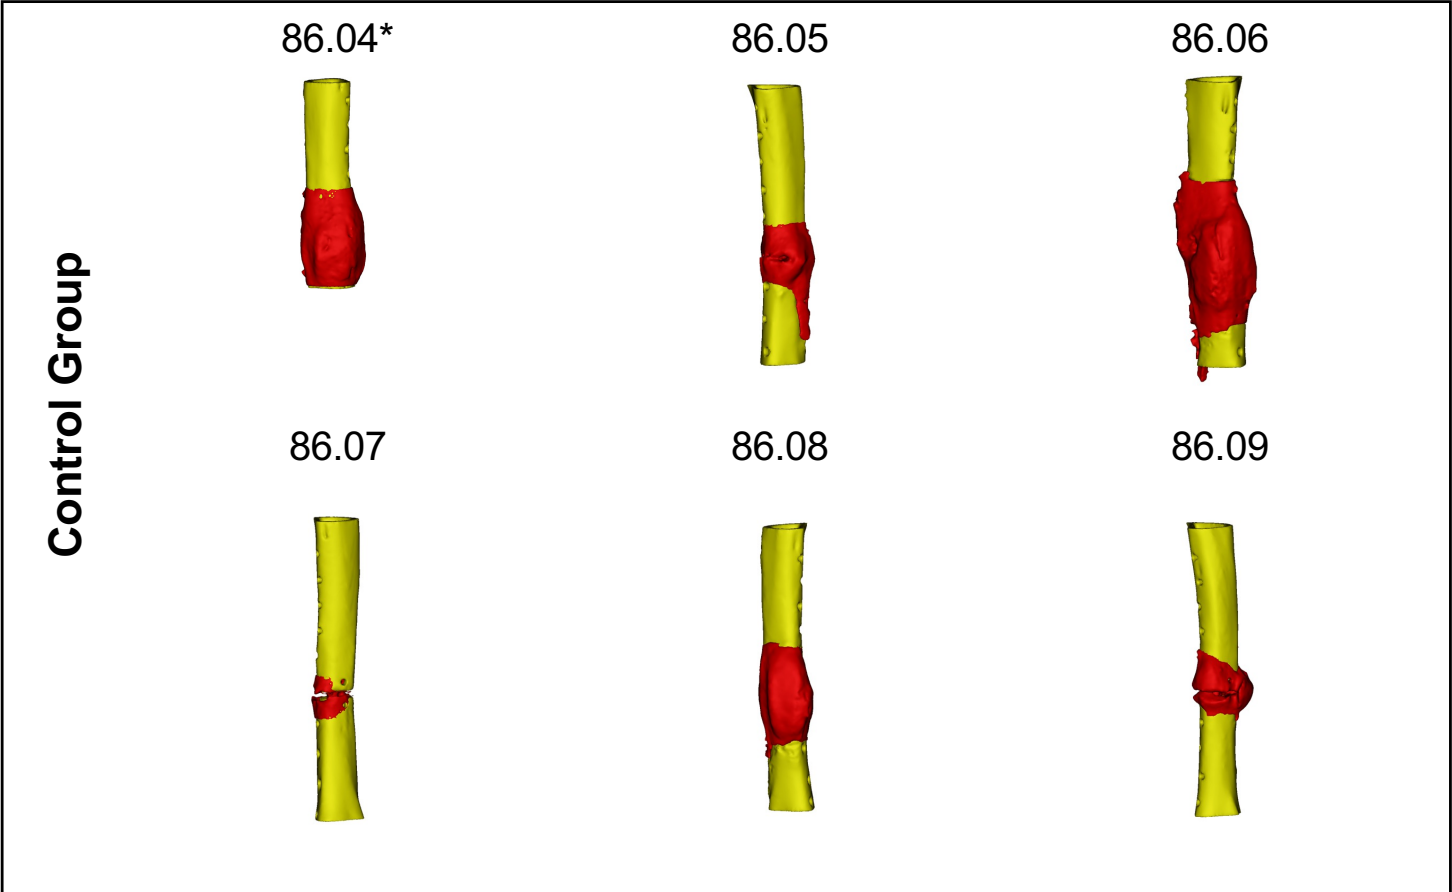
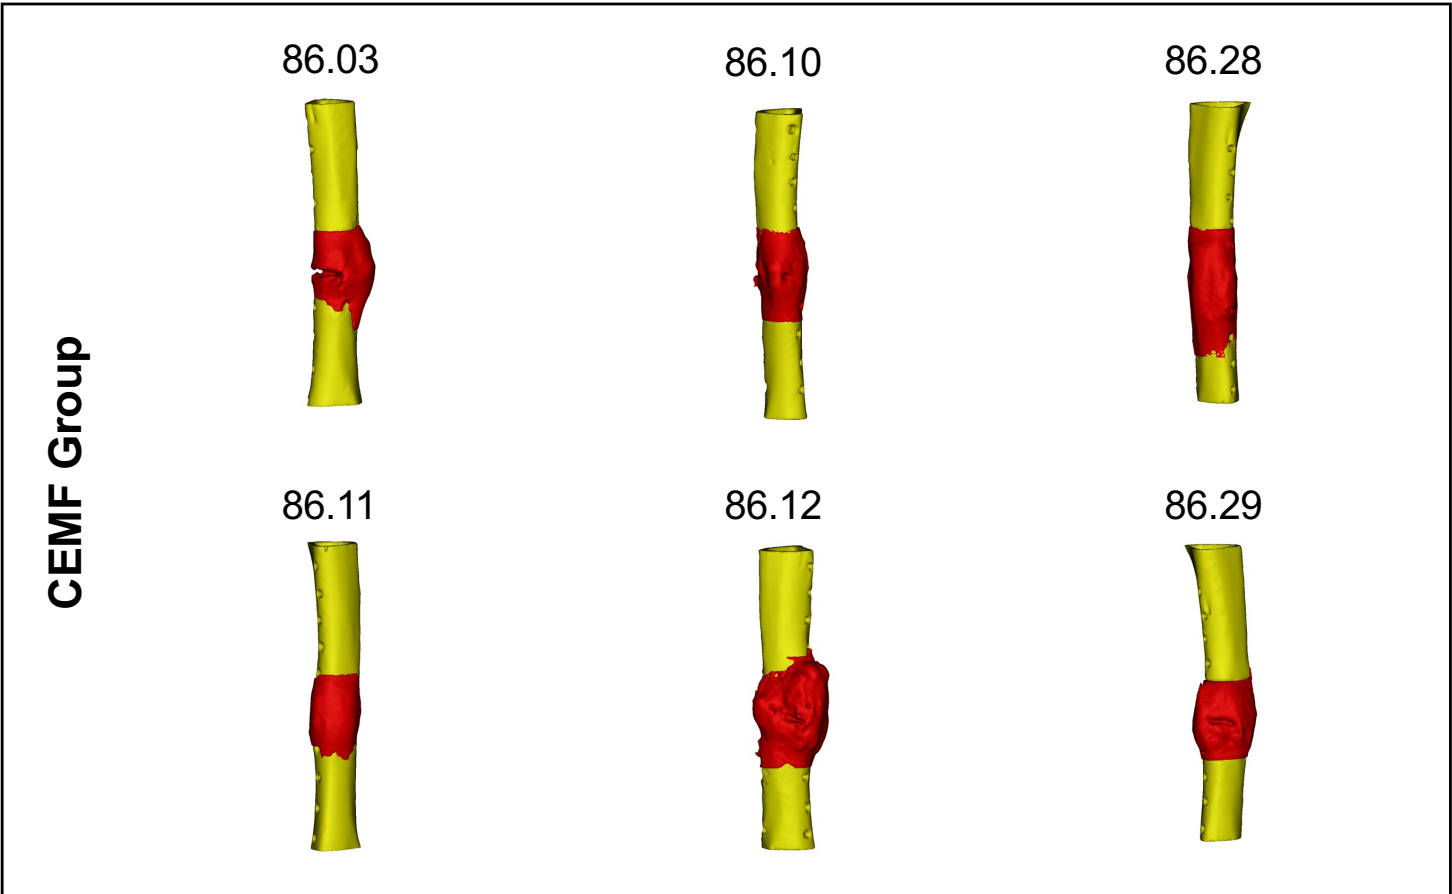
**Figure S4:** 3D renderings of CT scanned operated tibia showing cortical bone (in yellow) and callus (in red) for all sheep of the 3 mm gap model.

\*Scan for 86.04 had a large image artifact from a retained screw fragment. Virtual model was cropped to remove the affected region.

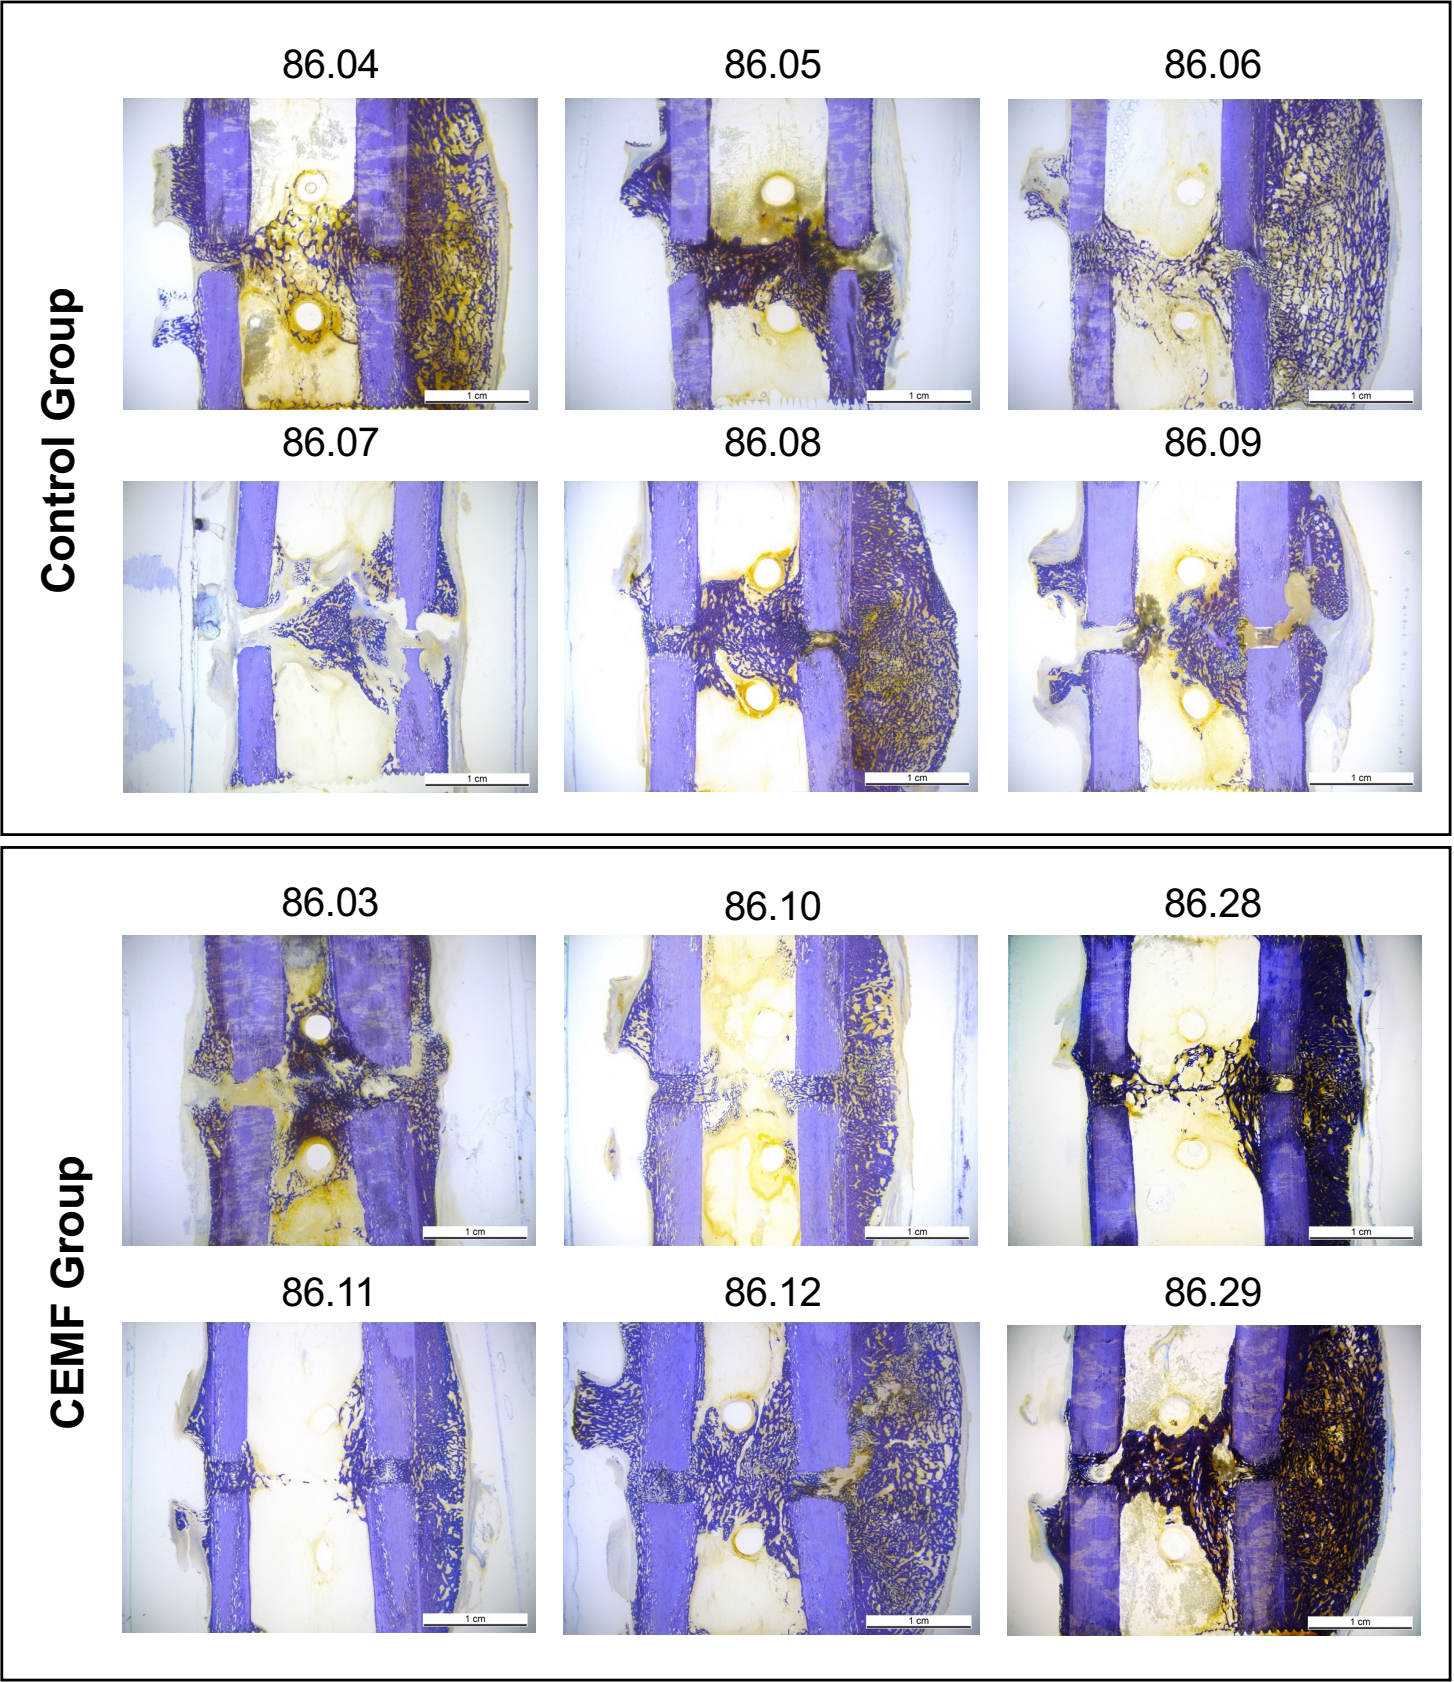
**Figure S5:** Toluidine blue surface stained ground sections for all sheep of the 3 mm gap model.

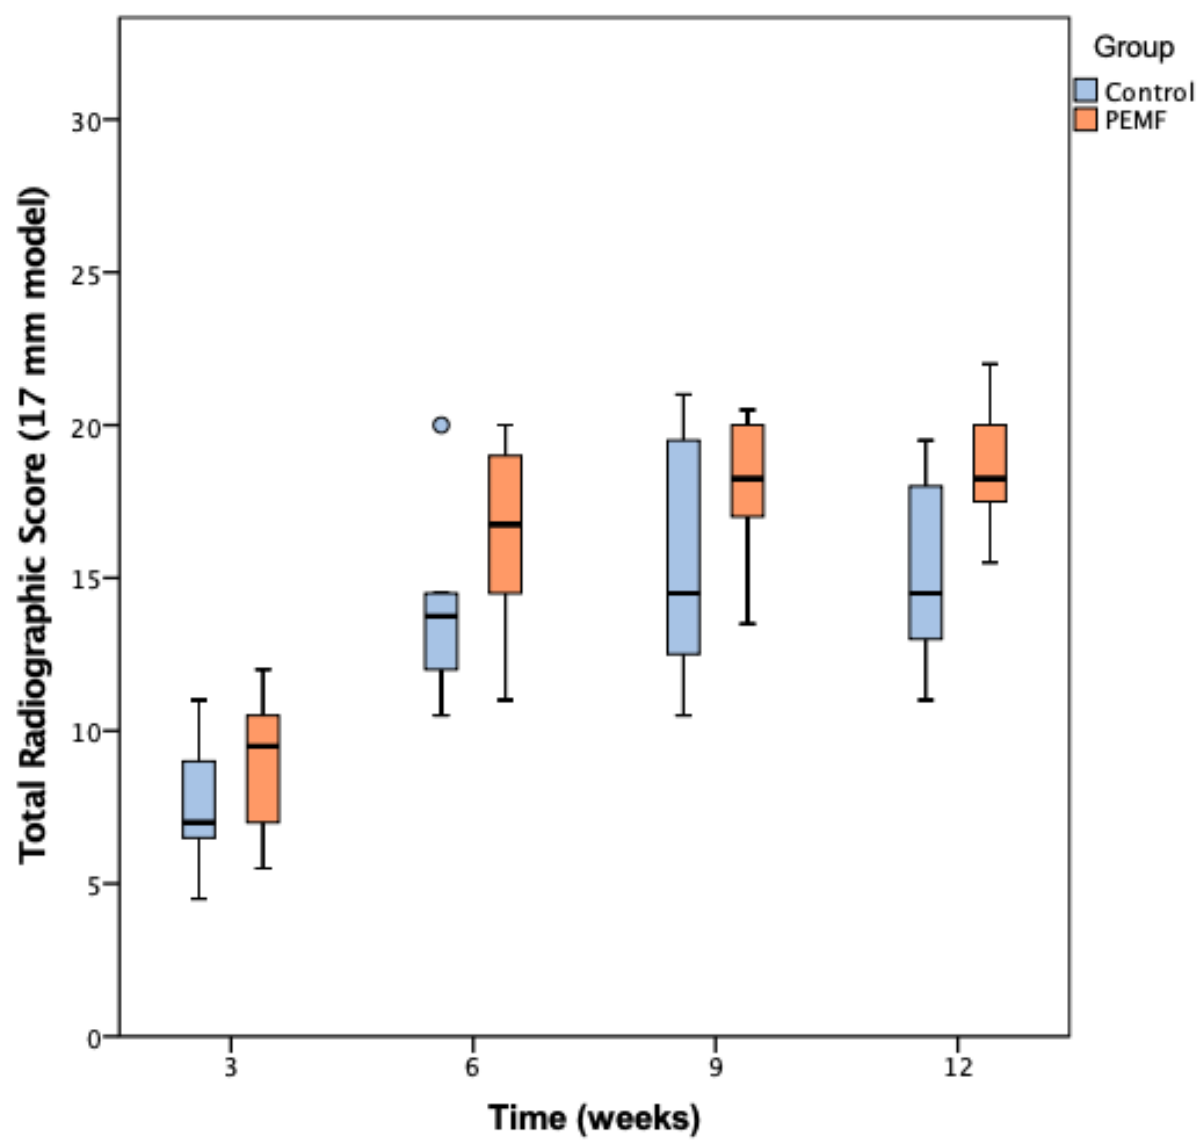
**Figure S6:** Box plot showing total radiographic scores (range 0 – 30) from all 17 mm model sheep from week 3 to week 12.

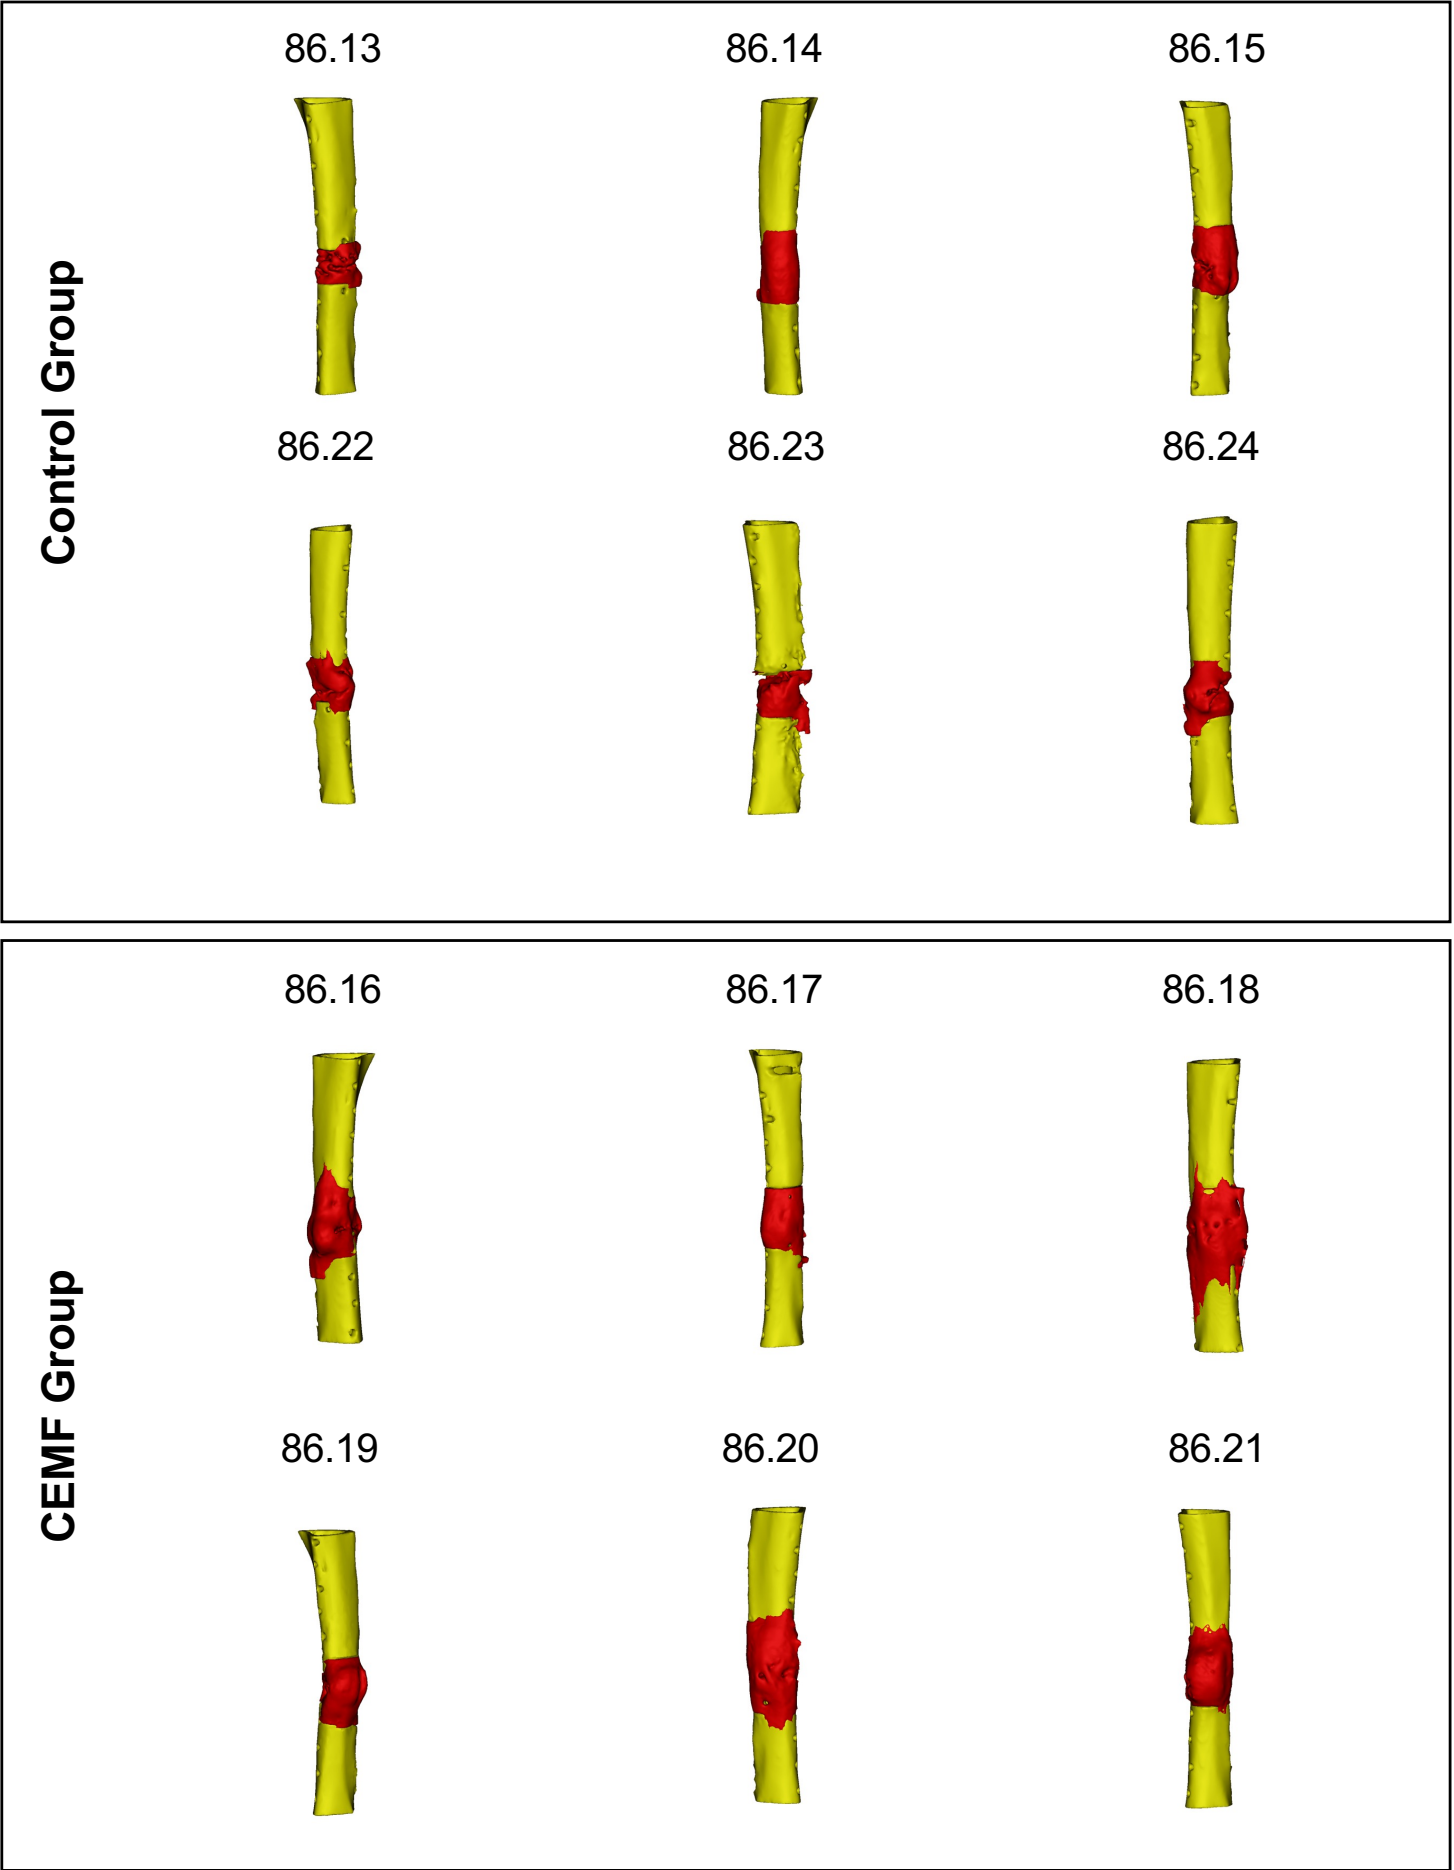
**Figure S7:** 3D renderings of CT scanned operated tibia showing cortical bone (in yellow) and callus (in red) for all sheep of the 17 mm graft model.

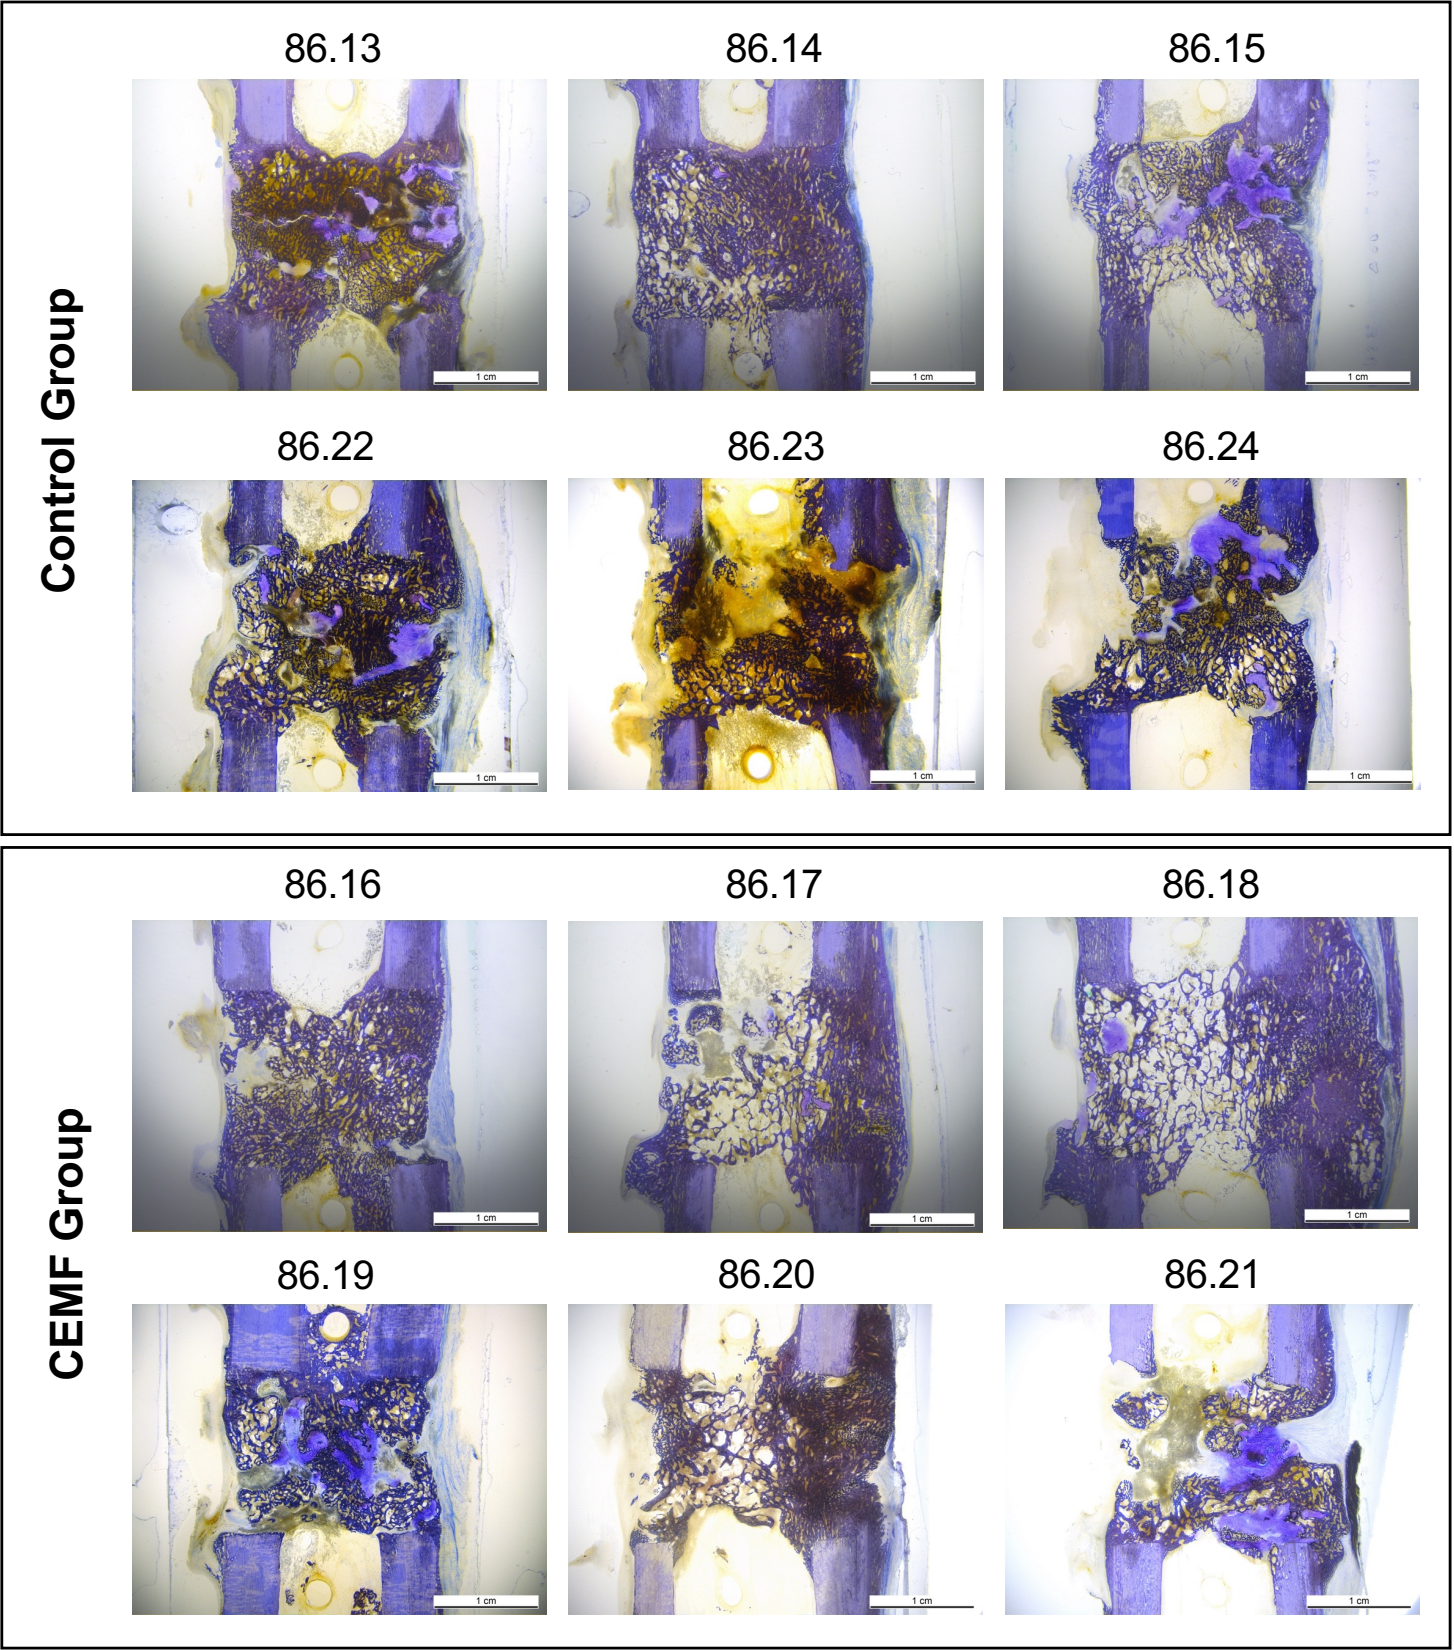
**Figure S8:** Toluidine blue surface stained ground sections for all sheep of the 17 mm graft model.
